**ANALYTICAL EVALUATION OF SELECTED CONCRETE  
STRUCTURES AGAINST EARTHQUAKES IN TURKEY**

**M.Sc. THESIS IN  
CIVIL ENGINEERING**

**FERİDE CEYLAN**

**JANUARY 2024**

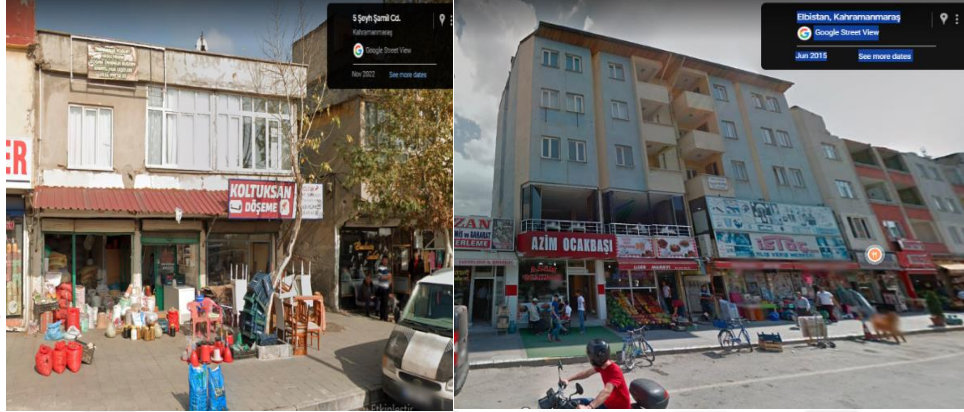
Figure 4. 8: Soft/weak floor condition of the examined structures

time of seismic effects, deformations and earthquake energy due to irregularities are concentrated on a single floor, causing the loss of stability of the structure [19].  
 Figura 4.8 soft/weak floor conditions in buildings.

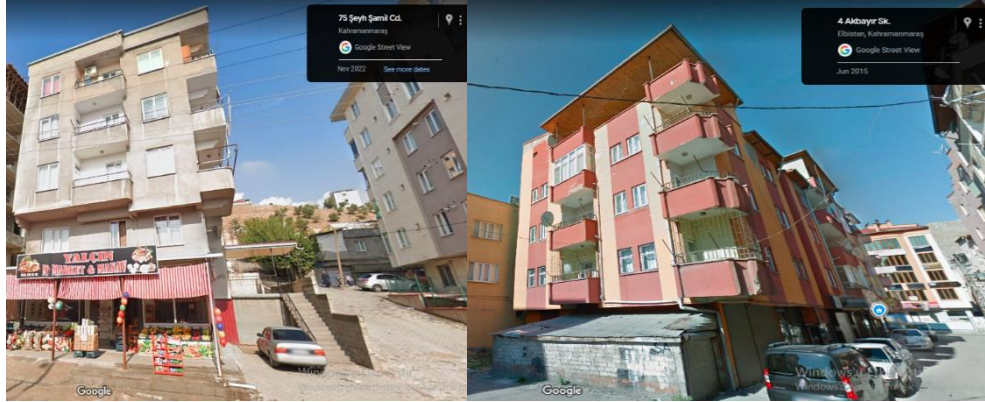
Figure 4. 9: Severe protrusion conditions in the examined structures

The due diligence of the heavy protrusions in the examined buildings is shown in the figure 4.9 below is also located.

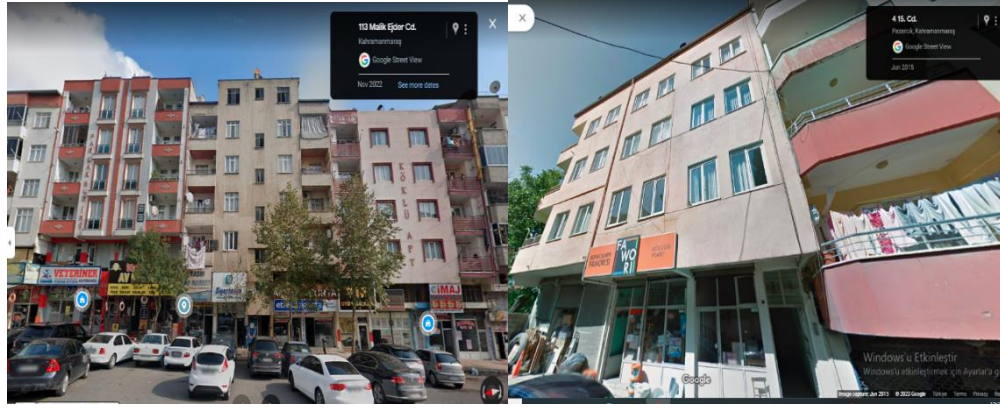
Figure 4. 10: Slab levels in the building layout/adjacent buildings under investigation

Building order / determination of the status of floor levels with adjacent buildings figure 4.10 in the buildings examined is also shown.

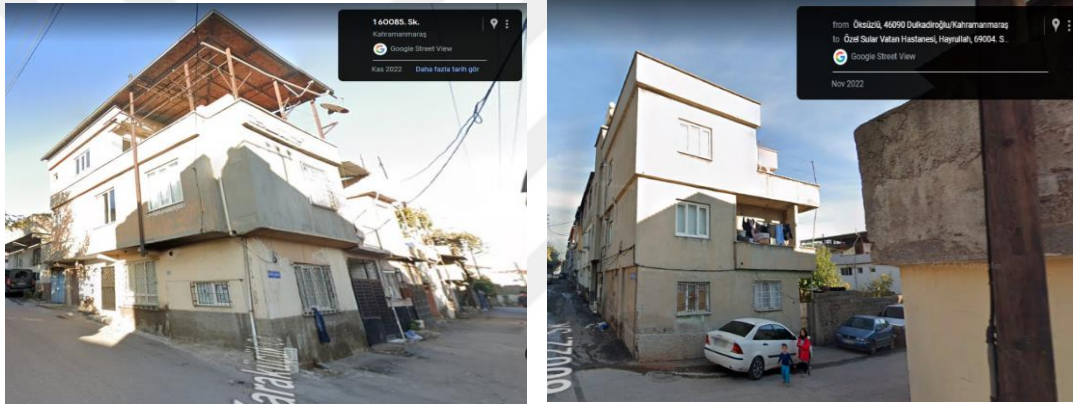
Figure 4. 12: Vertical irregularity of the examined structures

of the structures was detected. Figure 4.12 There are examples of vertical irregularities of the structures examined. [8].

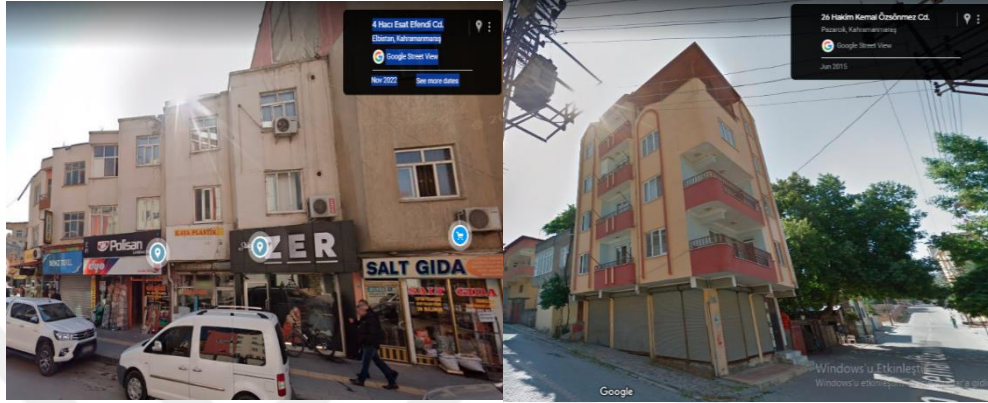
Figure 4. 14: Irregularity in the plan of the buildings examined

Another parameter taken into account is the straining/torsional effect in the plan. When the building plan is examined geometrically, the fact that it is not symmetrical or the irregular placement of the vertical structural elements reveals the non-filtering/torsional effect in the plan. While making the calculations, it was determined by taking into account the inconsistencies in the plan that may cause torsion in the structure. How the irregularity situation is determined in the plan is included in the figure 4.13. Figure 4.14 There are examples of irregularities in the plan of the buildings examined. [8].

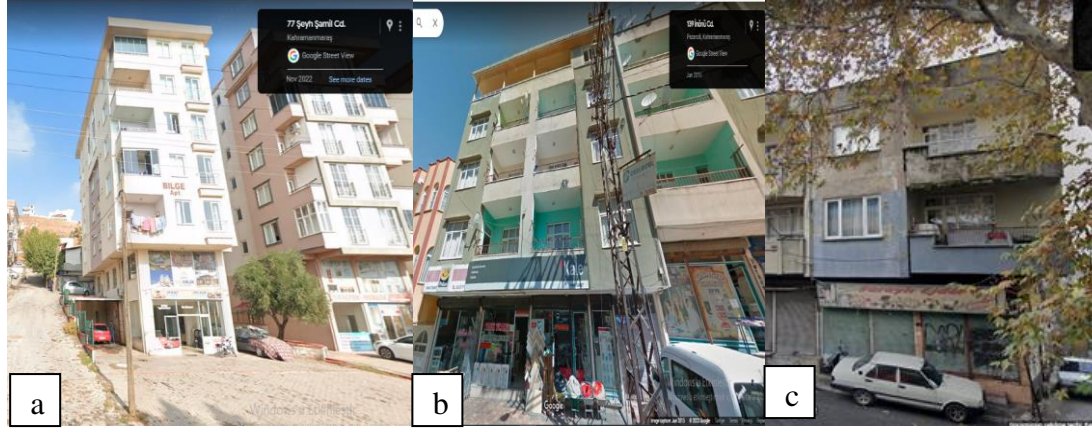
Figure 5. 3: good quality building b) Medium quality building c) Poor quality building

In terms of image quality, 22.5% were good, 45.83% were medium and 30.83% were poor. 59.17% of the buildings were built adjacent to each other. In this distribution, 20% of Dulkadiroğlu district, 29.17% of Elbistan district and 10% of Pazarcık district were built adjacent to each other. The fact that the number of floors is different in adjacent buildings, the floor levels are different and the building is on the adjacent edge increases the risk level.

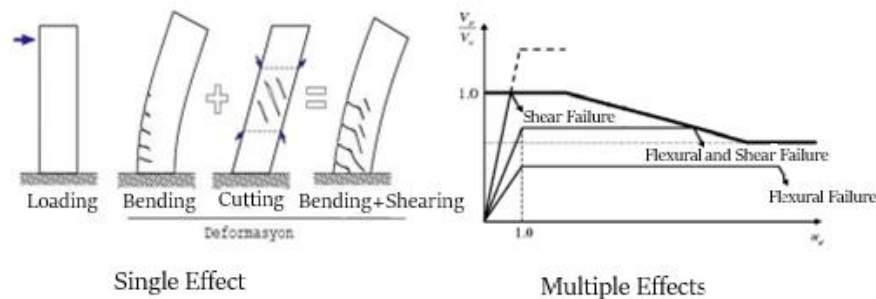
Figure 5. 7: Single and multiple impact injuries in columns

If the shear force, axial force and moment acting on reinforced concrete columns are more than the bearing capacity of the column, damage occurs in the column, which is the carrier element. Damage is seen in the column due to the inclined shear cracks being 45 degrees in the column, the formation of gaps due to the inability of the concrete to settle due to the dense longitudinal reinforcement in the column, the lack of strength of the concrete compressive strength between the concrete and the reinforcement, and the insufficient carrying capacity of the shear force in the column [23]. The formation of 45-degree shear cracks is due to the fact that the stirrup is not sufficient in the area where the junction areas of the column are located and the reinforcement sprout lengths are not paid attention to. Oblique shear cracks that occur in case of stirrup insufficiency also cause brittle fracture of the concrete [24]. In cases where concrete and reinforcement do not work together, the reinforcements are separated from the concrete when they do not reach the yield stress. The event that causes them to collapse suddenly occurs due to the crushing and cracking of the concrete before the longitudinal reinforcement of the column reaches the flow level. In this case, concrete pressure fracture damage occurs if the concrete compressive strength of the column or the excessive axial load of the column is very low. [23]

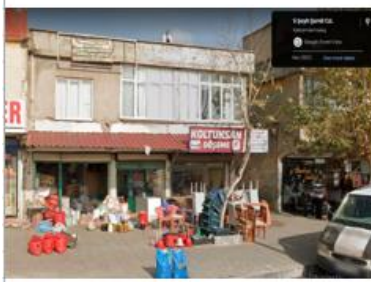
| | 4. YAPI | kat sayısı | 2 | | | YSP(BAÇP) | BDP |
| | | deprem sınıfı puanı | 2. bölge | | 120 | | 75 |

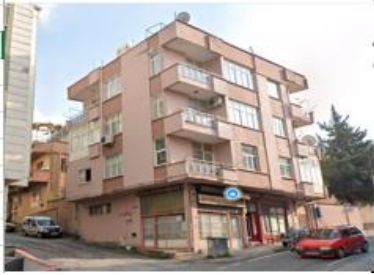
| | 40. YAPI | kat sayısı | 4 | | | YSP(BAÇP) | BDP |
| | | deprem sınıfı puanı | 2. bölge | | 90 | | 22 |

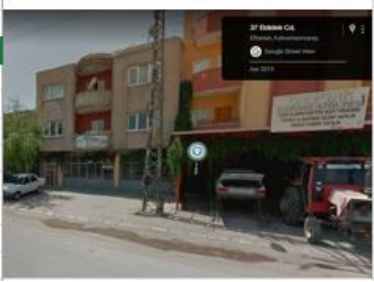
| | 42. YAPI | kat sayısı | 3 | | | YSP(BAÇP) | BDP |
| | | deprem sınıfı puanı | 2. bölge | | 100 | | 30 |

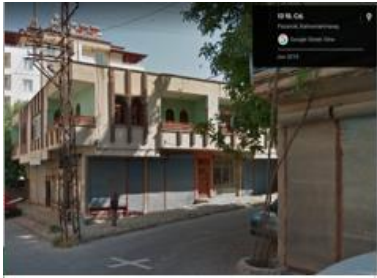
| | 81. YAPI | kat sayısı | 2 | | | YSP(BAÇP) | BDP |
| | | deprem sınıfı puanı | 1. bölge | | 90 | | 42 |

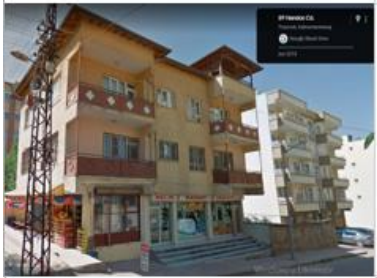
| | 82. YAPI | kat sayısı | 3 | | | YSP(BAÇP) | BDP |
| | | deprem sınıfı puanı | 1. bölge | | 80 | | 25 |

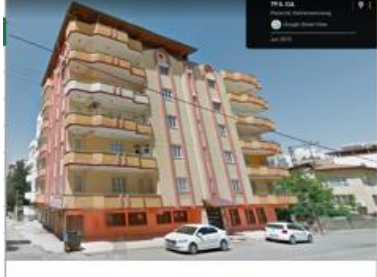
| | 83. YAPI | kat sayısı | 5 | | | YSP(BAÇP) | BDP |
| | | deprem sınıfı puanı | 1. bölge | | 60 | 65 | 60 |

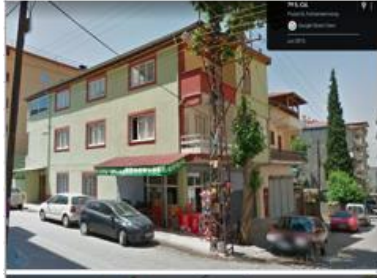
| | 84. YAPI | kat sayısı | 3 | | | YSP(BAÇP) | BDP |
| | | deprem sınıfı puanı | 1. bölge | | 80 | | 15 |

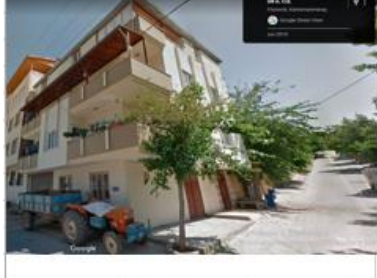
| | 85. YAPI | kat sayısı | 4 | | | YSP(BAÇP) | BDP |
| | | deprem sınıfı puanı | 1. bölge | | 70 | 75 | 52 |

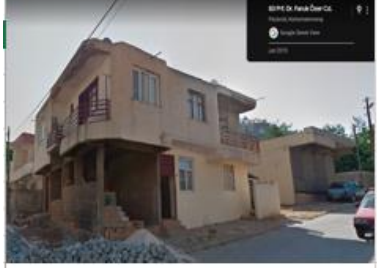
| | 86. YAPI | kat sayısı | 2 | | | YSP(BAÇP) | BDP |
| | | deprem sınıfı puanı | 1. bölge | | 90 | | 45 |

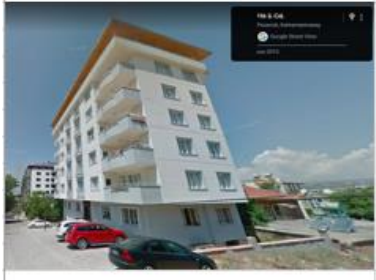
| | 87. YAPI | kat sayısı | 7 | | | YSP(BAÇP) | BDP |
| | | deprem sınıfı puanı | 1. bölge | | 50 | 55 | 70 |

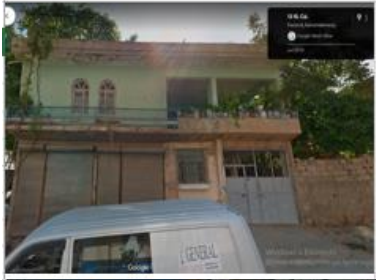
| | 88. YAPI | kat sayısı | 2 | | | YSP(BAÇP) | BDP |
| | | deprem sınıfı puanı | 1. bölge | | 90 | | 45 |

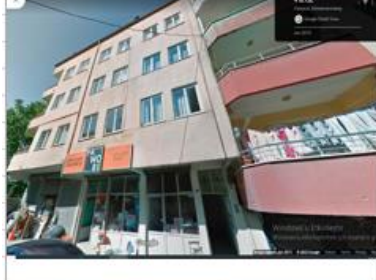
| | 89. YAPI | kat sayısı | 4 | | | YSP(BAÇP) | BDP |
| | | deprem sınıfı puanı | 1. bölge | | 70 | 75 | 55 |

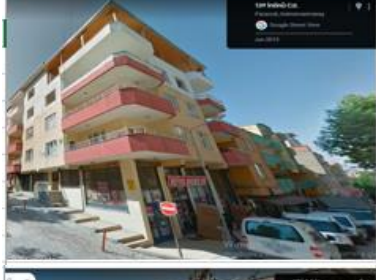
| | 90. YAPI | kat sayısı | 5 | | | YSP(BAÇP) | BDP |
| | | deprem sınıfı puanı | 2. bölge | | 60 | 65 | 22 |

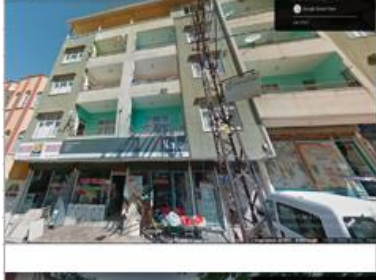
| | 91. YAPI | kat sayısı | 5 | | | YSP(BAÇP) | BDP |
| | | deprem sınıfı puanı | 1. bölge | | 60 | 65 | 5 |

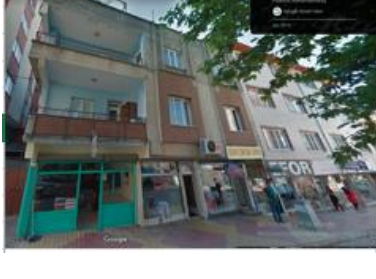
| | 92. YAPI | kat sayısı | 3 | | | YSP(BAÇP) | BDP |
| | | deprem sınıfı puanı | 1. bölge | | 80 | | 15 |
