THE USE OF ASBESTOS AS A CONSTRUCTION MATERIAL IN PUBLIC  
BUILDINGS: A CASE STUDY

A THESIS SUBMITTED TO  
THE GRADUATE SCHOOL OF NATURAL AND APPLIED SCIENCES  
OF  
MIDDLE EAST TECHNICAL UNIVERSITY

JANUARY 2020

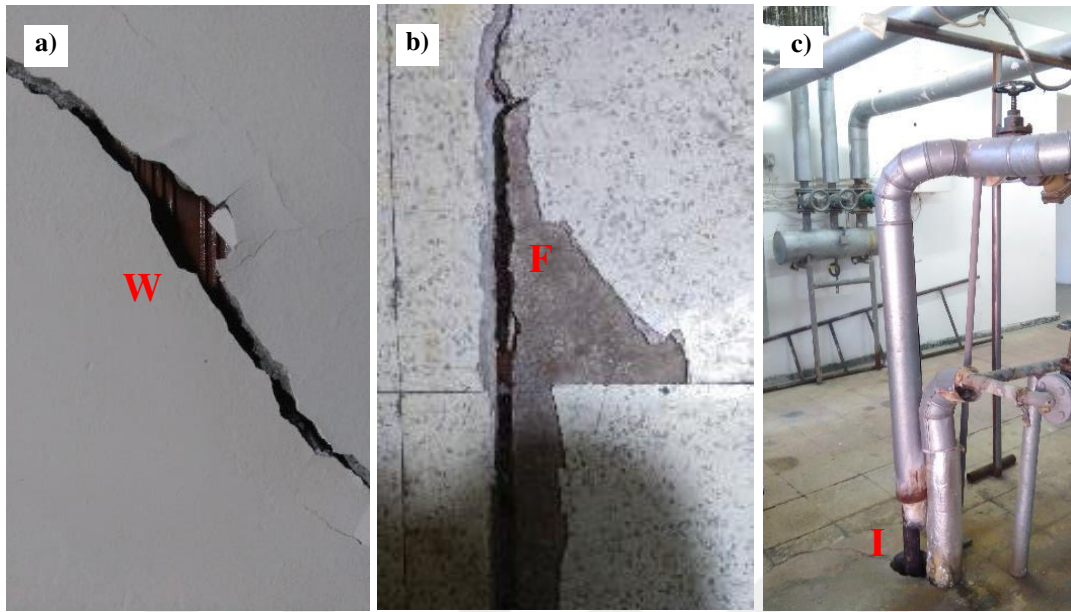
*Figure 3.1. The Building-A's current conditions; a) wall (W), b) floor (F), c) insulation (I)*

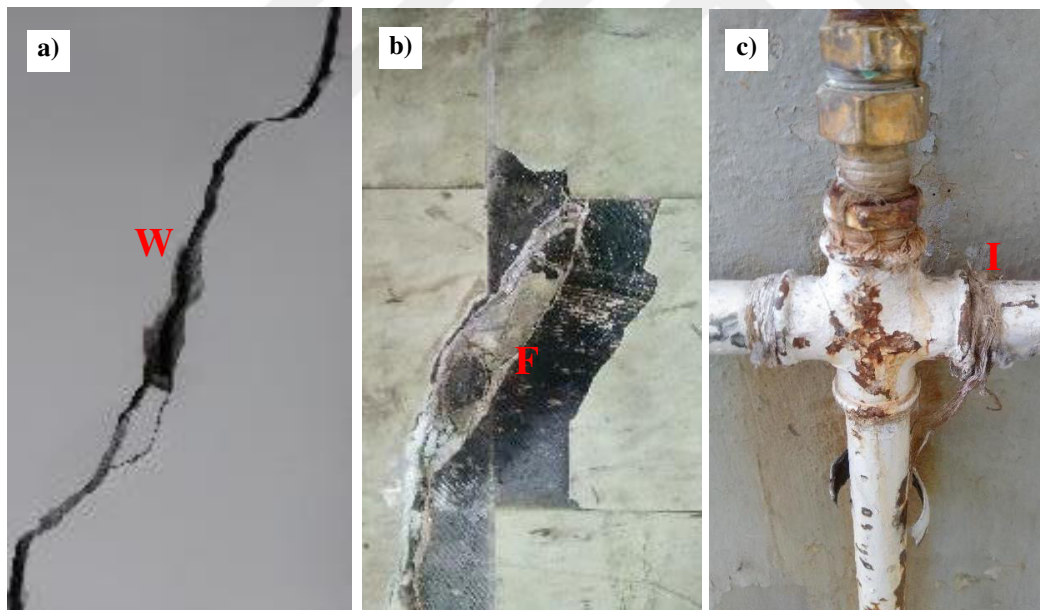
*Figure 3.2. The Building-B's current conditions; a) wall (W), b) floor (F), c) insulation (I)*

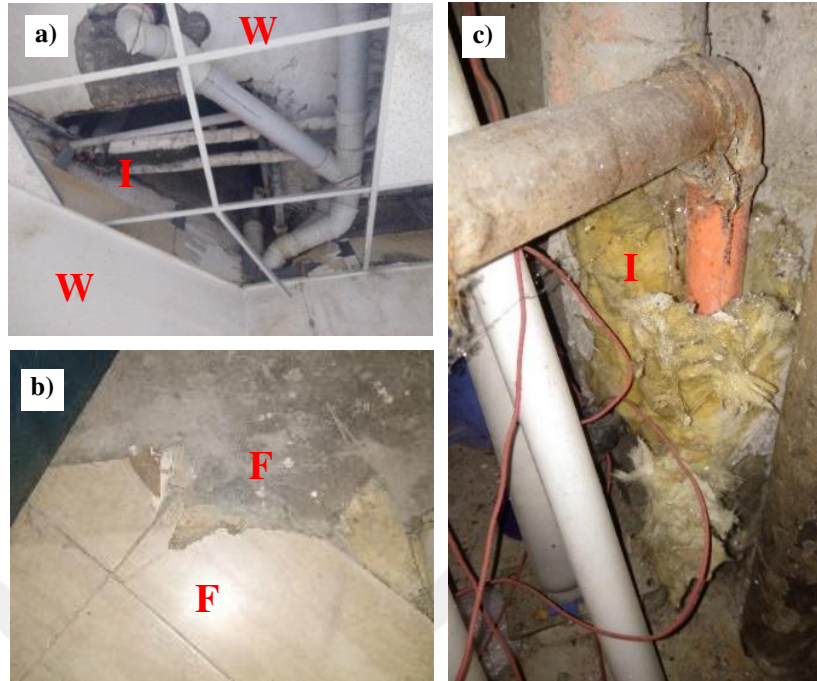
Figure 3.3. The Building-C's current conditions; a) wall (W) and insulation (I), b) floor (F), c) insulation (I)

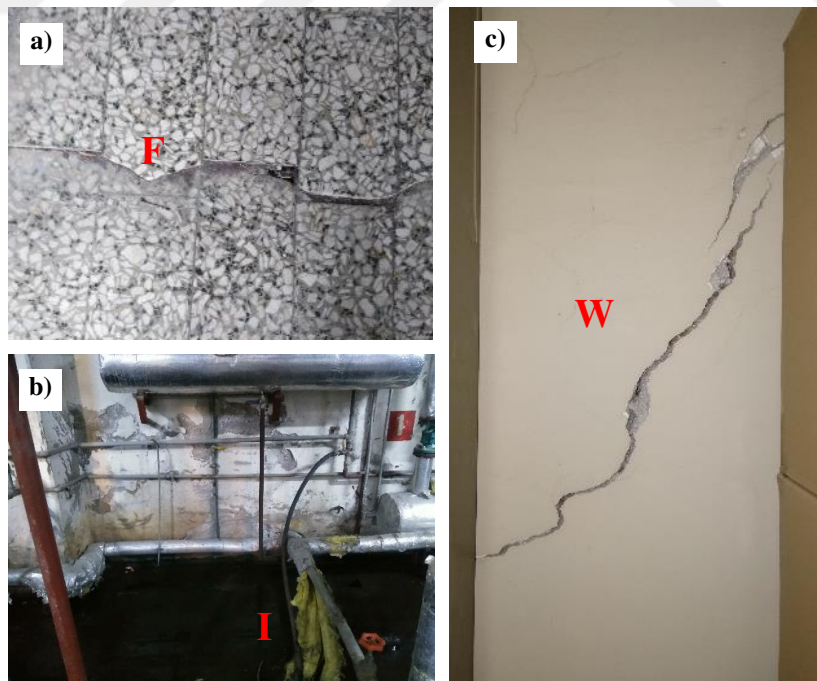
Figure 3.4. The Building-D's current conditions; a) floor (F), b) insulation (I), c) wall (W)

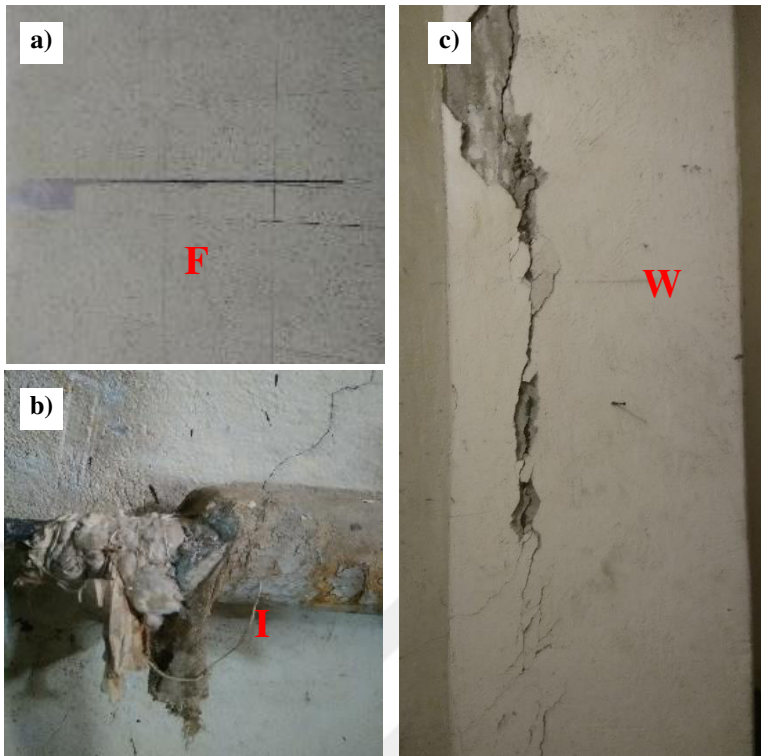
Figure 3.5. The Building-E's current conditions; a) floor (F), b) wall (W) & insulation (I), c) wall (W)

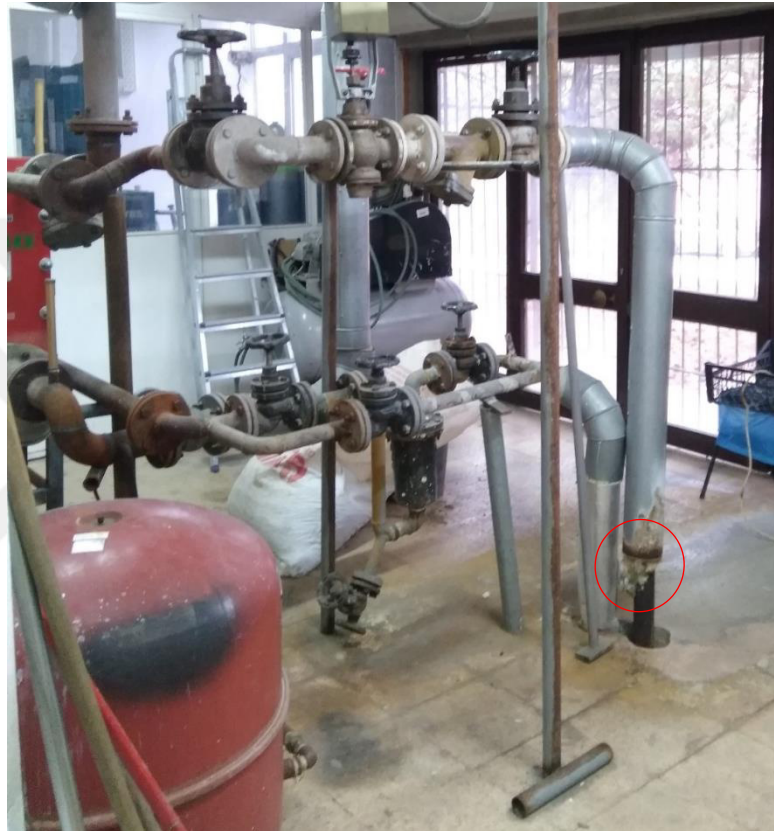
*Figure 4.2. The selected area for the risk assessment in Building-A [red circle shows the sampling location]*

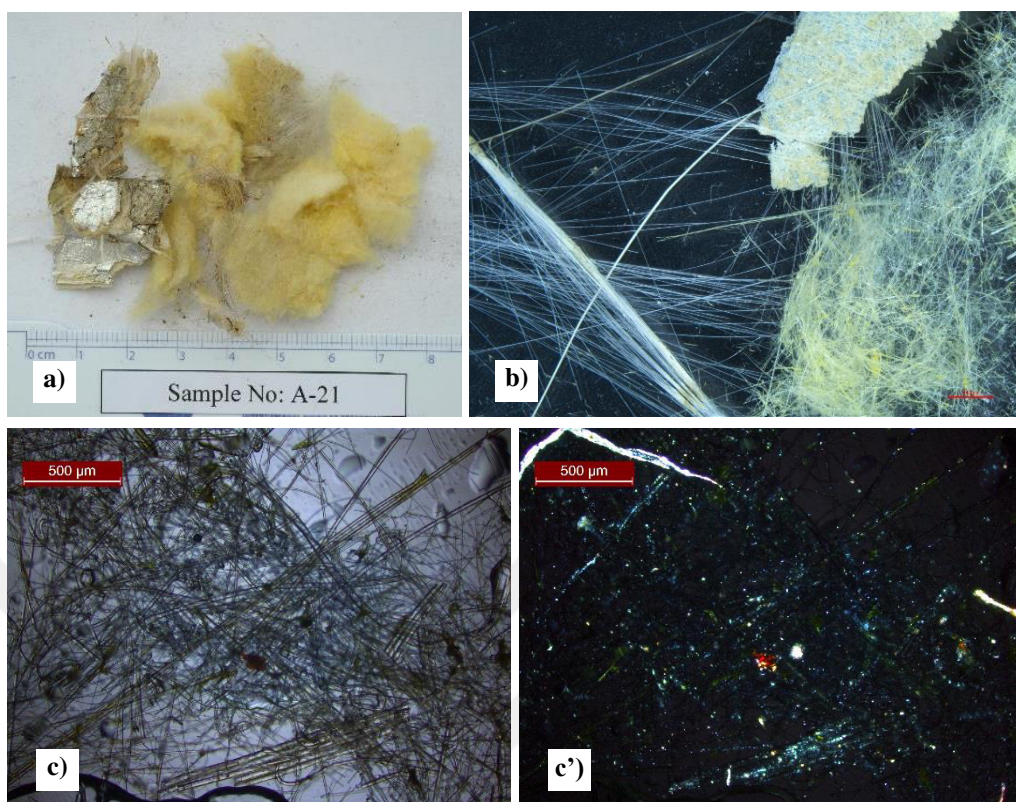
Figure 4.3. Macro to micro photographs of the sample A-21; a) sample's general view b) SM view, c&c') PLM view

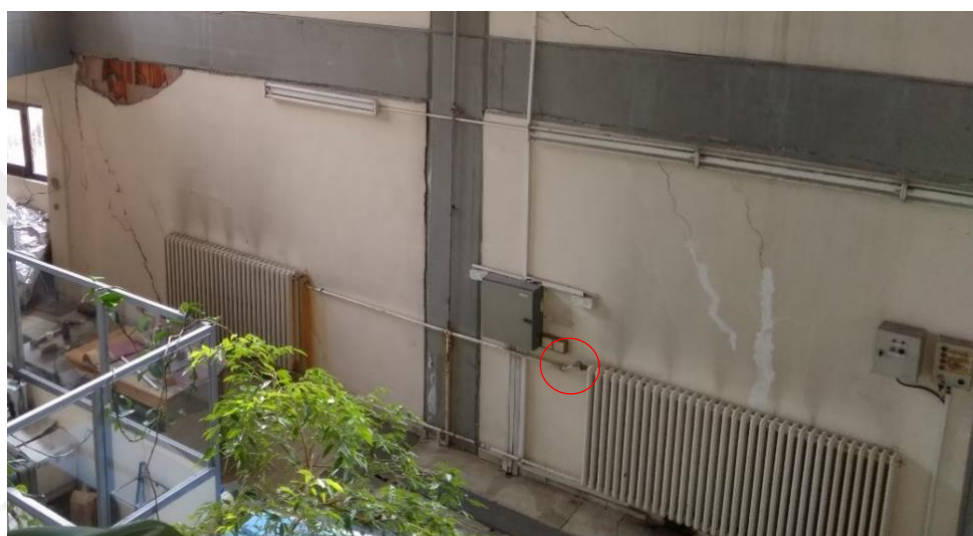
Figure 4.5. The selected area for risk assessment in the Building-B [red circle shows the sampling location]

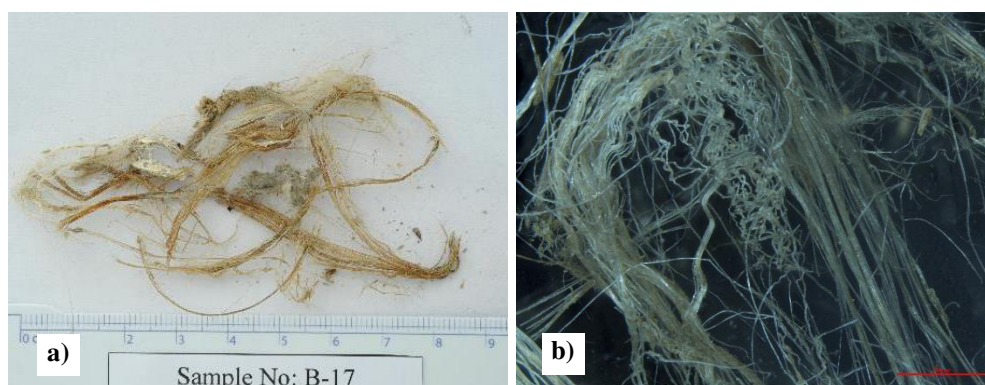
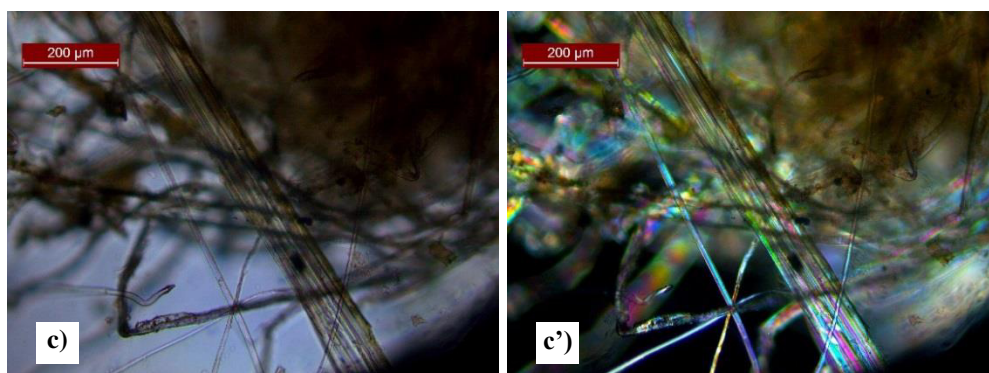
Figure 4.6. Macro to micro photographs of the sample B-17; a) sample's general view b) SM view, c&c') PLM view

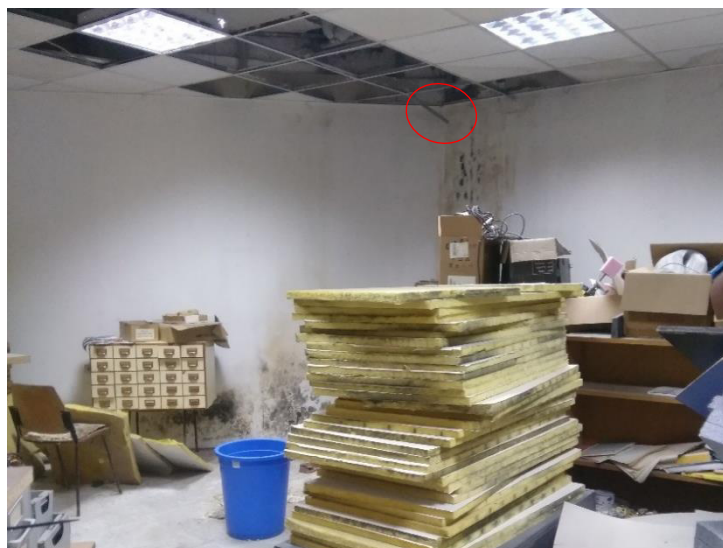
*Figure 4.8. The selected area for risk assessment in the Building-C [red circle shows the sampling location]*

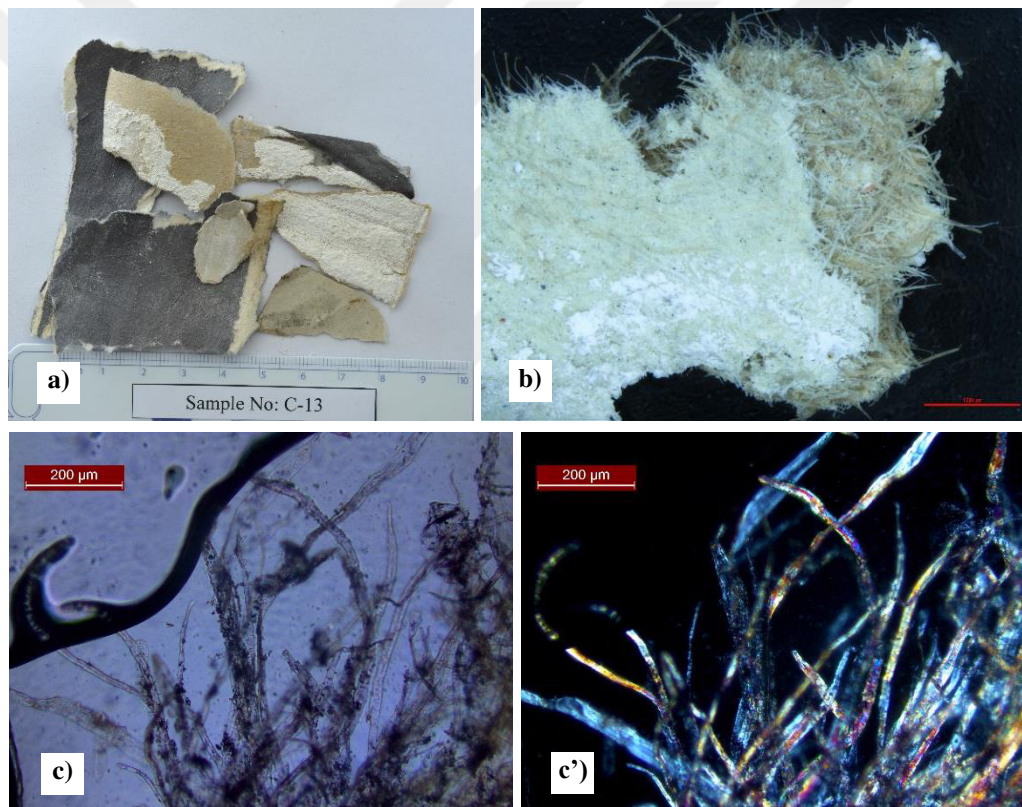
Figure 4.9. Macro to micro photographs of the sample C-13; a) sample's general view b) SM view, c&c') PLM view

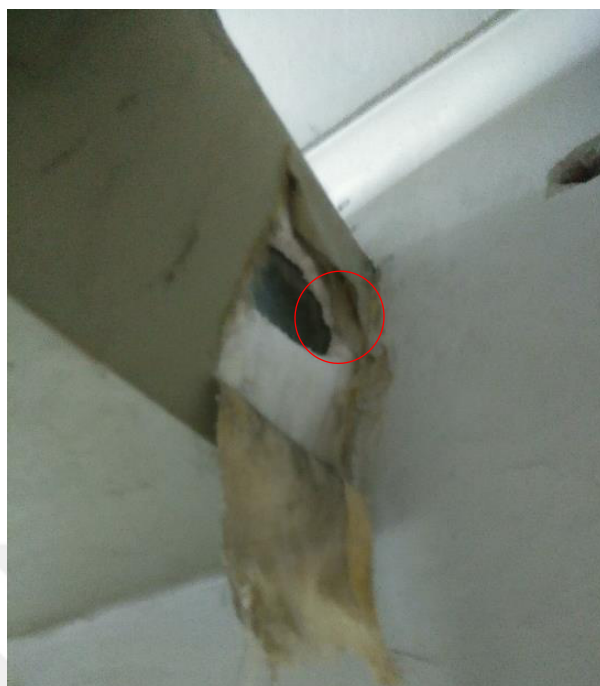
Figure 4.11. Selected area for risk assessment in Building-D [red circle shows the sampling location]

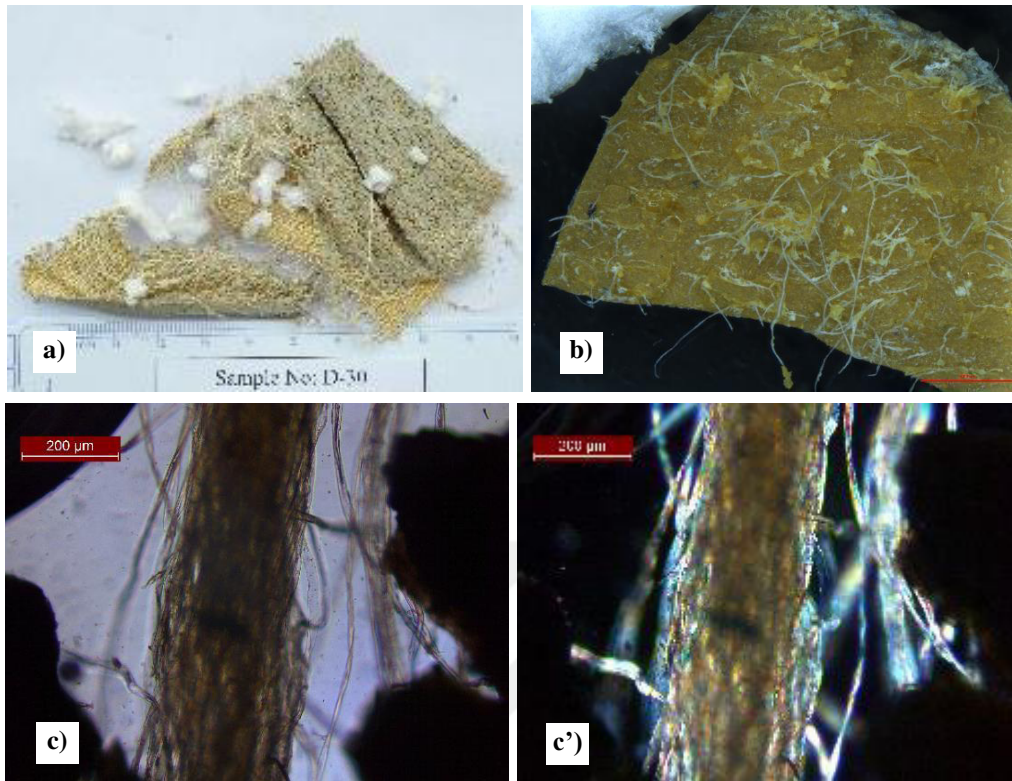
Figure 4.12. Macro to micro photographs of the sample D-30; a) sample's general view b) SM view, c&c') PLM view

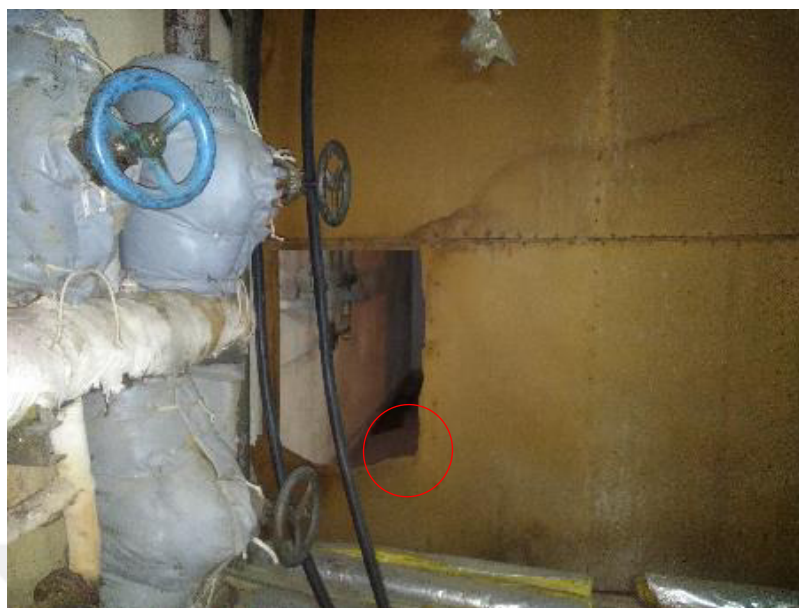
*Figure 4.14. The selected area for risk assessment in the Building-E [red circle shows the sampling location]*

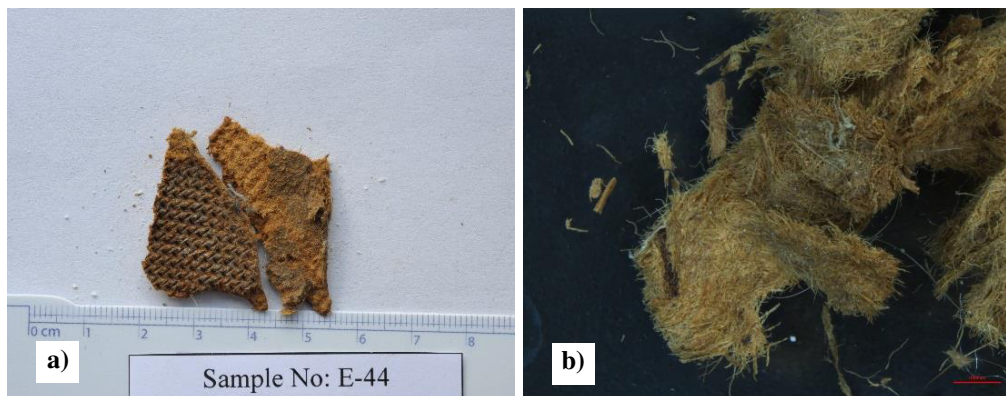
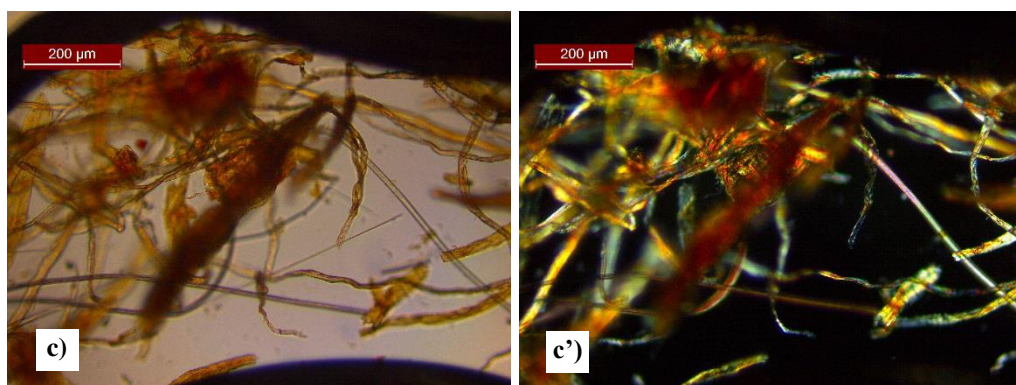
*Figure 4.15.* Macro to micro photographs of the sample E-44; a) sample's general view b) SM view, c&c') PLM view
