# **Analysis of Occupational Construction Accidents in North Cyprus**

Master of Science  
in  
Civil Engineering

Eastern Mediterranean University  
February 2014  
Gazimağusa, North Cyprus

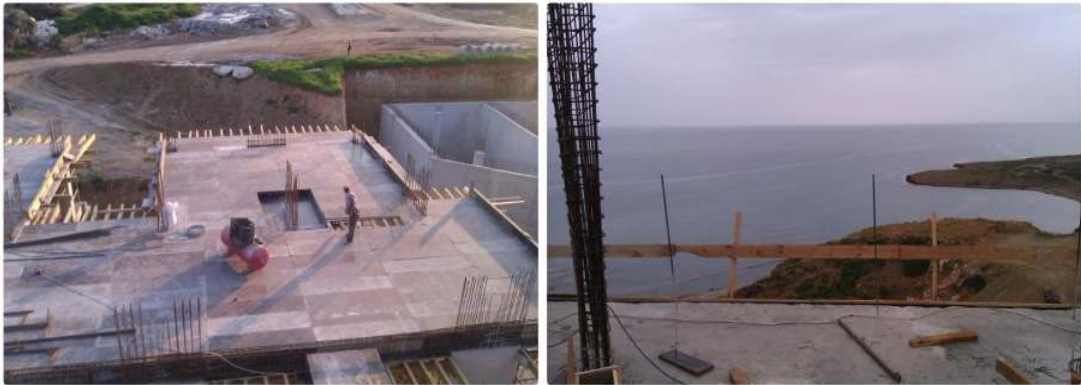
Figure 5.4. Guardrails in LPH project

A guardrail system is a “barrier erected to prevent employees from falling to lower levels”. Guardrail systems are vital for those workers who have to work on elevations of 6 feet (1.8 m) or more above ground level. OSHA regulated guardrails to be constructed from 2 inches (5 cm) x 4 inches (15 cm) lumbers and can range between 39 inches (1 m) and 45 inches (1.14 m) above the working level [41]. Guardrails can be established with different methods such as counterweighing, mounting on the roof as joists, or attaching to the wall or roof of the building. A sample of guardrails for floors and staircases in the case study can be viewed in Figures 5.4, 5.6, 5.7 and 5.8.

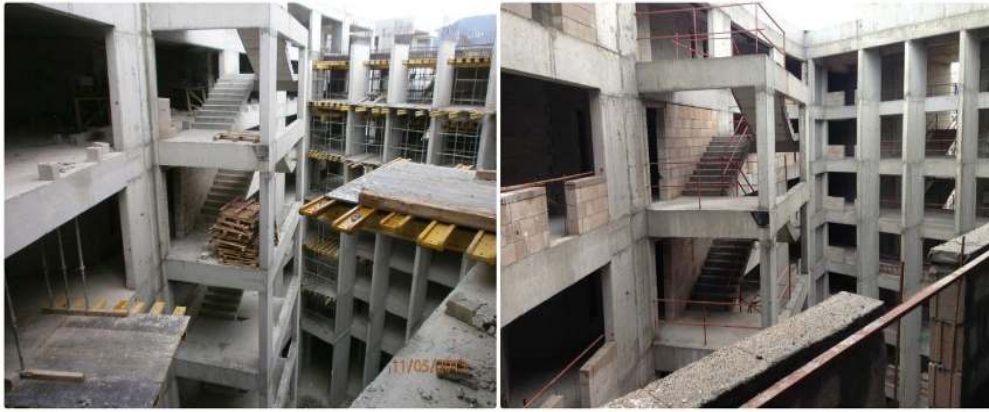
Figure 5.5 Guardrails in staircases (1)

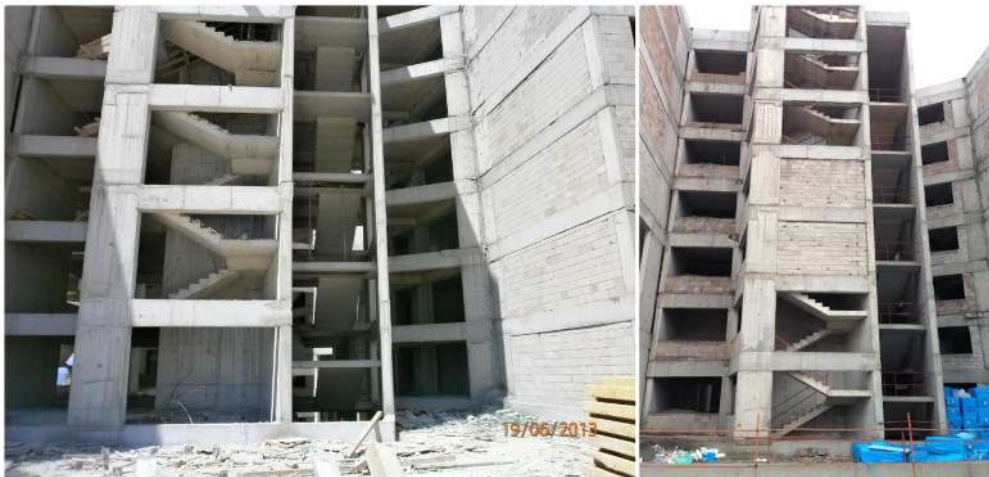
Figure 5.7. Guardrails in staircases (3)

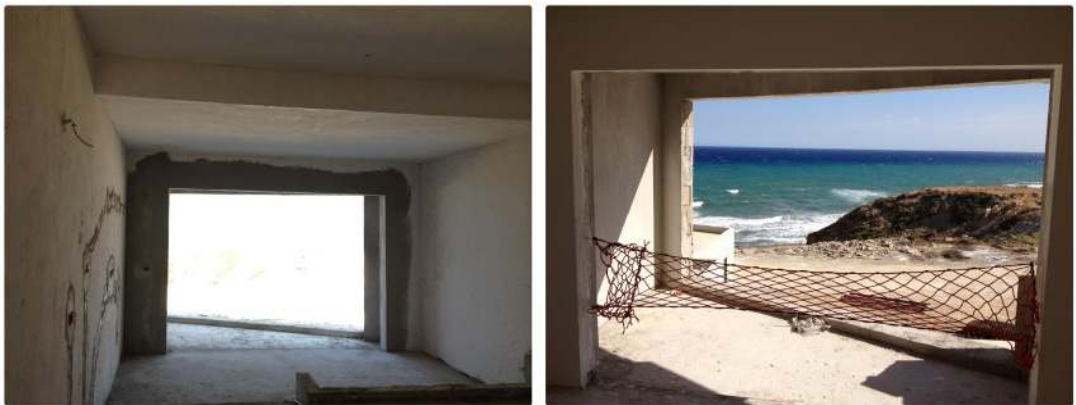
Figure 5.8. Safety net system in LPH project (1)

“A safety net system is a meshed netted structure located under the surface where employees are working which prevents them from making contact with the surfaces at lower levels during a fall. Net system can be used when working on high elevations, the systems should be installed no more than 9.1 m (30 ft) below the working surface and should have sufficient clearance to avoid contact with surfaces at lower levels on lower elevations. Mesh sizes are limited to 15 cm (6 in) by 15 cm (6 in) and should be properly secured to prevent enlargement of mesh openings during a fall [41]”. Figures 5.8 and 5.9 show a net system fall protection in the case study.

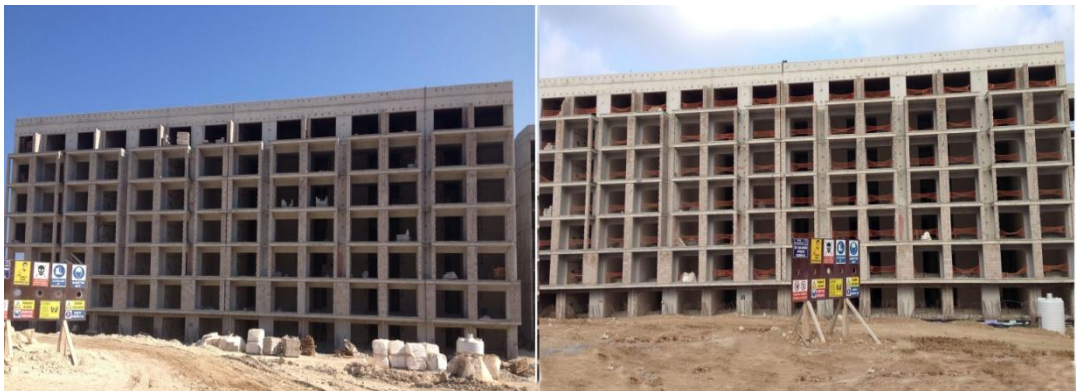
Figure 5.9. Safety net system in LPH project (2)

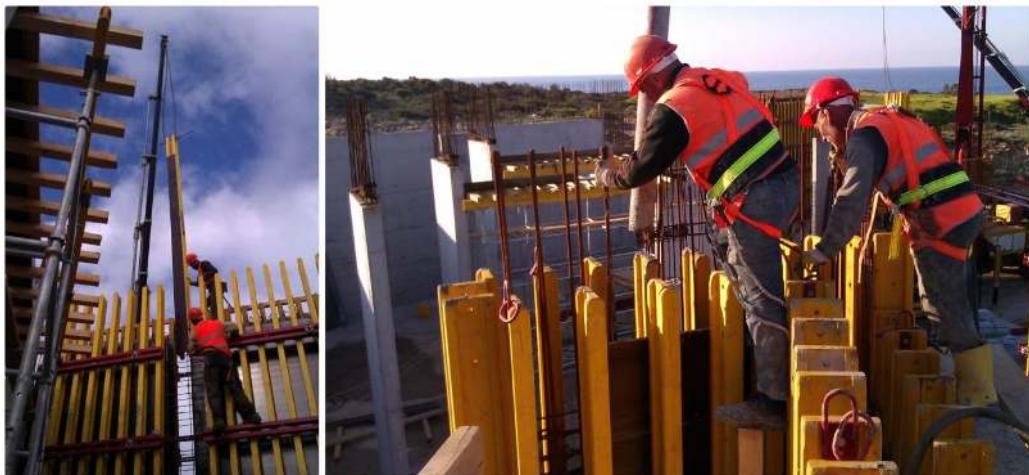
Figure 5.10. Utilizing a harness

“Personal fall arrests are used to protect workers under situations where falls can be potentially very harmful and will prevent the employee from making contact with a potentially dangerous surface below through deceleration. Personal fall arrest systems should be carefully inspected for wear damage and other types of deterioration before being used by employees [41]”. In Figure 5.10 it can be seen that workers during concrete casting used a personal fall arrest system in the image on the right side. The risk of a worker falling while assembling the formwork is observable in the image on the left.

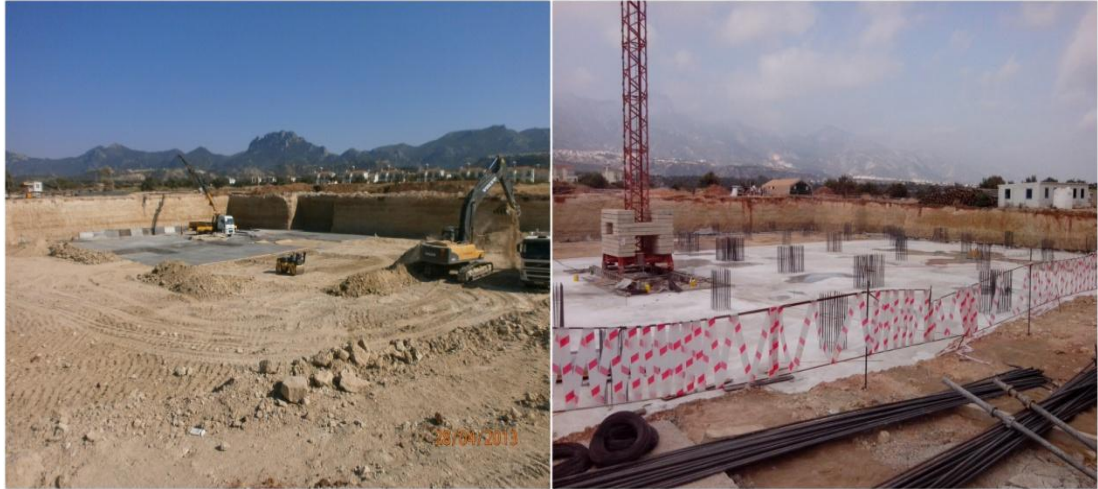
prevent falls [41]. Figure 5.11 shows the warning line system which informed and warned workers about the danger of falling from height.”

Figure 5.11. Warning line systems

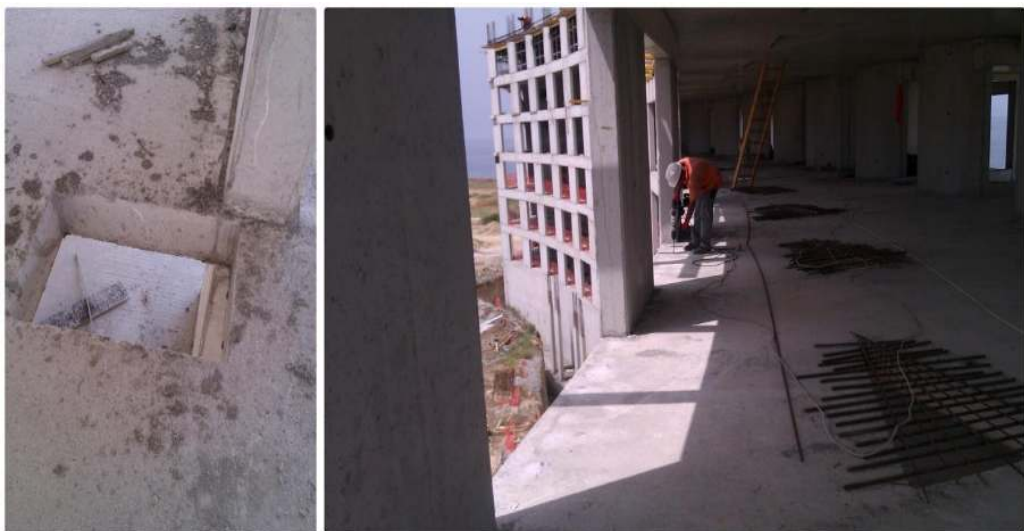
Since a considerable amount of falls occur through openings in floors, it is important to provide procedures to prevent those types of falls by properly covering floor openings [41]. Figure 5.12 depicts that the worker is covering the floor opening.

Figure 5.12. Floor covers for openings

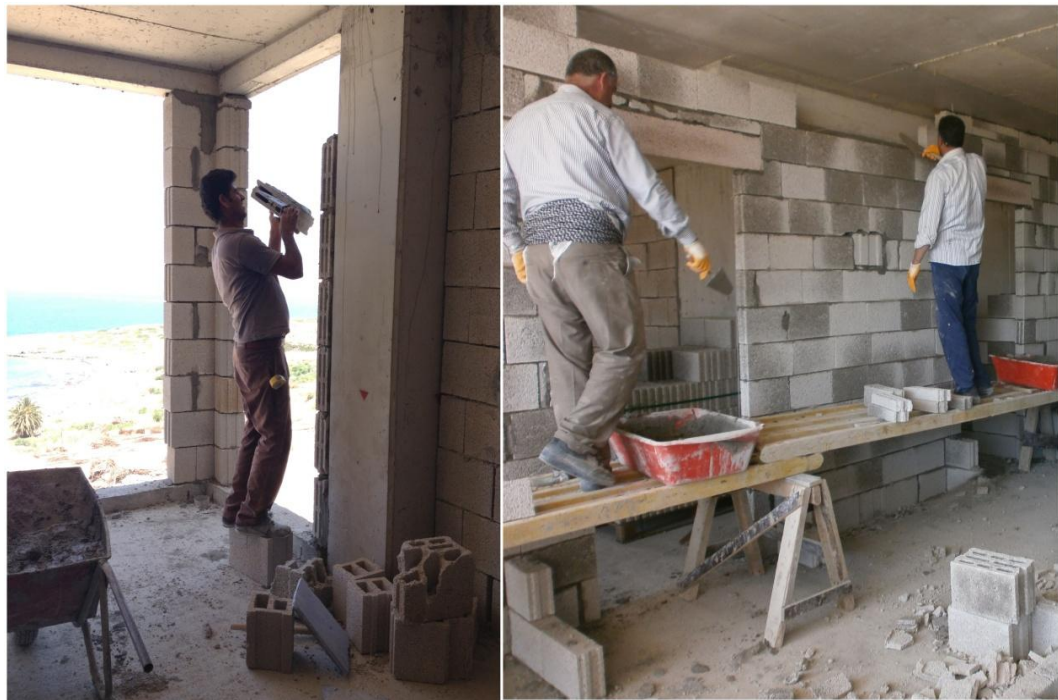
Figure 5.13 shows the appropriate and inappropriate form of using equipment for reaching higher height points of a wall. Using equipment on which the worker does not have any balance, is extremely dangerous.

Figure 5.13. Work at height level

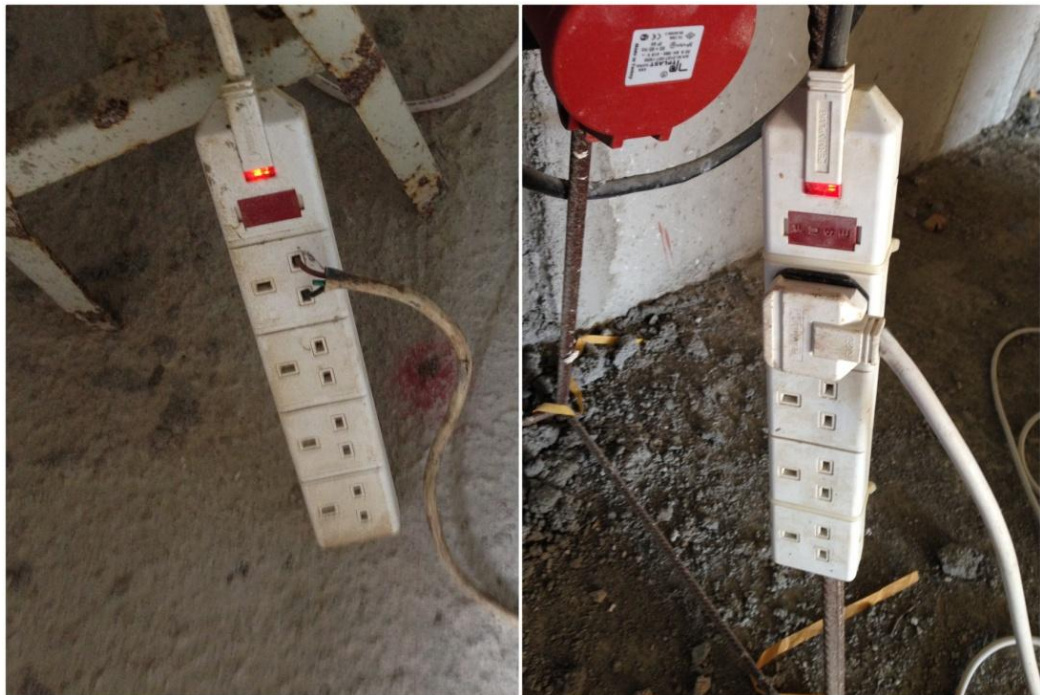
inappropriate forms of electricity plugging is shown in Figures 5.14 and 5.15. The lack of standard sockets can result in dangerous consequences.

Figure 5.15. Electric extension and socket

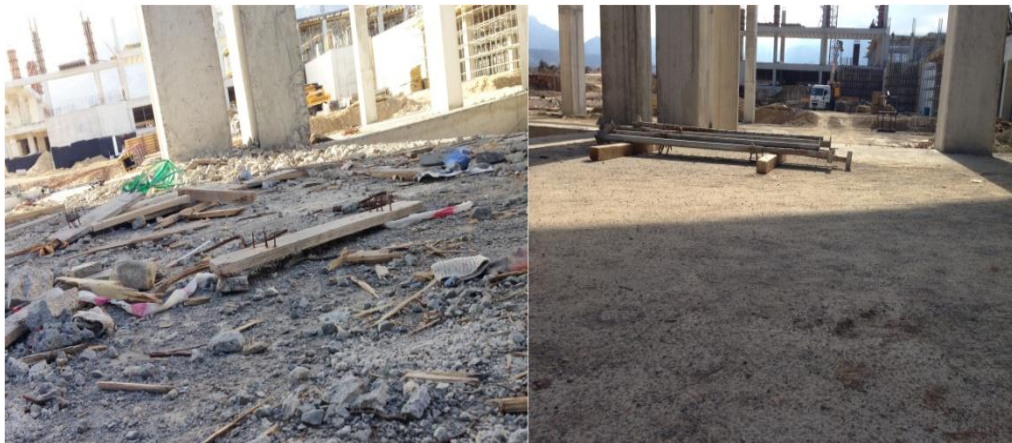
ignorance of wearing safety work gear like stepping on nails. Using appropriate shoes can also prevent from electrocuting (Figures 5.16 and 5.17).

Figure 5.17. Nail and sharp object

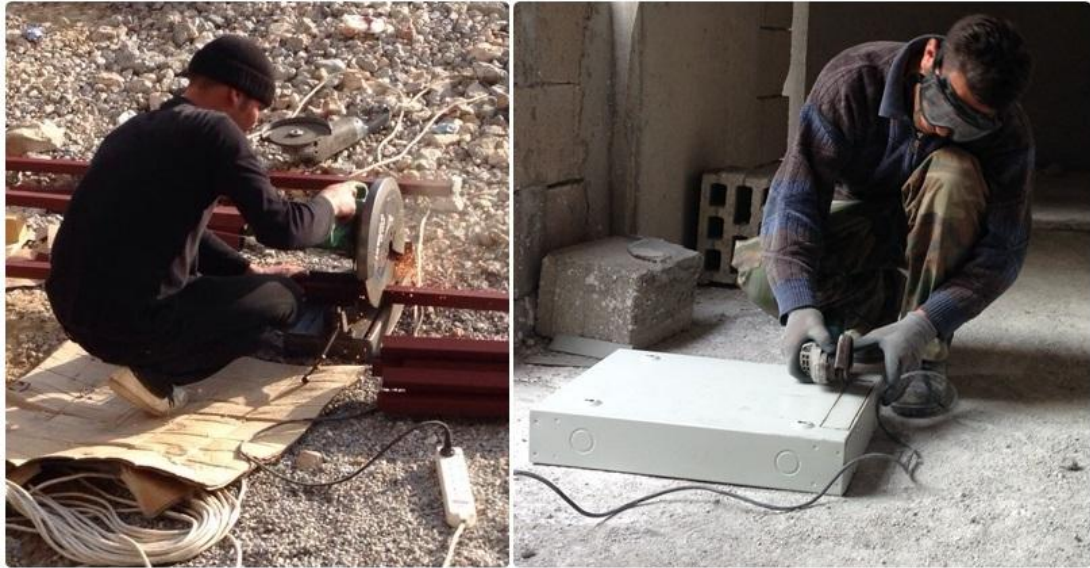
Figures 5.18 and 5.19 show the usage and lack of work gloves and protective glasses in the LPH for the workers. Using masks and ear muffs can also help prevent them harm.

Figure 5.18. Work glasses

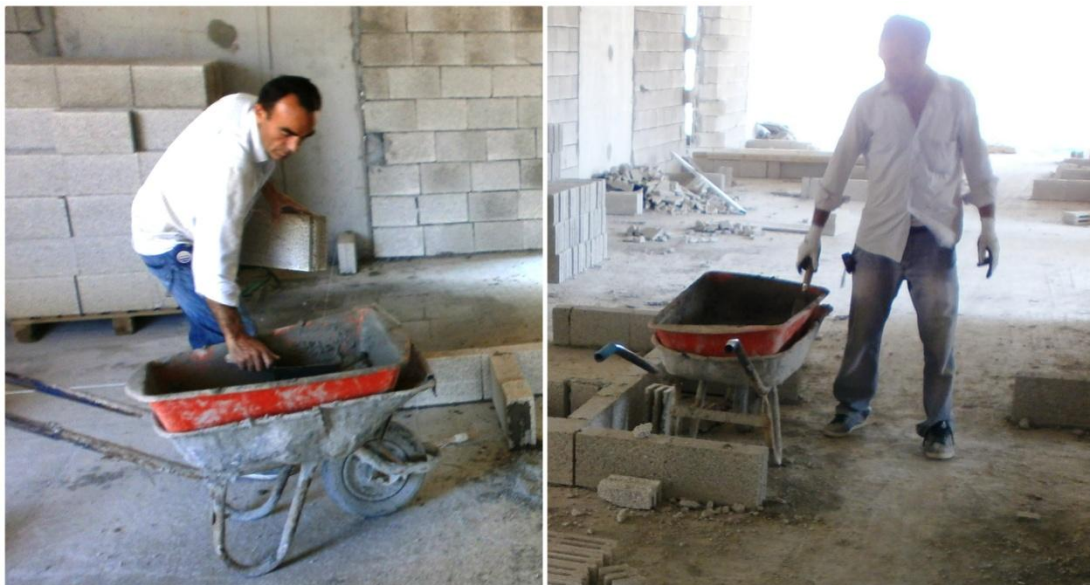
Figure 5.19. Work gloves
