# DETERMINATION AND EVALUATION OF S/N CURVES FOR TiN AND ZrN COATED 316 L HIP STEMS

A Thesis Submitted to the  
Graduate School of Natural and Applied Sciences of  
Dokuz Eylül University  
In Partial Fulfillment of the Requirements for  
the Degree of Master of Science in Metallurgical and Materials Engineering,  
Material Sciences Program

by  
N. Funda AK

July, 2002  
İZMİR

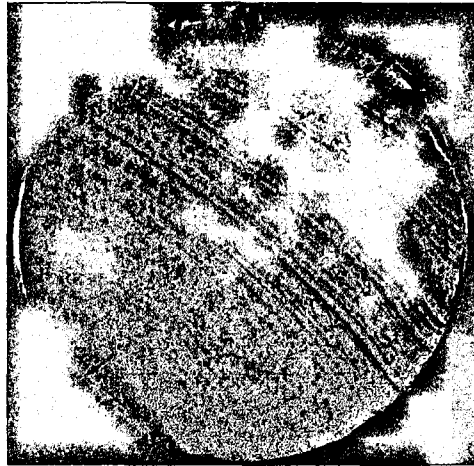
**Figure 4.5.** Beach marks on fatigue surface.

By marked contrast the fracture surface of stage II crack propagation frequency shows a pattern of ripples or fatigue fracture striations. Each striation represents the successive position of an advancing crack front that is normal to the greatest tensile stress. Each striation was produced by a single cycle of stress (Figure 4.5).

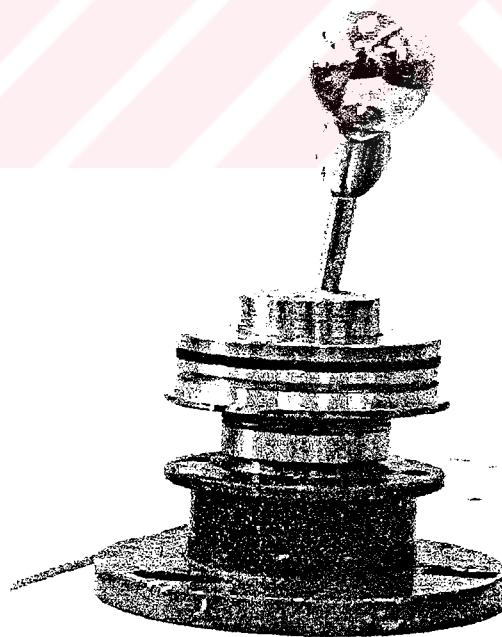
**Figure 5.6.** Specimen mounted on the test rig.

The specimen with test rig (Figure 5.6) was located in the testing machine with three clamps and partially immersed in the saline bath. Due to highly corrosive effect of the salt solution the hip implants were inserted in plastic holder. To maintain the specimens at 37 °C during testing temperature control unit was used. Peristaltic pump was used to control the flow rate of continuously aerated serum physiological solution (0.9 NaCl), which surrounded the specimen.
