**EVALUATION OF THE USE OF UAVS IN  
FLEXIBLE PAVEMENT INSPECTION BY USING  
GCPS: A CASE STUDY ON PALESTINIAN ROAD**

Master's Thesis

ALTINBAŞ UNIVERSITY

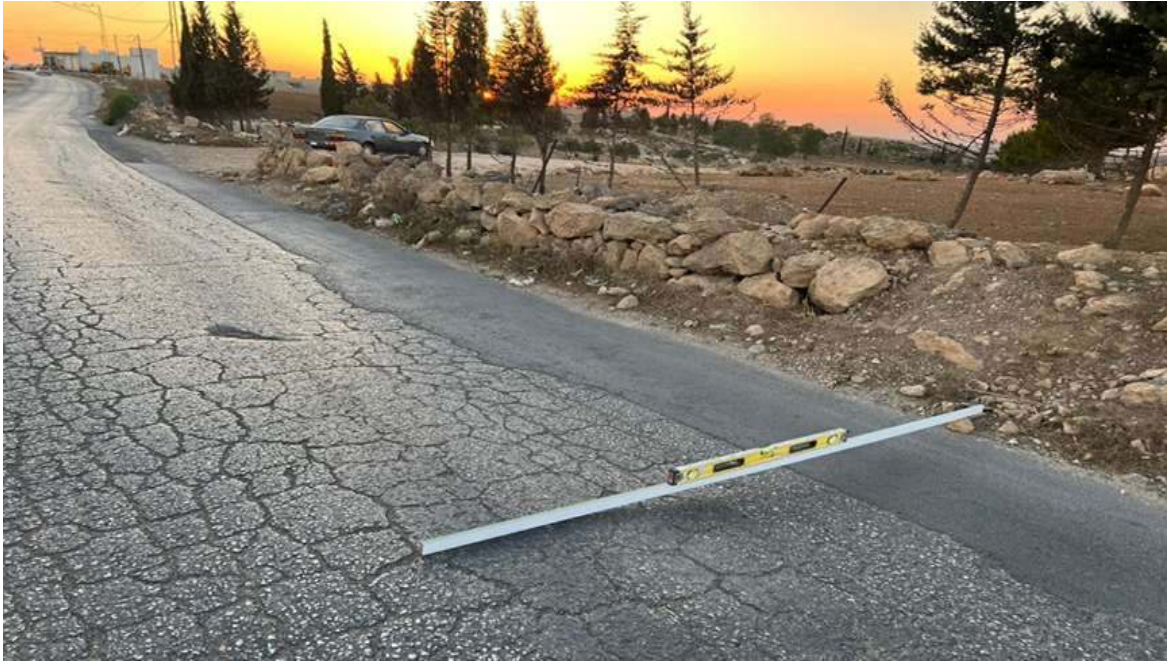
**Figure 3.2:** Sample for Ruts, Patches, and Cracks.

The surface quality of the pavement that was selected for this study was subpar, which resulted in a substantial amount of trouble for the people who used it in the neighborhood that surrounded it. It was discovered that there were several different kinds of distress, such as cracks that were longitudinal, transverse, and crocodile in shape, as well as places that were patched and rutted. Not only did these problems result in an uneven surface, but they also presented a threat to the safety of those who used the road. An additional factor that

contributed to the degeneration of the pavement was the fact that the cracks, particularly the crocodile cracks, were prevalent, and the patches that were utilized for repairs were deteriorating. Clearly visible rusting could be seen in the wheel grooves, which made the damage much worse. A selection of these distresses is depicted in Figure 3.2, which provides an illustration of the degree to which the pavement has deteriorated.

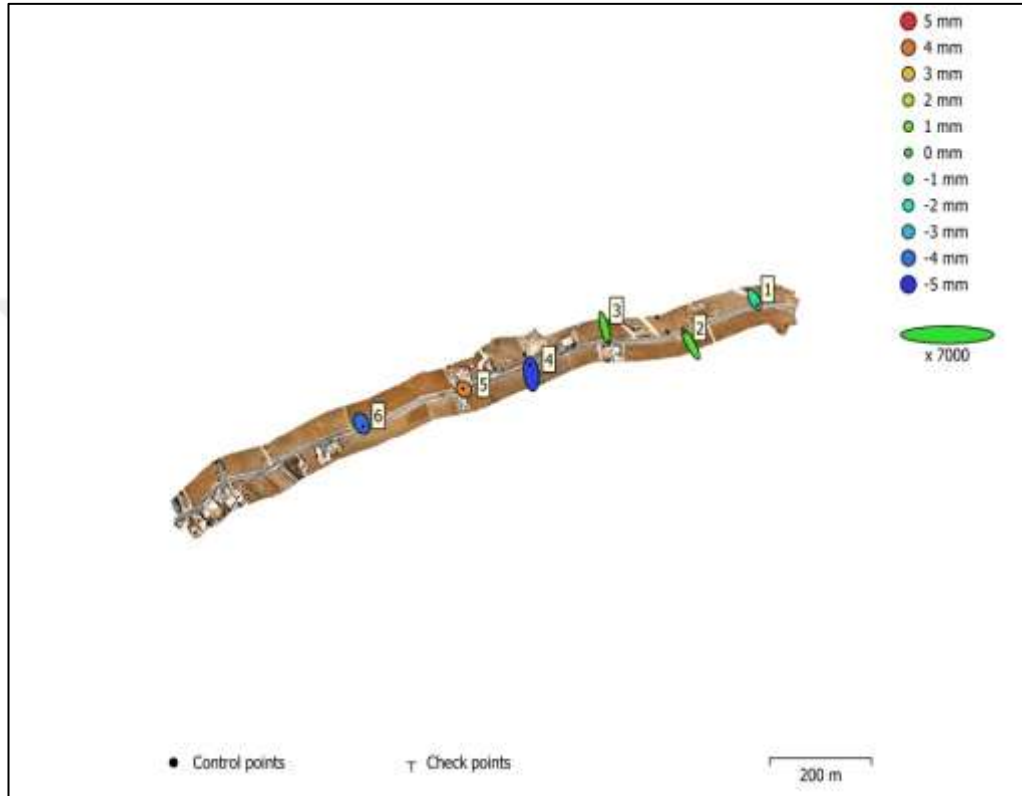
**Figure 3.3:** Gcps Locations and Error Estimates.

Following the identification and definition of the study area boundaries, the next critical phase in the data collection process involved conducting a thorough examination of the physical characteristics and surface conditions of the site. This included an assessment of the topography, such as the natural elevation changes, slope variations, and any surface irregularities that might affect UAV flight performance or the accuracy of photogrammetric outputs. Additionally, the condition of the pavement itself was carefully studied to understand the distribution and severity of surface distress features, which would later be analyzed through aerial imagery [5]. Based on this preliminary investigation, strategic decisions were made regarding the placement of Ground Control Points (GCPs) within the study area. These GCPs were positioned to ensure complete spatial coverage of the site,

including all relevant elevation changes, and to promote uniform distribution across the entire area. This was done to enhance the georeferencing accuracy of the photogrammetric models, both in the vertical and horizontal dimensions. The layout and spread of the GCPs, which were intentionally arranged to cover the periphery as well as the interior sections of the study zone, are clearly illustrated in Figure 3.3.

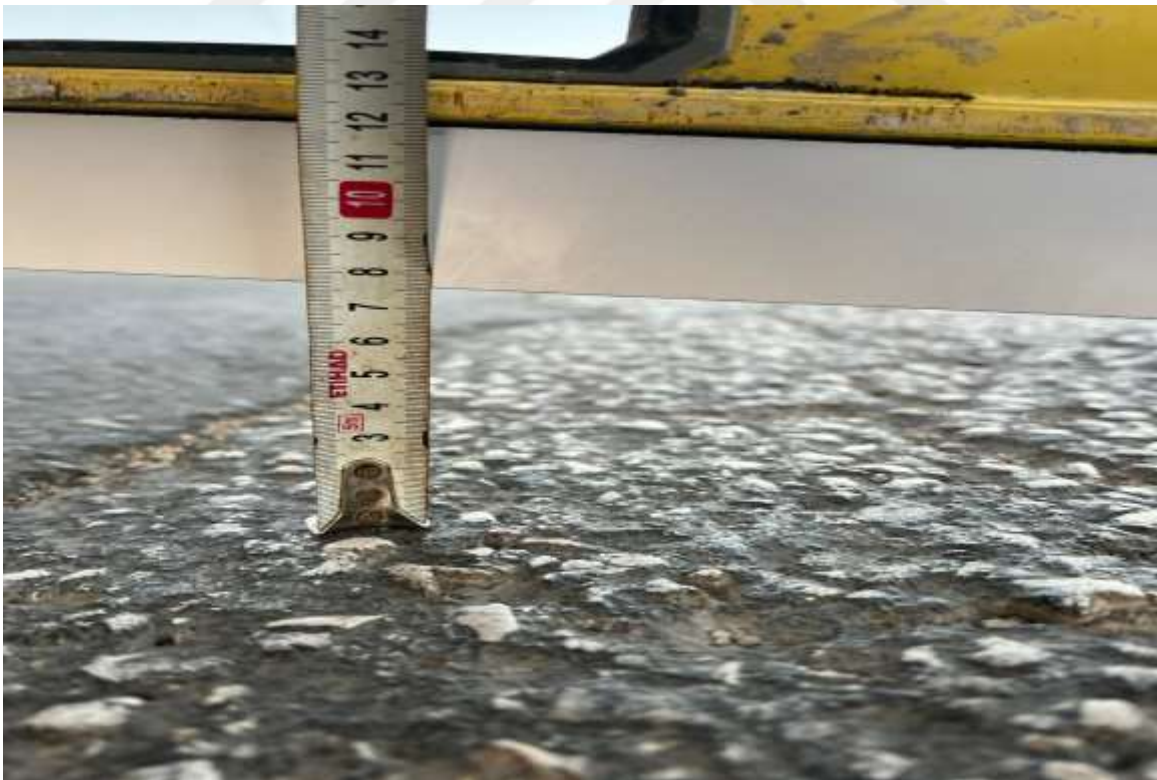
**Figure 3.5:** Sample Of Measuring Rut's Length Manual Method Using Meter and Ruler.

Figure 3.5 provides a visual example of the traditional measurement technique, showcasing how field personnel manually engage with pavement surfaces to identify and record defect characteristics. While this approach laid the foundation for early pavement condition assessment practices, its inefficiencies and limitations have driven the development of modern alternatives, such as UAV-based photogrammetry, which this study aims to explore and evaluate.

Despite its usefulness, this conventional method of data collection had several critical limitations. Most notably, the process was highly time-consuming and labor-intensive, requiring a substantial amount of manual input from field personnel. In particular, when applied to large-scale road networks or urban streets with extensive damage, the manual inspection process would become especially demanding. Inspectors often had to repeat measurements for accuracy and physically move across multiple units, sometimes under hazardous conditions or during extreme weather. This not only extended the time required for data collection but also introduced the potential for human error, including inconsistent measurements, observational bias, and fatigue-related inaccuracies [70,71,75].

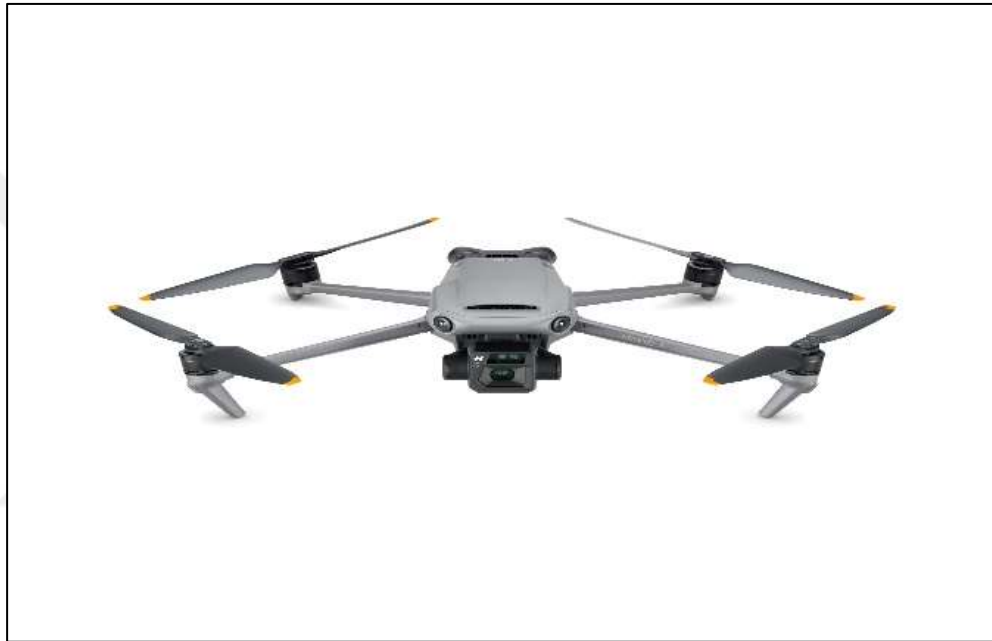
**Figure 3.6:** DJI Mavic 3 (L2D-20c) Drone Features.

Another benefit of this UAV system is that it comes fully assembled and ready for use without requiring any custom modifications or technical adjustments. All necessary components such as the GPS navigation system, flight stabilization features, and remote-control unit are included in the set. This integrated design allows the user to begin operations with minimal setup time, which is especially helpful when working in multiple locations or under time constraints. The GPS system in particular, ensures that flight paths are precise and that images can be georeferenced accurately during post-processing.

The digital camera that comes with the DJI Mavic 3 is also a key feature of the system. It provides high-resolution images suitable for detecting cracks, surface deformations, and other signs of pavement distress. This camera, along with the quadcopter's flight stability and GPS accuracy, makes the system well-suited for photogrammetric applications like those used in this study. Together, these features make the DJI Mavic 3 a cost-effective, efficient, and technically capable solution for collecting the aerial data required for evaluating pavement conditions.

Table 3.2 provides a detailed and comprehensive summary of the technical specifications and operational capabilities of the UAV system used in this study, with a particular focus on the characteristics of the cameras integrated into the system for the purpose of data collection. The table outlines the essential features of each camera, including resolution, sensor type, focal length, and other imaging properties that directly influence the quality and precision of the data acquired during the UAV flights. These specifications are critical in determining the suitability of the cameras for photogrammetric applications, especially when high-resolution imagery is required to detect and analyze pavement surface distresses such as cracks, rutting, and potholes.

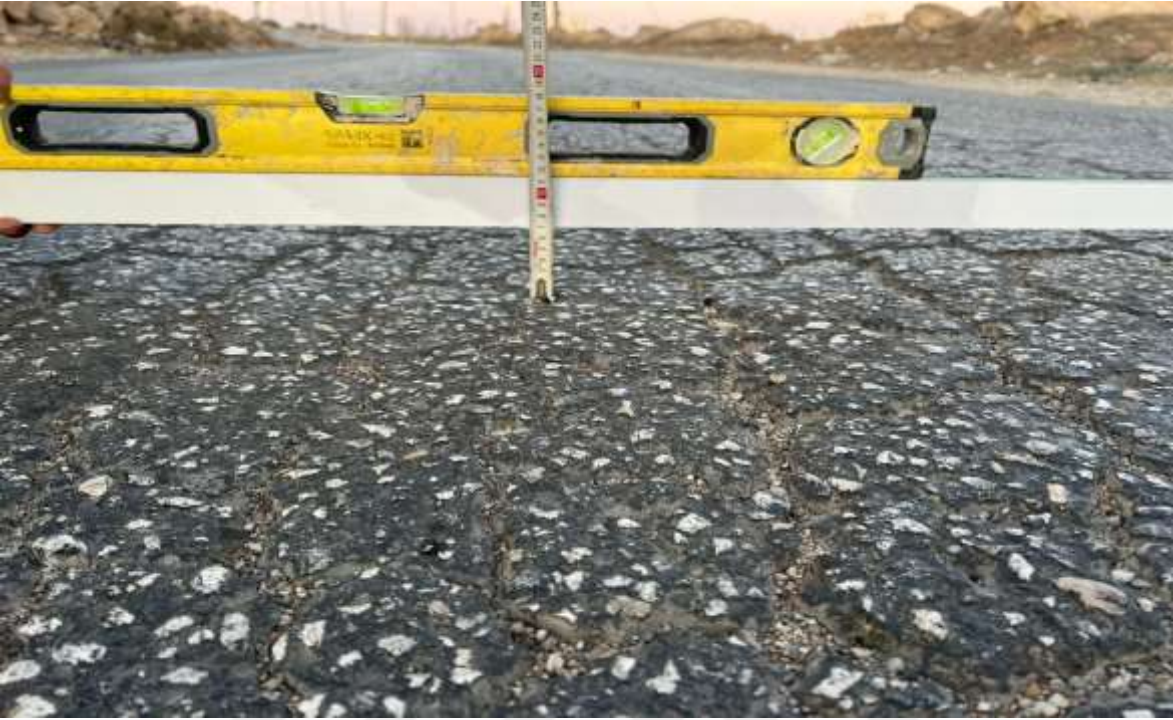
**Figure 3.10:** Measurement for The Depth Of Rut Using Conventional Methods.

The values obtained from the digital model were then compared against the manual measurements, which were treated as the ground-truth reference, and the differences between the two sets of measurements were calculated and

analyzed to determine the precision and reliability of the UAV-based 3D model for pavement distress evaluation.

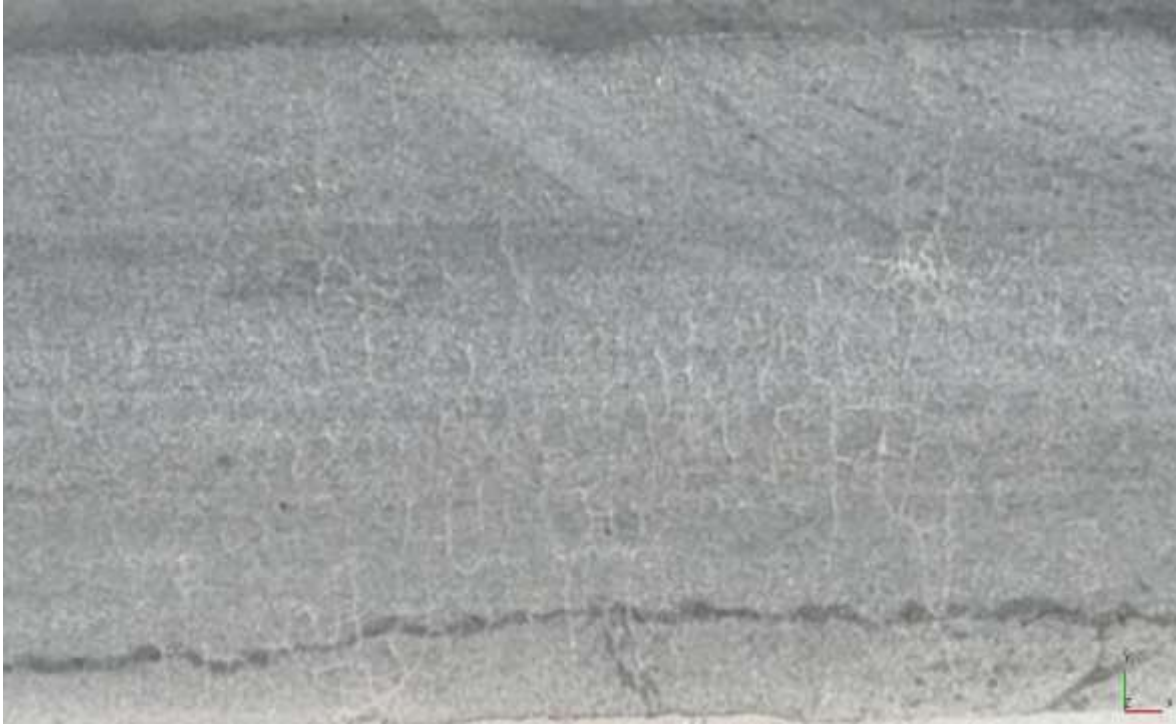
**Figure 4.4:** The Cracked and Uncracked Areas Before the Crack Mapping Process.

The accuracy of the approach that has been presented in differentiating between pavement surfaces that are cracked and those that are not cracked is shown in Figure 4.4. This method is capable of discriminating between the two types of surfaces with an amazing accuracy rate of up to 96 percent. The great degree of accuracy that this method provides allows for the thorough and dependable evaluation of the status of pavements. since a result, the technique is extremely beneficial for applications in pavement management and road maintenance, since it guarantees that sections that have deteriorated are accurately detected and remedied in a timely way.
