**EVALUATION OF THE USE OF UAVS IN  
FLEXIBLE PAVEMENT INSPECTION BY USING  
GCPS: A CASE STUDY ON PALESTINIAN ROAD**

Master's Thesis

İstanbul, 2025

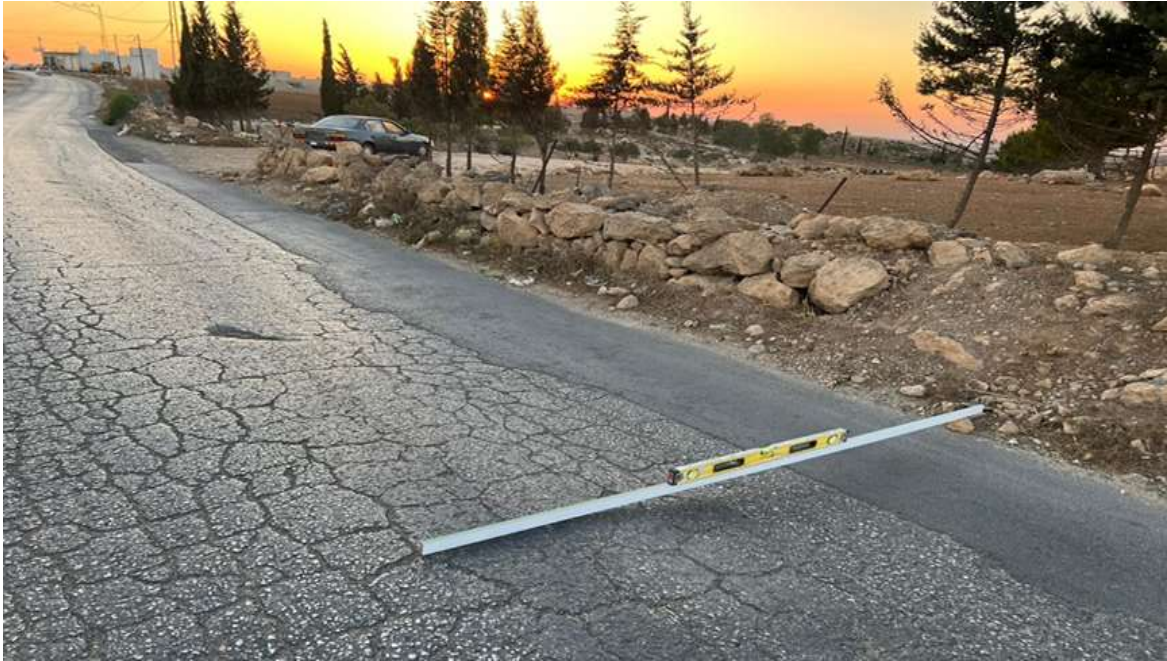
**Figure 3.2:** Sample for Ruts, Patches, and Cracks.

The surface quality of the pavement that was selected for this study was subpar, which resulted in a substantial amount of trouble for the people who used it in the neighborhood that surrounded it. It was discovered that there were several different kinds of distress, such as cracks that were longitudinal, transverse, and crocodile in shape, as well as places that were patched and rutted. Not only did these problems result in an uneven surface, but they also presented a threat to the safety of those who used the road. An additional factor that

contributed to the degeneration of the pavement was the fact that the cracks, particularly the crocodile cracks, were prevalent, and the patches that were utilized for repairs were deteriorating. Clearly visible rusting could be seen in the wheel grooves, which made the damage much worse. A selection of these distresses is depicted in Figure 3.2, which provides an illustration of the degree to which the pavement has deteriorated.

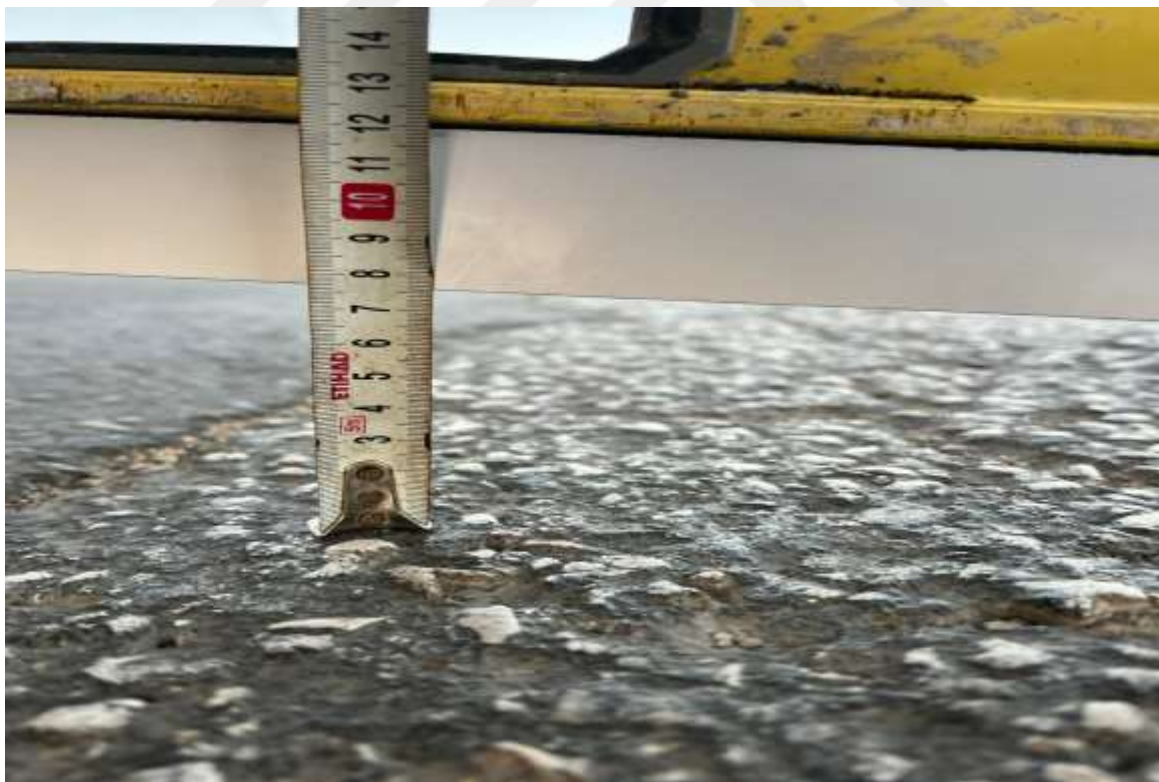
**Figure 3.5:** Sample Of Measuring Rut's Length Manual Method Using Meter and Ruler.

Figure 3.5 provides a visual example of the traditional measurement technique, showcasing how field personnel manually engage with pavement surfaces to identify and record defect characteristics. While this approach laid the foundation for early pavement condition assessment practices, its inefficiencies and limitations have driven the development of modern alternatives, such as UAV-based photogrammetry, which this study aims to explore and evaluate.

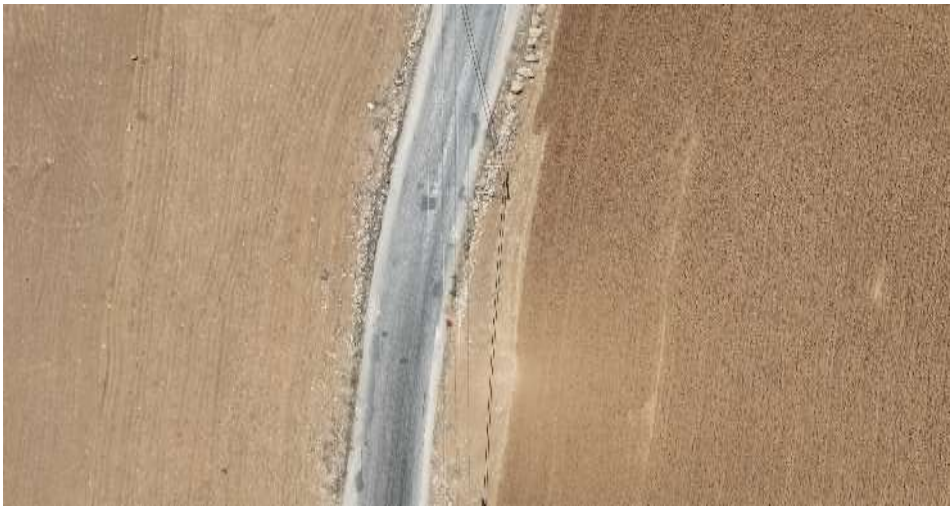
**Figure 3.7:** Sample Of UAV Images.

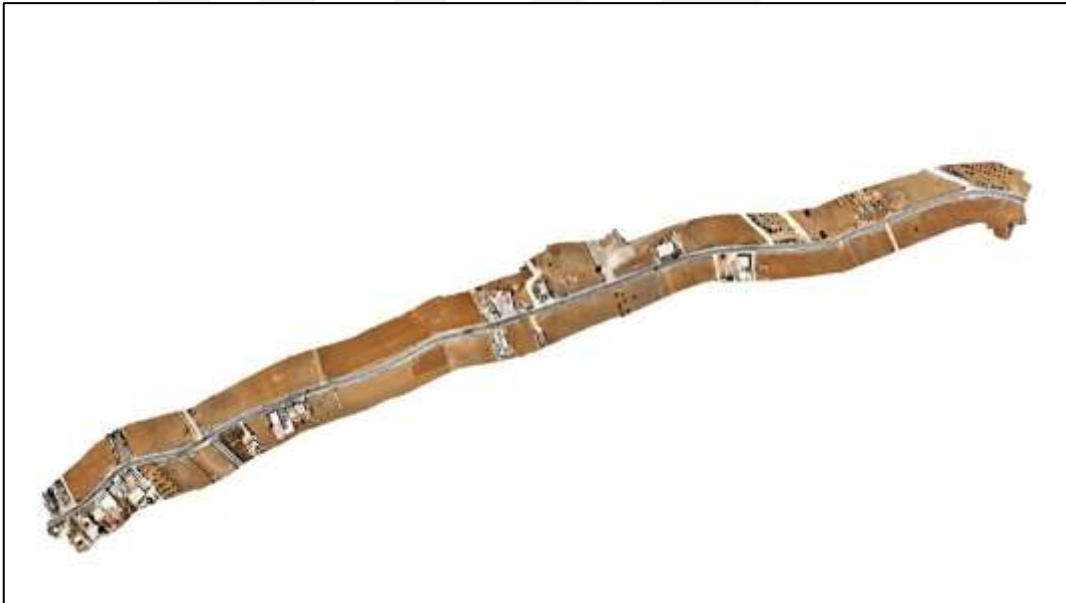
**Figure 3.8:** Orthophoto With Coordinates System.

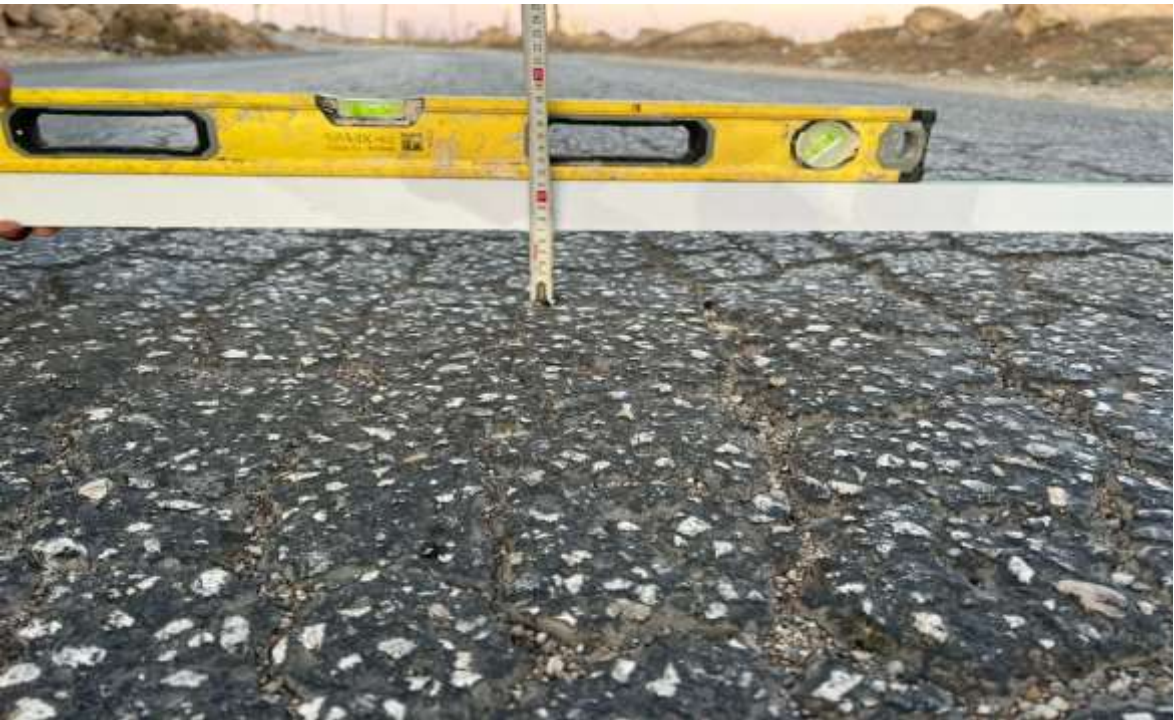
**Figure 3.10:** Measurement for The Depth Of Rut Using Conventional Methods.
