**EVALUATION OF SAFETY FACTOR OF SELECTED  
ANCIENT BUILDINGS IN IRAQ AGAINST  
EARTHQUAKE LOADS**

**M.Sc. THESIS  
IN  
CIVIL ENGINEERING**

**BY  
AHMED H. ALWANI  
MAY – 2022**

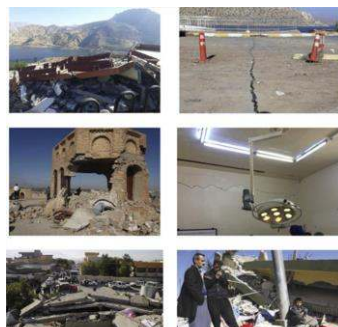
Seismic hazards pose a threat to Iraq. Earthquakes are likely to occur, and they can cause significant damage. After the most recent earthquake in November 2017, such hazards occurred and were recorded (Halabjah earthquake). Unfortunately, there is a scarcity of research on the assessment of earthquake hazard on Iraqi soil. Figure 1 showed the damages to various structures in Iraq as a result of the Halabjah earthquake. shown figure 2.1.

**Figure 2.1** Damages to various structures in Iraq as a result of the Halabjah

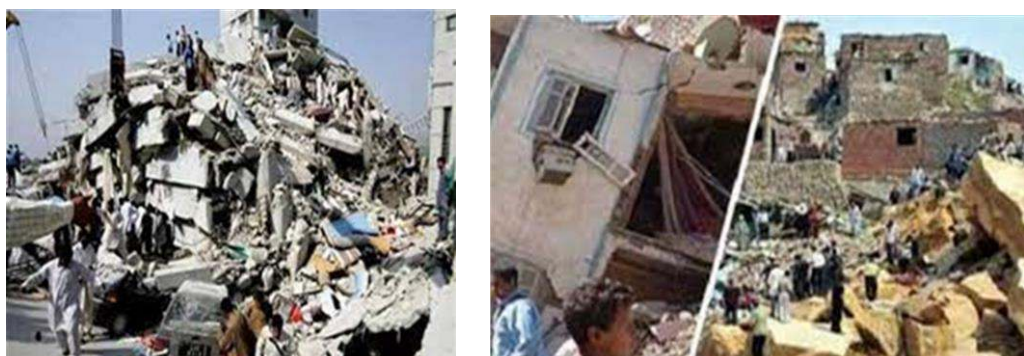
Egypt witnessed a devastating earthquake on October 12, 1992, and its intensity was 5.8 on the Richter scale, and antiquities had a share of this destruction, especially the historic buildings of Cairo, registered as a world ancient since 1979. 210 monuments were affected and damaged in the 1992 earthquake out of 560 impacts. A large block fell from the Great Pyramid in Giza, which had previously been subjected to falling stones in the earthquake of the sixties of the last century, and the 1992 earthquake caused the fall of a stone block in the Temple of Hatshepsut and the Temple of Kom Ombo in Aswan, and the destructive force of the earthquake was vertically, which made the statues in temples Luxor is buried in the ground for a distance of 4 meters, and most of the buried statues represented the goddess Sekhmet, the goddess of war. There were also a number of earthquakes that occurred in the Dahshur region and led to the destruction of the small pyramids and their transformation into simple rocks. Able to absorb earthquake waves. Islamic monuments were also among the most damaged monuments as a result of the 1992 AD earthquake. A large number of historical Islamic monuments were damaged; including a large number of mosques and ancient minarets, including; the minaret of Al-Hanafi Mosque, which fell completely. As for the cultural buildings that were damaged as a result of the 1992 earthquake, it included about 17 houses and culture palaces, including Al-Jawhara Palace, Al-Amr Beshtak Palace, Prince Taz Palace, which exposed many of its pillars and columns to great damage, and Al-Sinary House in Sayyida Zainab. It was much damaged before it was restored later shown figure 2.2.

**Figure 2.2** Damages of Egypt earthquake , 1992

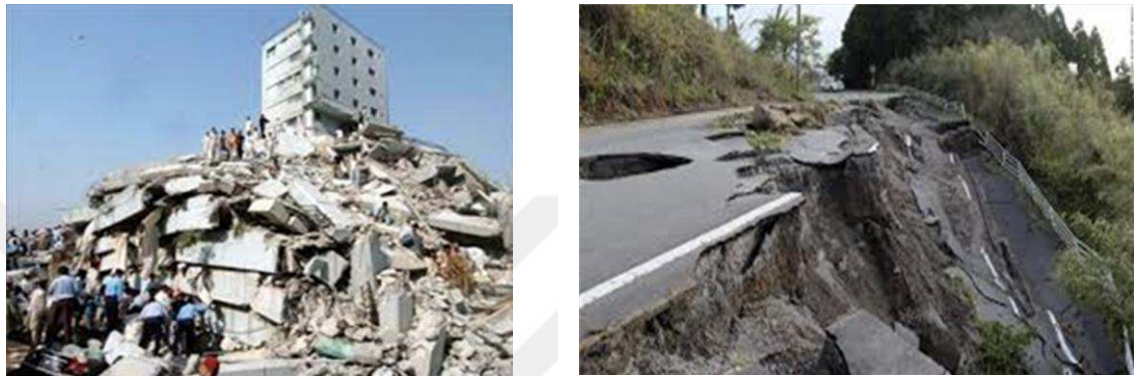
The devastating August 4, 2020 earthquake caused damage to thousands of buildings of varying degrees, whether newly built or those whose construction dates back more than 150 years. The number of damaged buildings is estimated at tens of thousands, of which 650 are antiquities, some of which date back to the eighteenth or nineteenth century, and most of them were concentrated in the regions of Gemmayzeh, Mar Mikhael, Ashrafieh and Jeitaoui. Shown figure 2.3.

**Figure 2.3** Damages of Lebanon earthquake

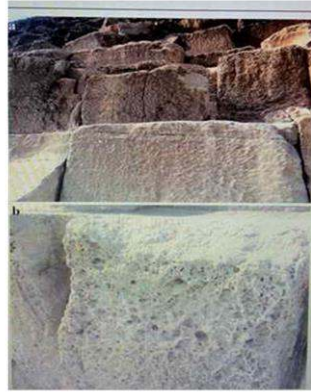
(figure 2.5 a, b). Due to overloading, material decay, and strength regression, the backing limestone blocks cracked, affecting the great pyramid's stability. On the surfaces of the backing limestone blocks, the honeycomb (differential) weathering effects are visible. The outer-facing limestone blocks go completely unnoticed.

**Figure 2.5. a, b** Cracking and splitting of backing limestone blocks at Giza

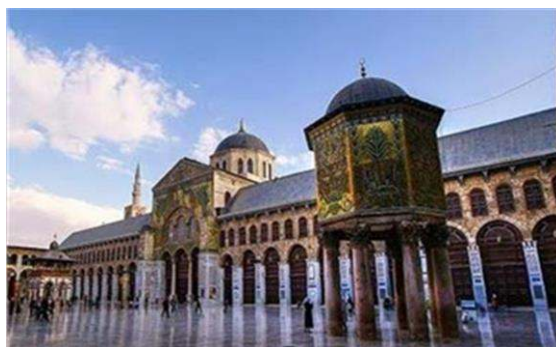
**Figure 2.6** Umayyad Mosque in Damascus

The Umayyad Mosque – Shown at figure 2.6. – was subjected to a severe state of deterioration in the eighties of the last century. An example of safety factor application studies. It was also found through the mechanical properties tests and various analysis that there was a significant deterioration in the resistance of limestone to pressure and tensile stresses as a result of the presence of cracks and cracks in the stone as a result of the internal stresses resulting from the blooming of salts on the surface Efflorescence and under the surface sub-florescence and within the stone components Crypto florescence as a result of the rise of salt solutions in Building materials used in the walls of the mosque. In the eighties and early nineties of the last century, a large-scale renovation of the mosque was carried out. The restorations included the western minaret of the mosque (the minaret of Qaitbay), the western facade of the mosque, and the northern wall of the mosque overlooking the tomb of Salah al-Din. The western entrance to the mosque was also re-paved, the floors were renewed and the damaged stone bases of the columns were replaced. Treating damaged wood, restoring and repairing the halls, re-establishing and installing a dome inside the courtyard of the mosque (Mostafa, 2009).

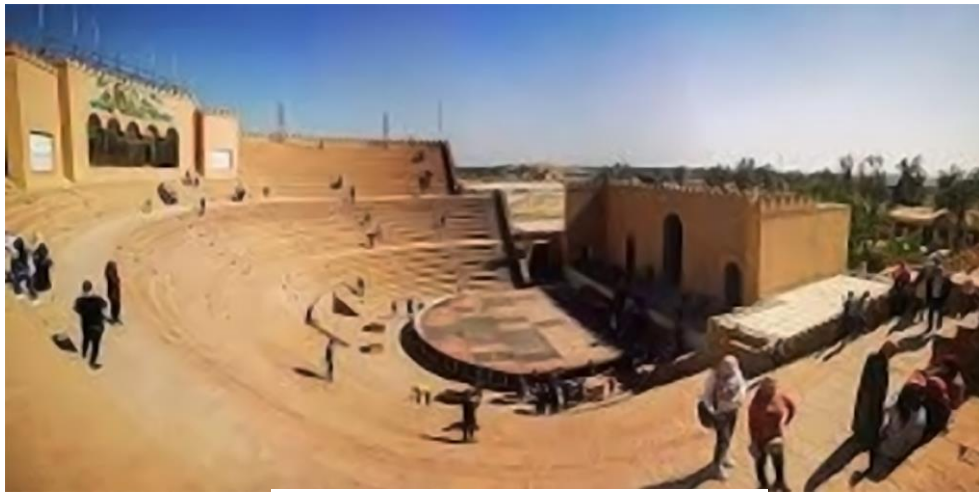
**Figure 2.8** Babylonian theater

The construction of the Babylonian theater is one of the distinctive buildings, whose foundations have remained steadfast in the face of geographical changes, soil erosion, and groundwater that threatened all traces of Babylon. shown figure 2.8.

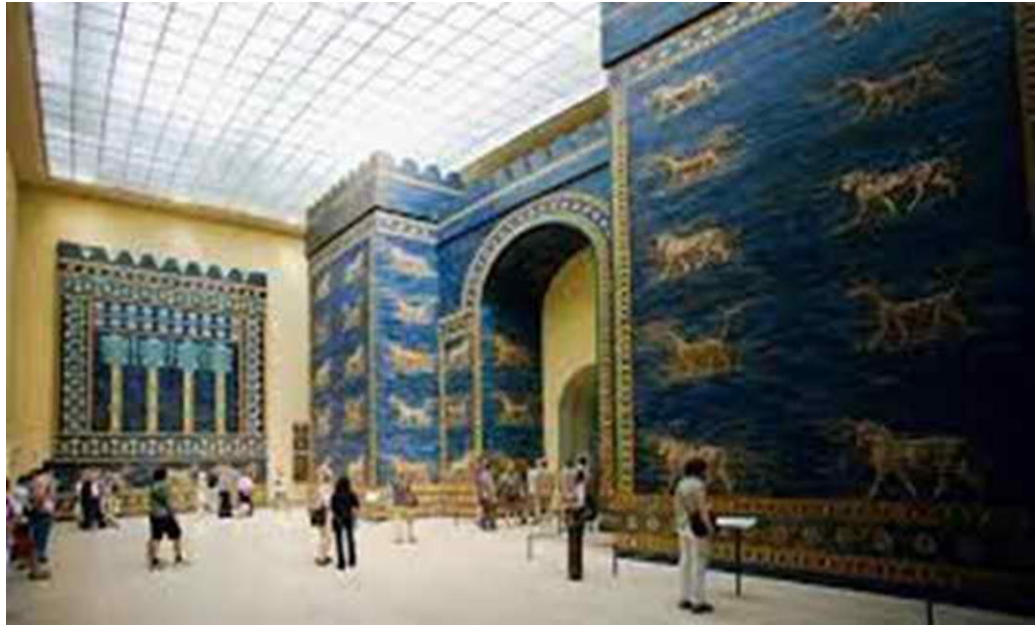
**Figure 2.10** Ishtar Gate.

That gate, which was built in 575 BC, was the first to meet a visitor to Babylon. It was constructed using polished stones similar to ceramic, which bear the colors cobalt blue and sea green. These stones are decorated with carvings depicting 575 dragons and bulls shown figure 2.10.

**Ishtar Gate** The eighth gate of the inner city of Babylon, which was built by Nebuchadnezzar in 575 BC in the north of the city as a dedication to Ishtar, the Babylonian gods. The Germans found the original Ishtar Gate in the days of the Ottoman Empire, and it was transferred to Germany and placed in the Pergamon Museum in Berlin and is still in the museum to the present time. The gate, which is part of the city walls of Babylon, was considered one of the Seven Wonders of the World until the 6th century. Replacing it with the Lighthouse of Alexandria. The Ishtar Gate with the towers is fifty meters high and eight meters wide.

The Ishtar Gate's facade is adorned with glazed bricks carved with dragons and bulls in successive rows. The animal carvings are made out of yellow or brown bricks, with blue bricks surrounding them. The blue-coated brick is thought to be made of lapis lazuli, but this has not been confirmed. Figure 3.1 (a, b, c). showed some pictures of Ishtar Gate during different historical periods.

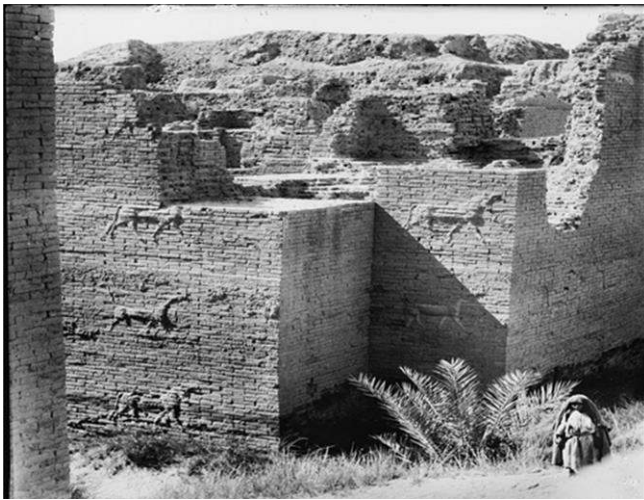
**Figure 3.1 a** A picture of the ruins of Ishtar gate from the excavations of 1930

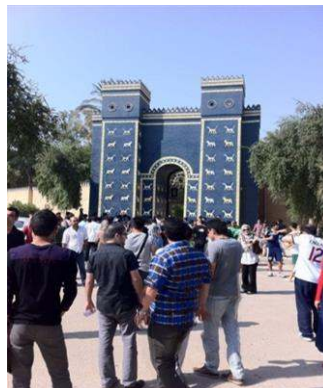
**Figure 3.1 c** Ishtar Gate in Babylon at the end of 2011

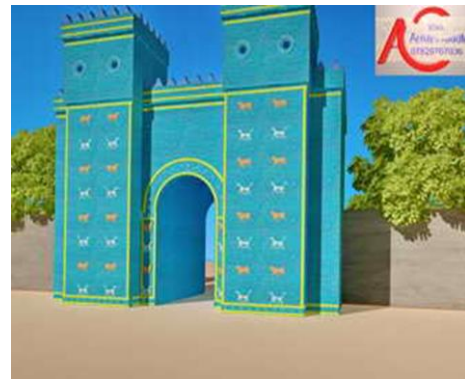
**Figure 3.3** Ishtar Gate (3DS MAX 2021)

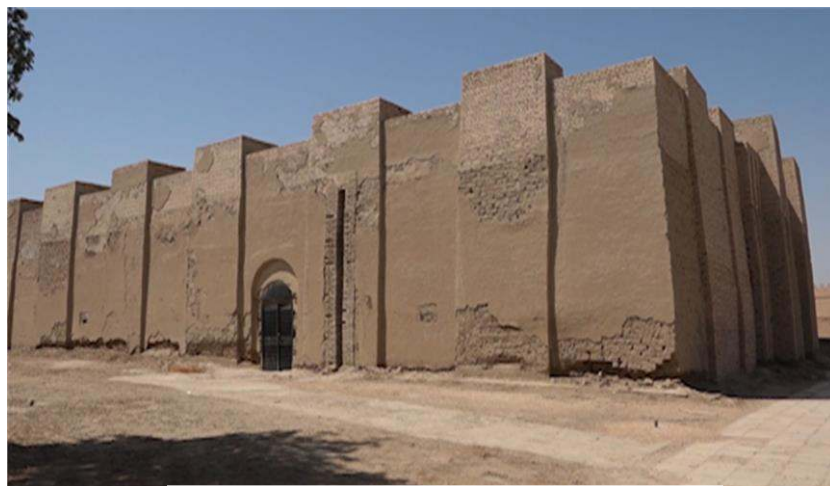
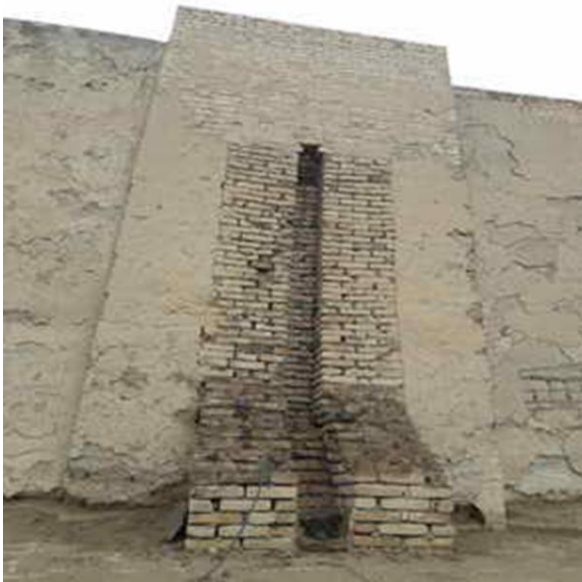
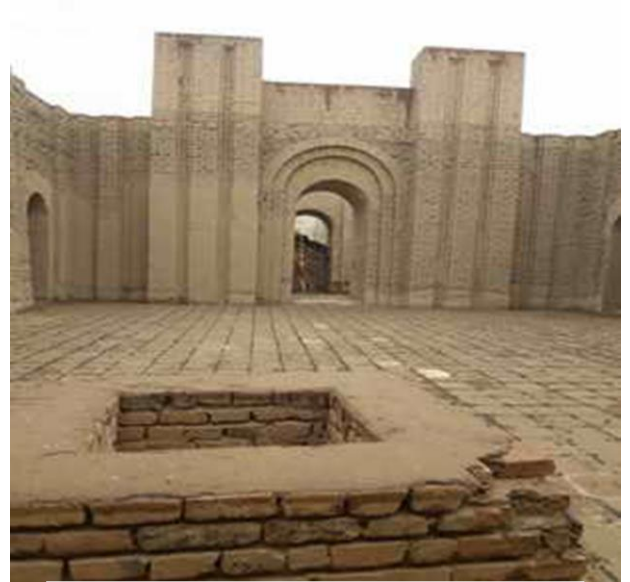
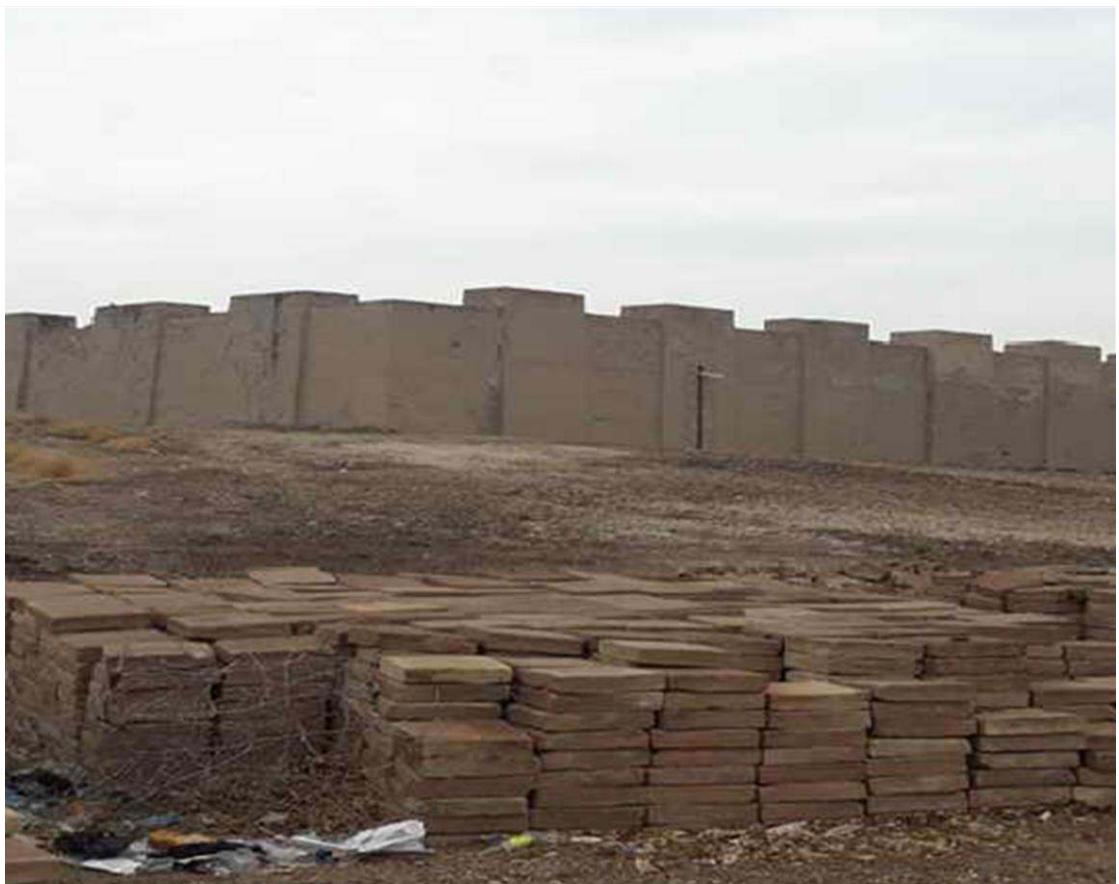
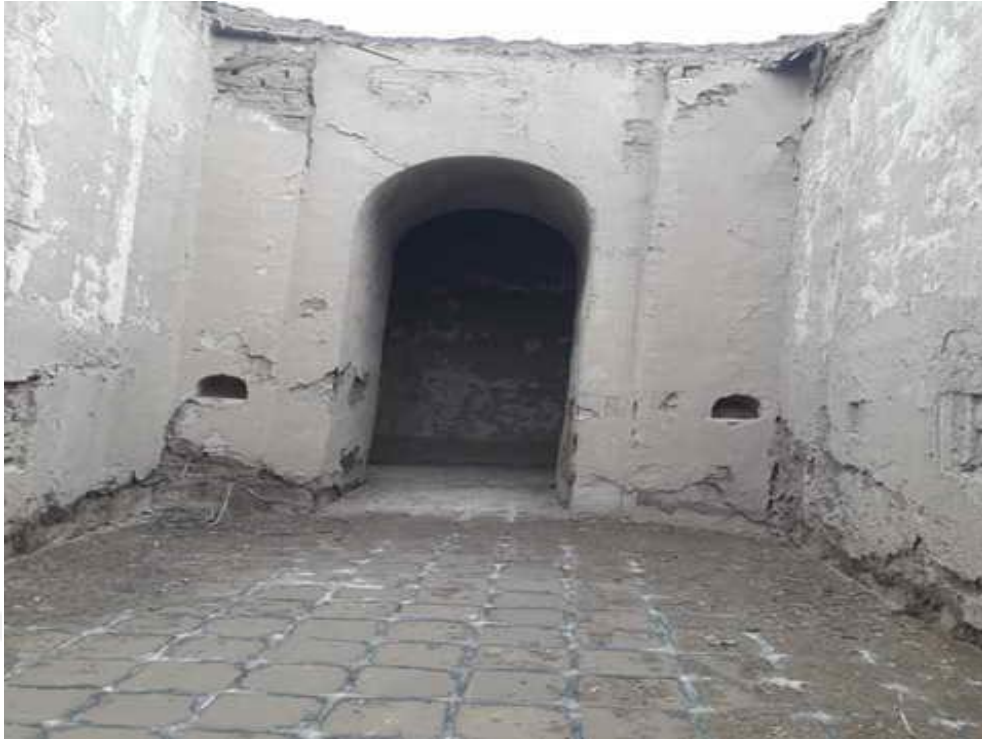
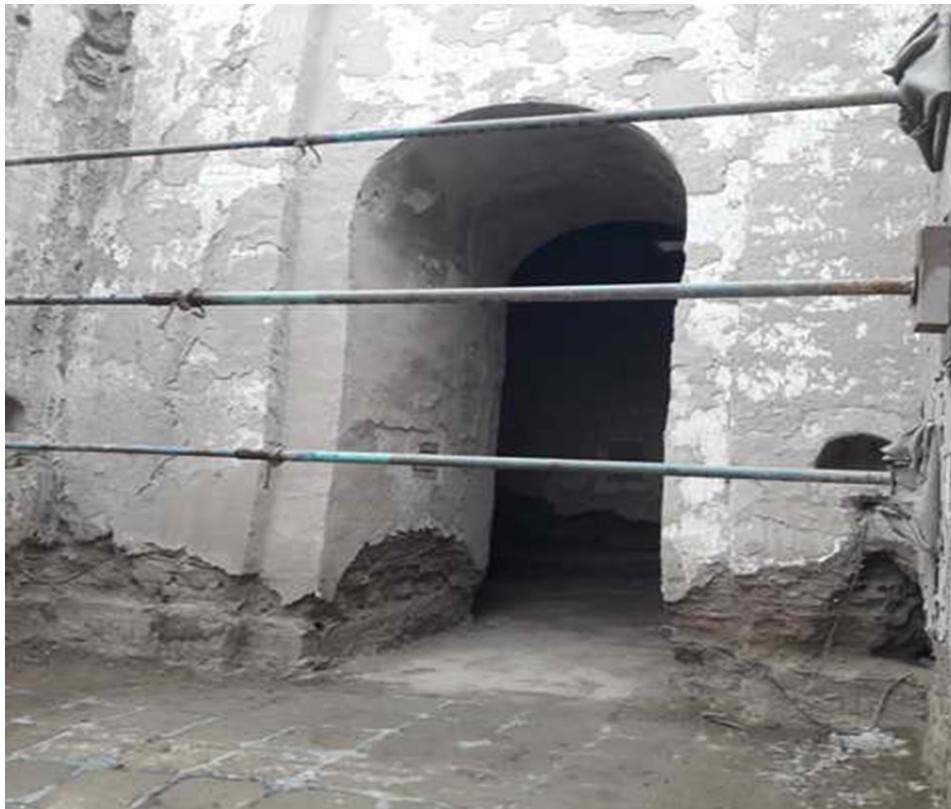
It is considered one of the four most important temples of the ancient Babylonian state, in addition to the temple of Asigila, which was dedicated to the worship of Marduk, the temple of Ishtar and the temple of Nabu. This temple is for women only, and this temple was built from mud, which is the main material used in construction in the old city, because of many advantages, the most important of which is that it dries quickly and makes the place cool in summer and warm in winter. On this basis, the temple consists of a courtyard surrounded by several rooms, including a holy room, the sanctuaries in which religious hymns were held, and in which statues of the goddess were also placed. The walls of the Natmakh temple are exposed to recklessness at the present time, as they are considered a deer due to the excavation work below the area in which the temple is located shown figures 3.4a-i.

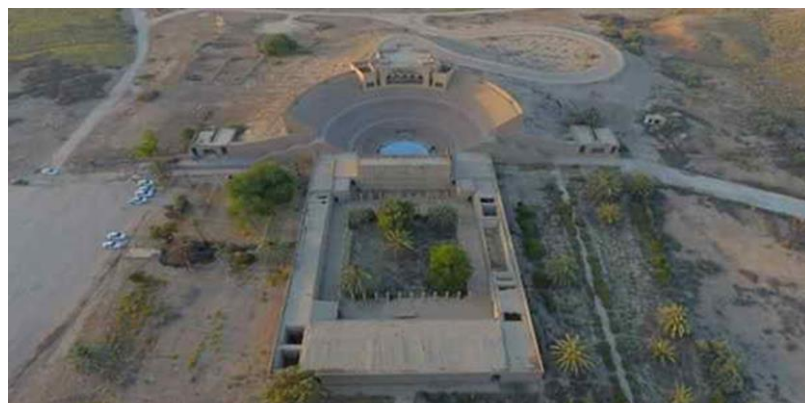
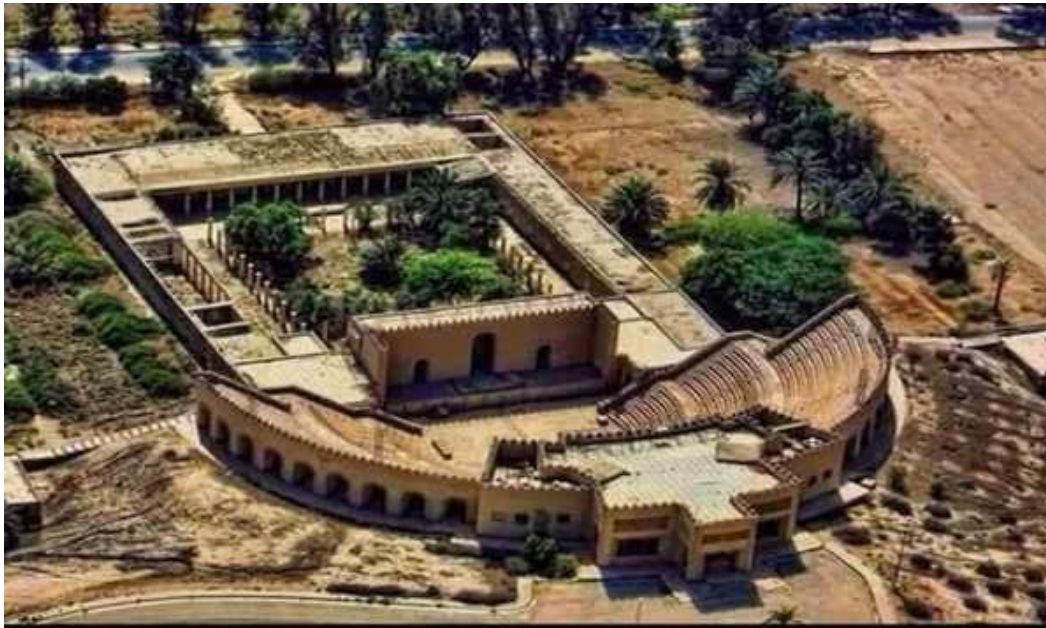
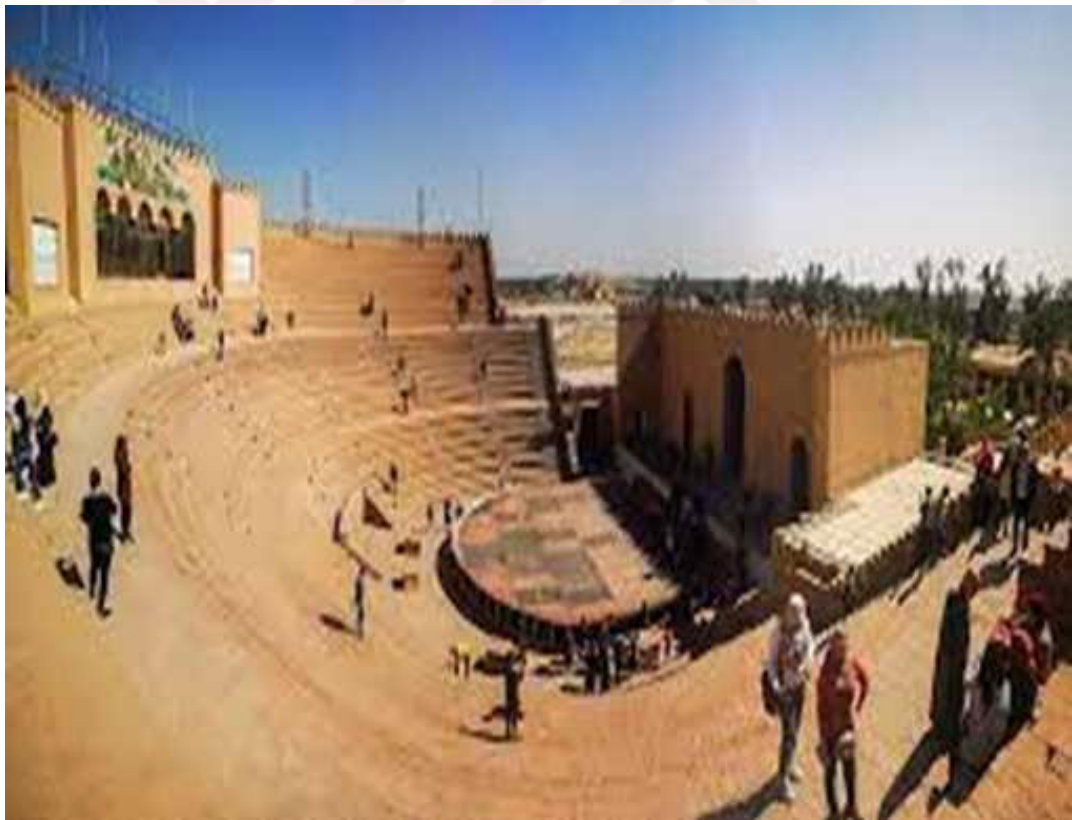
This theater was built during the time of the African King Alexander the Great and was built from the bricks of the Tower of Babel (331 BC) and continued throughout the ages and ages to perform all the activities and activities at that time. This building was built in the northern part of the city of Babylon over a group of hills known as Al-Hira, attributed to the red color of its soil. It takes the form of a semi-circular theater, and through these stands there are nine stairs to go up and down. These terraces consisted of three stages, the first stage included six seating, the second stage was nine, and the third stage was twelve seating areas, and a walkway (1-9 meters) wide was prepared between each stage and the other. The internal facade of the theater was decorated with stucco relief, and in the front of the theater in front of the stands there was a row of twelve columns constructed with bricks and plaster.

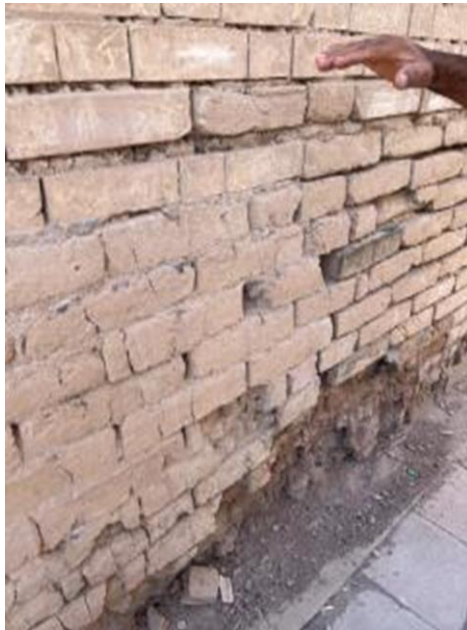
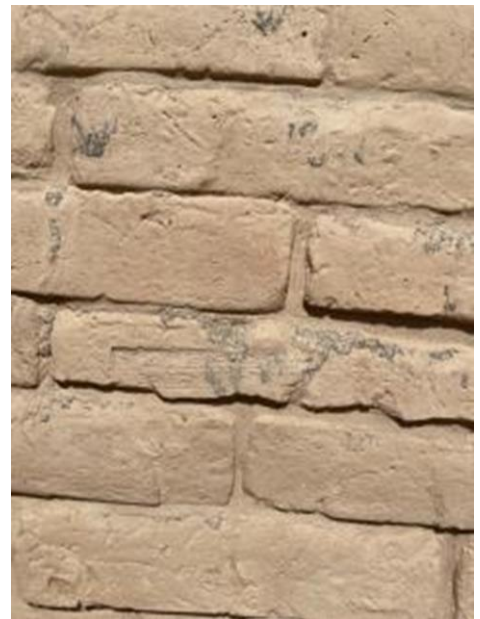
The dimensions of the bricks used in the construction of most of the archaeological sites in Babylon are (23 x 10 x 8) cm, as it was built in a beautiful way and shown in the picture below, which shows the cuneiform writing used at that time

**Figure 4.4** Masonry shape

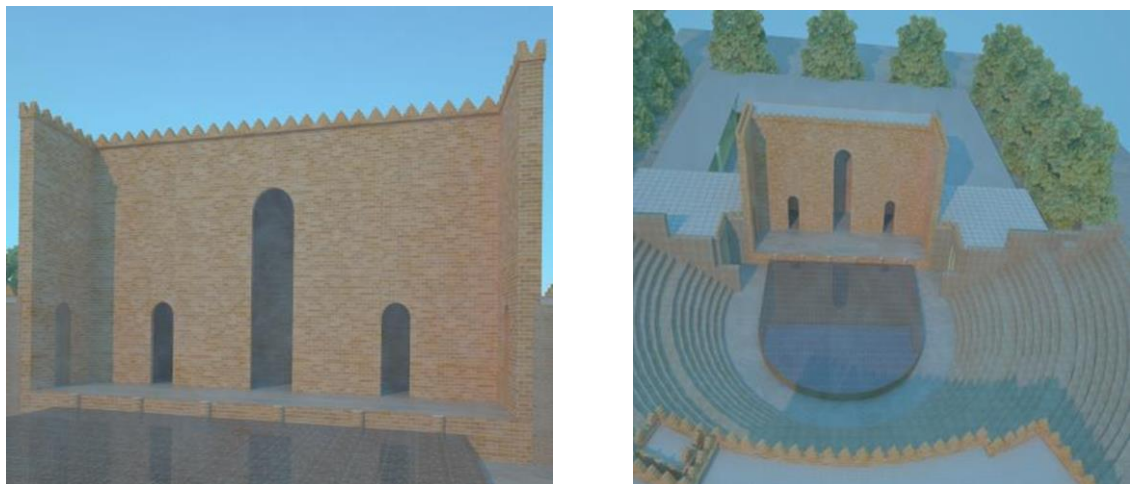
This site was built using bricks and lime plaster as a binding material, the width of the walls (850)mm, noting that there are no internal partitions connecting the walls among themselves, which makes the building more exposed to dynamic factors (earthquakes, winds, snow, etc...).

**Figure 4.5** Modeling of Babylonian's Theater by 3ds MAX

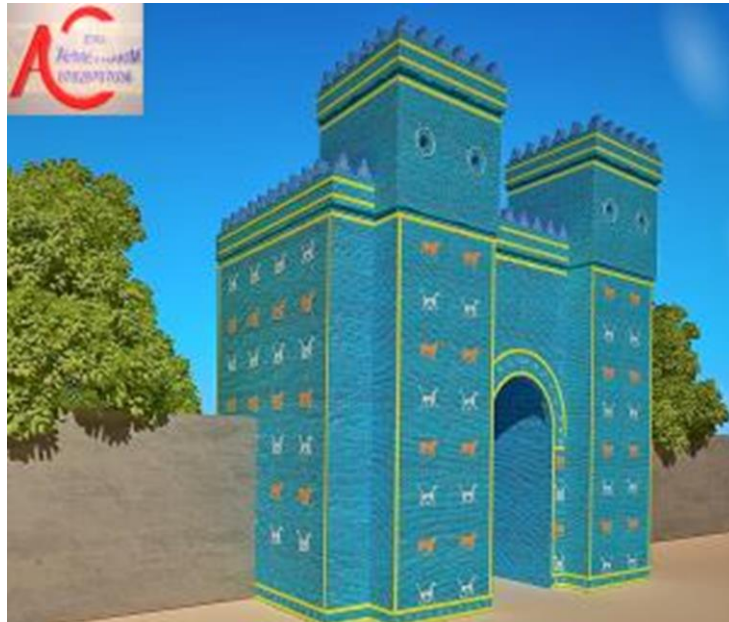
This site was built using bricks and lime plaster as a binding material, the width of the walls (850)mm, noting that there are no internal partitions connecting the walls among themselves, which makes the building more exposed to dynamic factors (earthquakes, winds, snow, etc...).

**Figure 4.14** Modeling Ishtar Gate by 3ds MAX

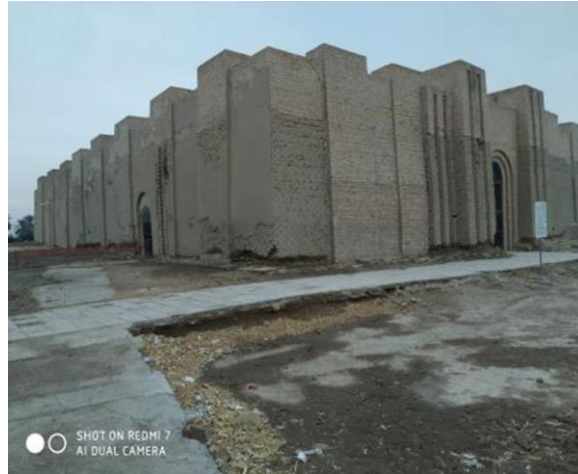
This site was built using bricks and lime plaster as a binding material, the width of the walls (850)mm, noting that there are no internal partitions connecting the walls among themselves, which makes the building more exposed to dynamic factors (earthquakes, winds, snow, etc...).

**Figure 4.22** Natmakh Temple
