**UNIVERSITY OF GAZİANTEP  
GRADUATE SCHOOL OF  
NATURAL & APPLIED SCIENCES**

**EXPERIMENTAL INVESTIGATION AND FINITE ELEMENT MODELING  
OF REHABILITATED AND STEEL FIBER RC MEMBERS**

**Ph.D THESIS  
IN  
CIVIL ENGINEERING**

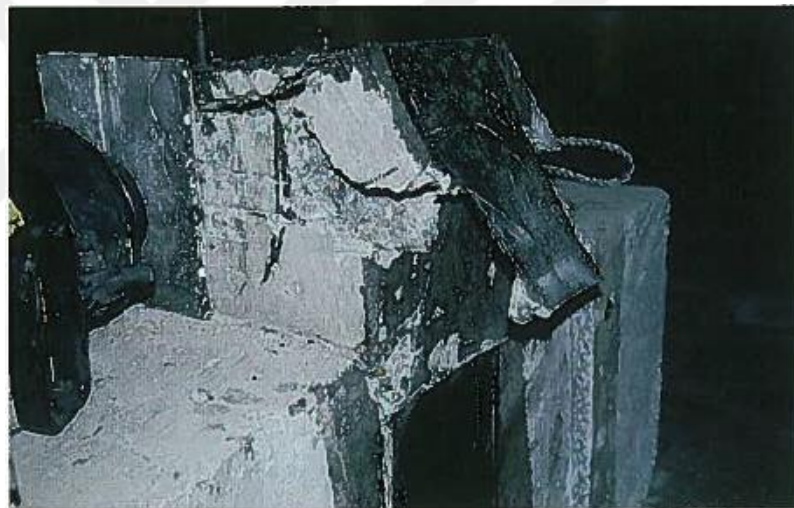
**Figure 2.1** Failure of Bracket after fabric cut

Corry and Dolan in 2001 examined rehabilitation of damaged column brackets specimens using Carbon Fiber Reinforced Polymer (CFRP). The procedure failure of samples was loaded to 75 % of its nominal capacity and then the cracked bracket was strengthened to increase the original capacity until 50 %, and then retested until failure. Fig. 1 shows the failure mode of the bracket after tested. The researchers found that strengthening must be at least two layers of CFRP to verifying the recommended load and when it uses a single layer of CFRP, the failure will be a sudden failure.

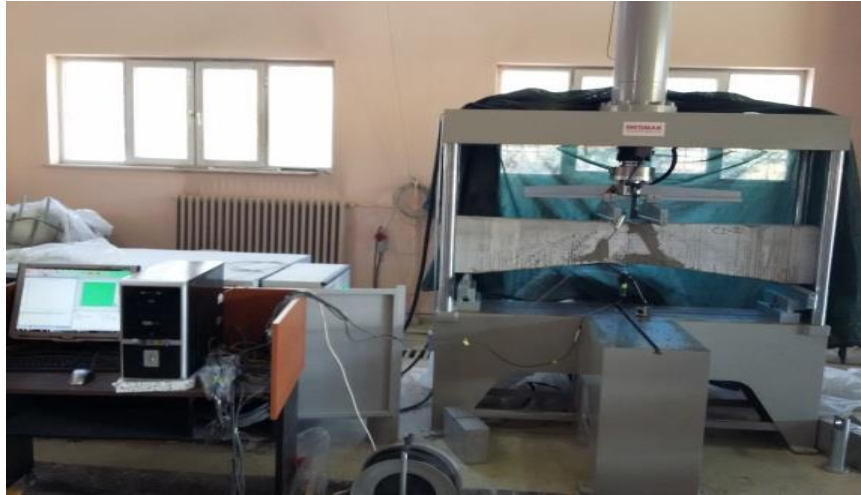
**Figure 3.4** Test setup for four-point loading test

All haunched beams before and after the rehabilitation were tested under four-point load by 500 kN capacity, displacement controlled loading machine. Loading rate was 0.2 mm/min for all tests. Two linear variable displacement transducers (LVDTs) were used to record the deflections of haunched beams as shown in Figure 3.4. Loads and corresponding deflections were recorded for every 0.2 seconds continuously until the end of tests. All of the beams were loaded until failure to provide better insight of the post-peak behavior.

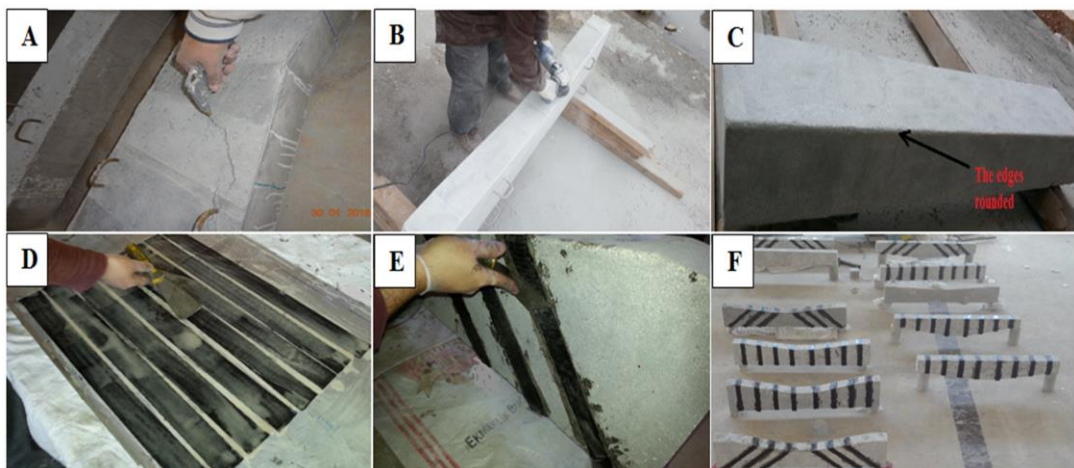
**Figure 3.12** Photos show some steps of rehabilitation and strengthening

The cracks were cleaned by using compressed air to remove dust and loose materials, which are affected by the efficiency of bonding as shown in Figure 3.12 (A). The cracks wider than 0.3 mm should be pressure injected with epoxy before FRP installation which affect the performance of the externally bonded FRP system through delamination or fiber crushing accordance with ACI 440.2R and ACI 224.1R (ACI 224 2008, ACI 440 2008).

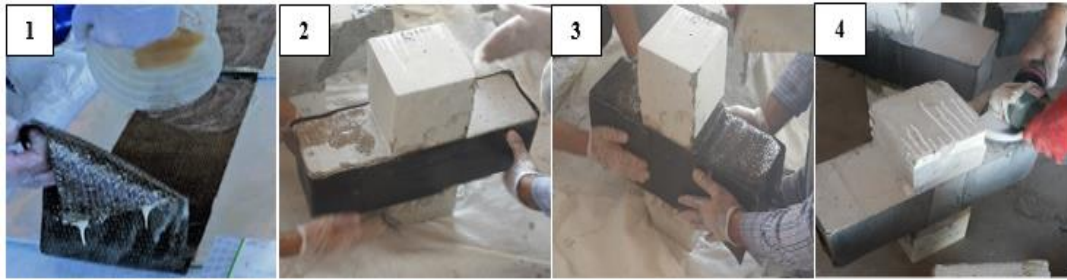
**Figure 4.4** Configuration steps of bonding surface and applying the BFF with epoxy

The second part of group two of corbels was strengthened with BFF in addition to repairing of cracks. The wet lay-up method was followed to replace the strips of BFF which is recommended by ACI 440.2R-08 (ACI 440 2008). Three strips of the BFF were prepared in specific dimensions that are compatible with the corbel dimensions. The components of crack repairing epoxy (epoxy hardener and resin) were mixed by an electric drill machine according to datasheet of the repairing epoxy. Then the BFF was saturated with the lower viscosity epoxy for gluing process. The saturated BFF were glued bi-directionally onto the corbels to achieve better resistance to the combination of vertical and horizontal stresses. Therefore, one layer of the fabric was placed parallel to the corbel axis, and the other layer was wrapped transversally to the corbel surface. Afterward, a trowel was used to eliminate air voids and to achieve perfect adhesion between the fabric and corbel surface. At last, grinder machine was used again for leveling bottom surface of corbels to provide successful simultaneous load transfer mechanism up to both of the supports. The steps of strengthening with BFF are illustrated in Figure 4.4.

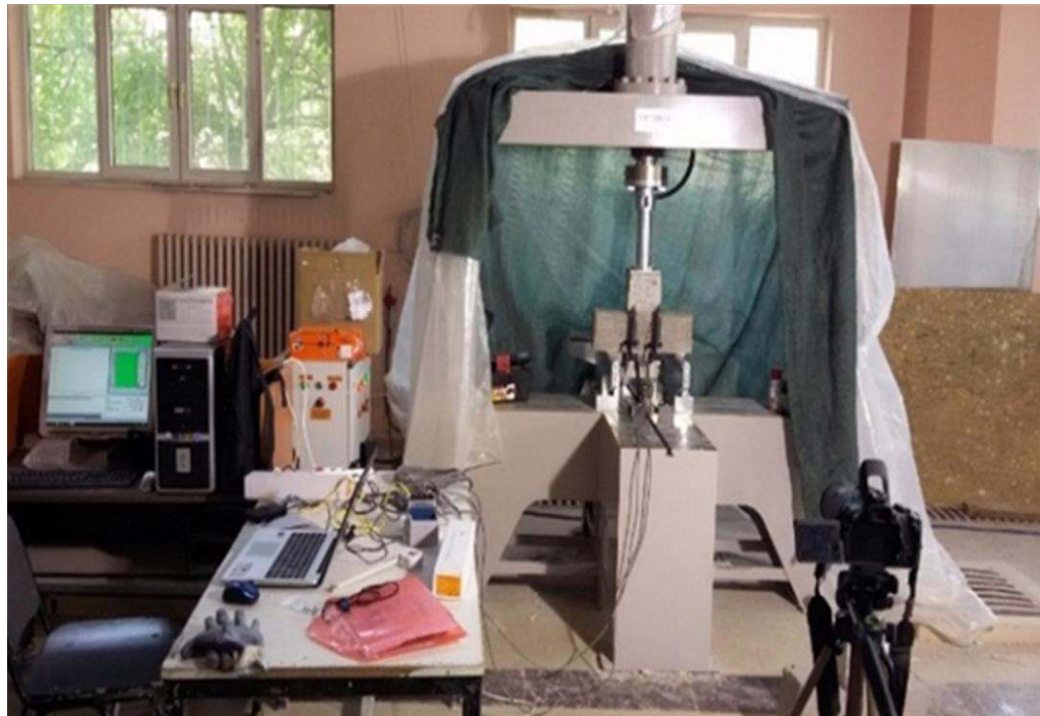
**Figure 4.5** Corbel Setup on the test machine

The values of compressive strength were determined as average of three cylindrical samples (150 \*300) mm according to ASTM C39 specification. All corbels before and after the rehabilitation were tested under a three-point load (Figure 4.1). The maximum load capacity of the machine used was 500 kN. The loading rate displacement controlled (0.2 mm/min), the datasets were recorded every 0.2 s. Two LVDTs were used to record the deflections of corbels as shown in Figure 4.5.

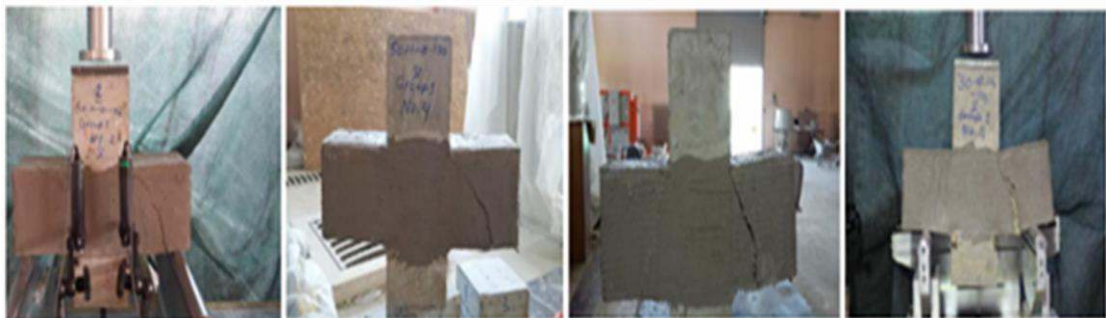
**Figure 4.7** The mode of failure in the Basalt Fiber Mesh (Rupture in the Fibers)

The failure modes of the corbels before and after rehabilitation are summarized in Table 4.7. The modes of failure for the corbels before the rehabilitation; flexural failure, shear failure, flexural/shear failure and diagonal splitting failure (Fattuhi 1990). Obviously, the mode of failure after rehabilitation was simply ruptured in the BFM for all corbels and no other type of a failure like a de-bonding failure was observed in the BFM. This type of failure (rupture in the BFM) was a most significant and interesting outcome of this study. Figure 4.7 shows the failure in BFM after being tested for four selected corbels, which is occurred in all samples of part one of first group. Moreover, summary of all results of the corresponding corbels were given in Table 4.7.

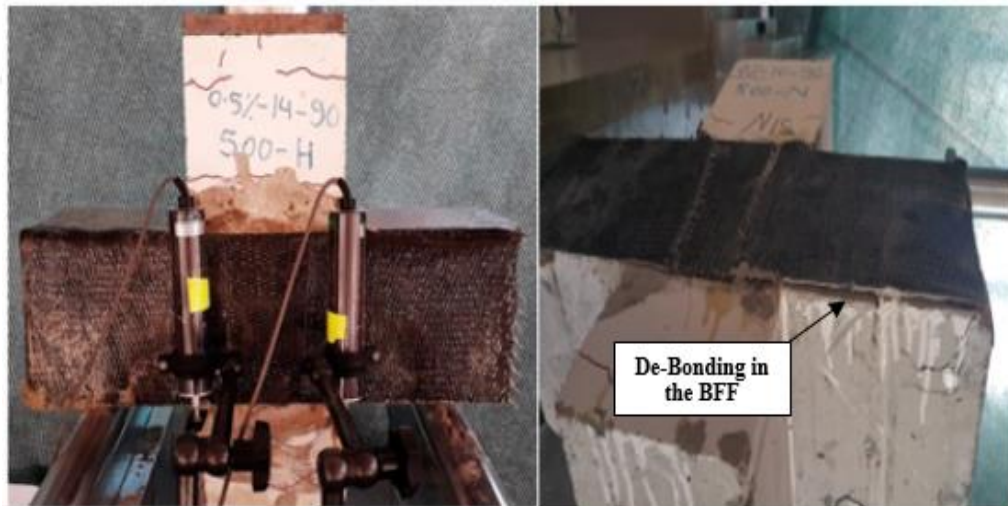
**Figure 4.12** BFF-strengthened specimen with de-bonding failure

The Load-Deflection relationships of BFF-strengthened corbels are shown in Table 4.13. The corbels numbered C43 to C51 represent normal strength concrete corbels and remaining ones (C52 to C60) refer to high strength concrete corbels. Moreover, it can be concluded from the results of second group (Table 4.10 and 4.12) that the damaged due to the high level heated degree  $750^{\circ}\text{C}$  adversely affected the compressive strength of concrete as can be seen in the results of cylindrical compressive strength beside to the capacity of corbels. Summary of all behaviour of the corresponding corbels were given in Table 4.13.

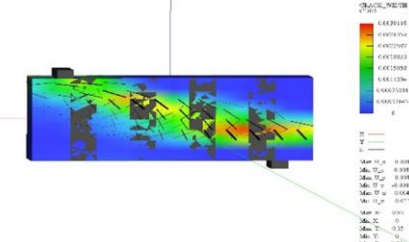
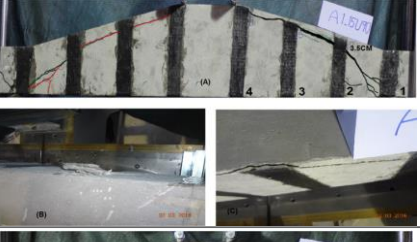
**Table 5.13** Cracks pattern of testing rehabilitated haunched beams via FE analysis of strengthening hunched beam cracks for HB1 until HB7

| Name of RCHB | Beam code | Experimental | Finite Element |
|---|---|---|---|
| 1 | Rf1U90 | <p>(A) (B) (C)</p> | |
| 5 | A1-15U90 | <p>(A) (B) (C)</p> | |
