# **THE TOWER HOUSES IN FOÇA**

**A Thesis Submitted to the  
Graduate School of Natural and Applied Sciences of  
Dokuz Eylül University  
In Partial Fulfillment of the Requirements for  
the Degree of Master of Science in Architecture, Restoration Program**

**by  
Bilge YILDIRIM**

**February, 1997  
İZMİR**

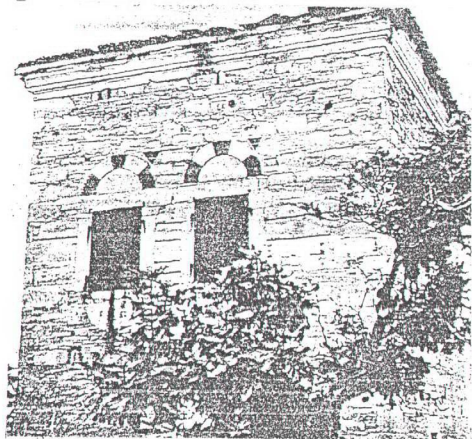
FIGURE 2.8. South Elevation

SOURCE: Weaver, M.E. (1971, Vol.12). A Tower House at Yeni Foça. *Balkan Studies*, p.269

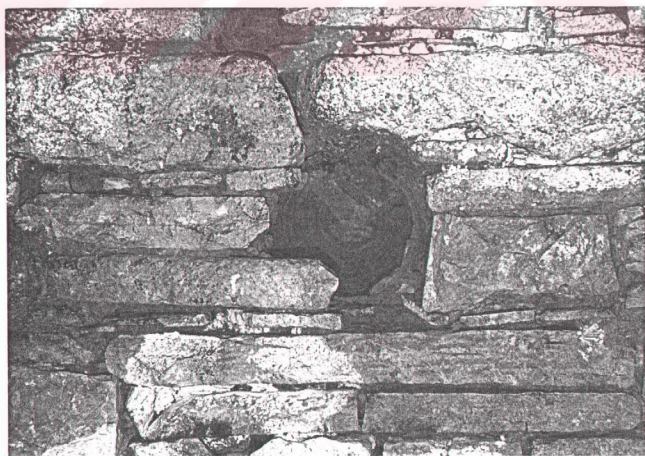
FIGURE 2.24. The Hallow in the Wall

They were allowed in, and after they left the church, her family found a broken pitcher in the wall, suggesting that they took golden materials that might be hidden in the pitcher (FIGURE 2.24)].

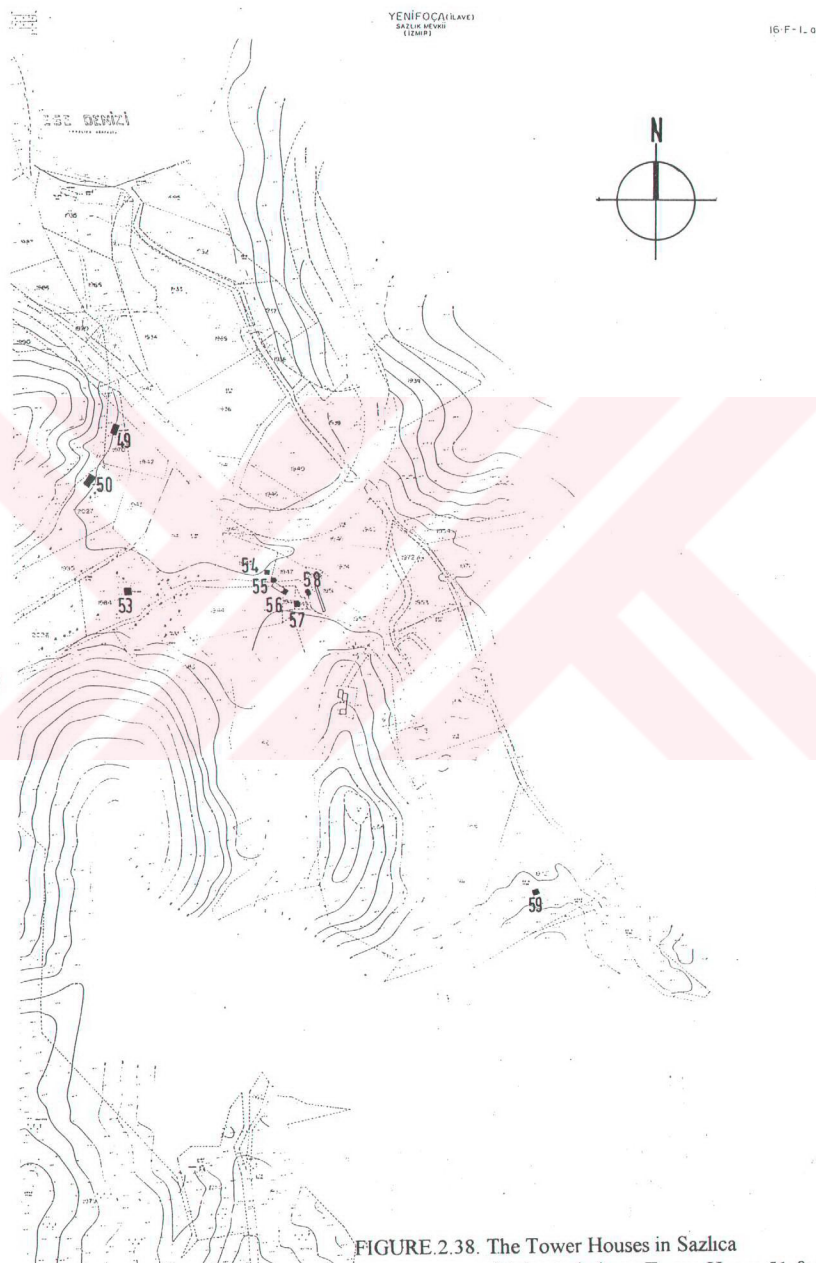
FIGURE.2.38. The Tower Houses in Sazlıca  
(Estimated places Tower House 51 & 52)

The locations of the tower houses at Kartera and Sazlıca are shown in the maps of Figures.2.37 and 2.38. The present conditions and dimensions of the tower houses in these districts are stated in Figures.2.38.a and 2.38.b.

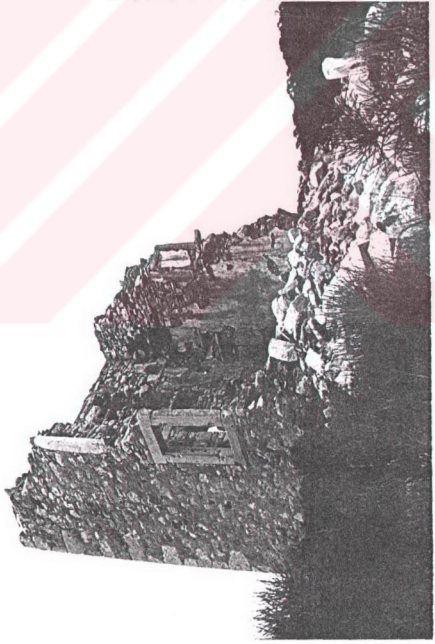
FIGURE.2.40. A Tower House at Kartera

ACTUAL STATE

:Almost Disappeared

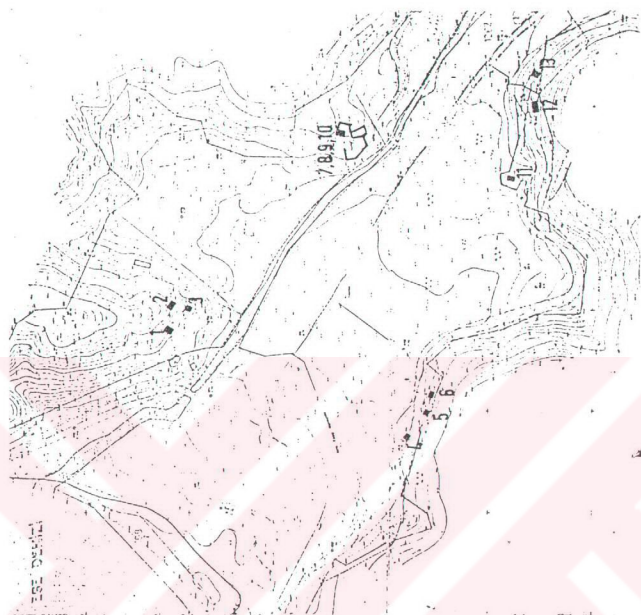
FIGURE 2.42. A Tower House at Kartera

PROVINCE :İZMİR  
COUNTY :Foça  
DISTRICT :Kartera  
CITY BLOCK NO :1262  
LOT NO :4  
THE DEGREE OF PROTECTION:Second Degree Natural Reserve  
DATE OF BUILDING :The late of 1800's  
PRESENT OWNER :S.S.İnbat Obası Ara ve Yapı Kooperatifi  
ACTUAL STATE :Almost Disappeared

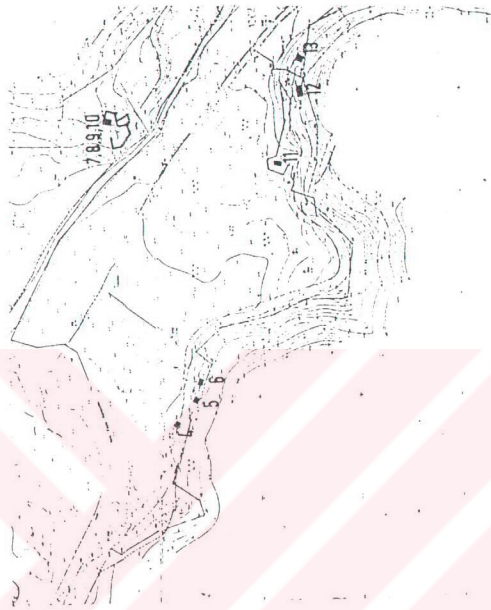
FIGURE.2.43. A Tower House at Kartera

PROVINCE :İZMİR  
COUNTY :Foça  
DISTRICT :Kartera  
CITY BLOCK NO :1261  
LOT NO :4  
THE DEGREE OF PROTECTION:Second Degree Natural Reserve  
DATE OF BUILDING :The late of 1800's  
PRESENT OWNER :S.S.İmbat Obası Arsa ve Yapı Kooperatifi  
ACTUAL STATE :Disappeared

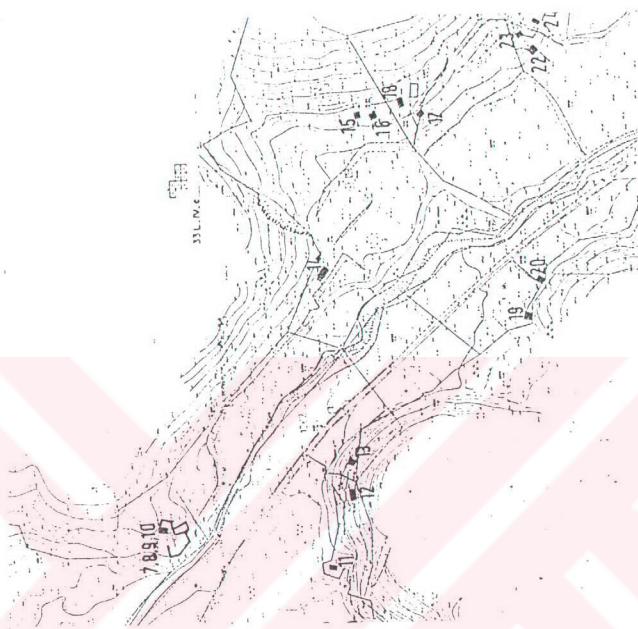
FIGURE 2.54. A Tower House at Kartera

LOT NO :  
THE DEGREE OF PROTECTION: Second Degree Natural Reserve  
DATE OF BUILDING : The late of 1800's  
PRESENT OWNER : S.S Imbat Obasi Arsa ve Yapı Kooperatifi  
ACTUAL STATE : Significantly Existent

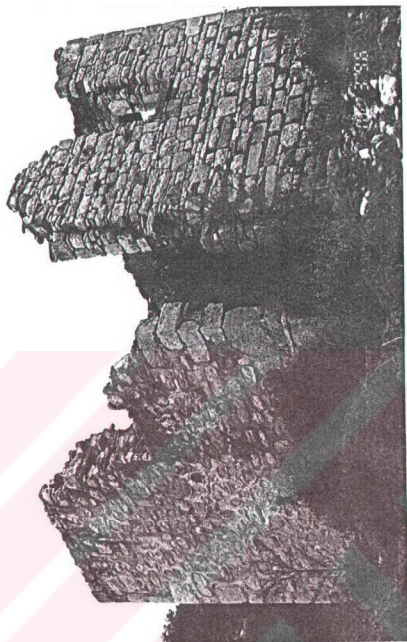
FIGURE 2.56. A Tower House at Kartera

PROVINCE :İZMİR  
COUNTY :Foça  
DISTRICT :Kartera  
CITY BLOCK NO :1261  
LOT NO :3  
THE DEGREE OF PROTECTION:Second Degree Natural Reserve  
DATE OF BUILDING :The late of 1800's  
PRESENT OWNER :S.S.İnbat Ohas Arsa ve Yapı Kooperatifi  
ACTUAL STATE :Almost Disappeared

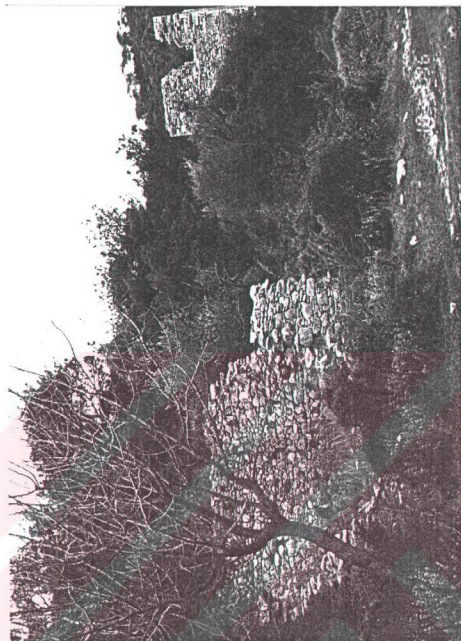
FIGURE 2.61. A Tower House at Kartera

PROVINCE :İZMİR  
COUNTY :Foça  
DISTRICT :Kartera  
CITY BLOCK NO :193  
LOT NO :3

THE DEGREE OF PROTECTION:Second Degree Natural Reserve  
DATE OF BUILDING :The late of 1800's  
PRESENT OWNER :S.S.İmbat Obası Arsa ve Yapı Kooperatifi  
ACTUAL STATE :Disappeared

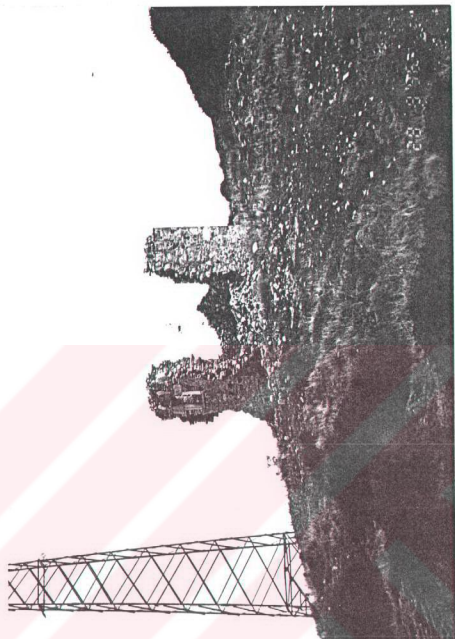
FIGURE 2.80. A Tower House between Kartera and Sazlica

Disappeared

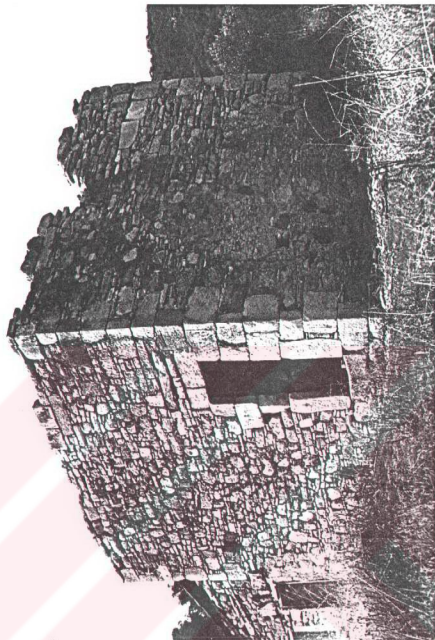
FIGURE 2.81. A Tower House between Kartera and Sazlica

PROVINCE :İZMİR  
COUNTY :Foça  
DISTRICT :Kartara-Sazlıca  
CITY BLOCK NO :  
LOT NO :  
THE DEGREE OF PROTECTION: ----  
DATE OF BUILDING :The late of 1800's  
PRESENT OWNER :  
ACTUAL STATE :Significantly Existent

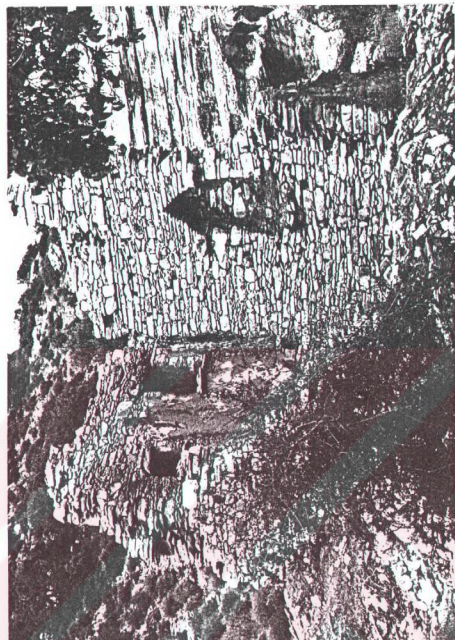
FIGURE 2.86. A Tower House at Sazlıca

Disappeared

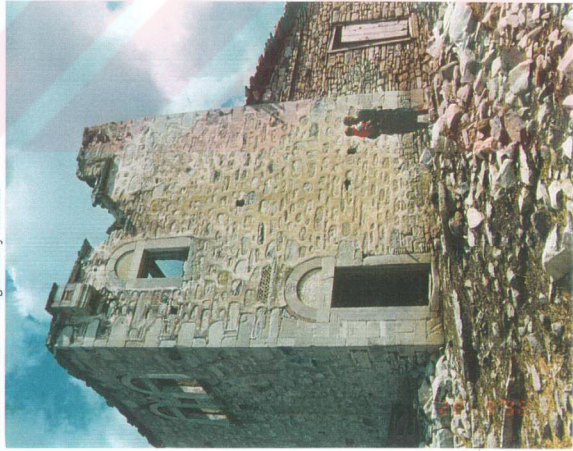
FIGURE 2.99. A Tower House at Sazlıca

PROVINCE :İZMİR  
COUNTY :Foça  
DISTRICT :Sazlıca  
CITY BLOCK NO :  
LOT NO :1944  
THE DEGREE OF PROTECTION:First Degree Natural Reserve  
DATE OF BUILDING :1841  
PRESENT OWNER :Hatice-Hayati Deniz, Birsen Tunay, Arni Yavuz, Gülnaz Dalbıçer  
ACTUAL STATE :Significantly Existent

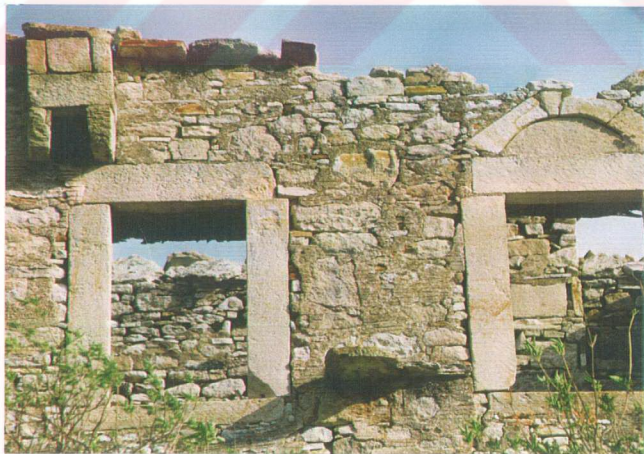
FIGURE 2.114. Flatstone Eave, Machicolation

It is an element that encircles the parapet wall which, in turn, limits the height of a tower house. They are made of smoothly-cut thin stone plates. One can see them in many tower houses. However, they are usually not in a good condition anymore.

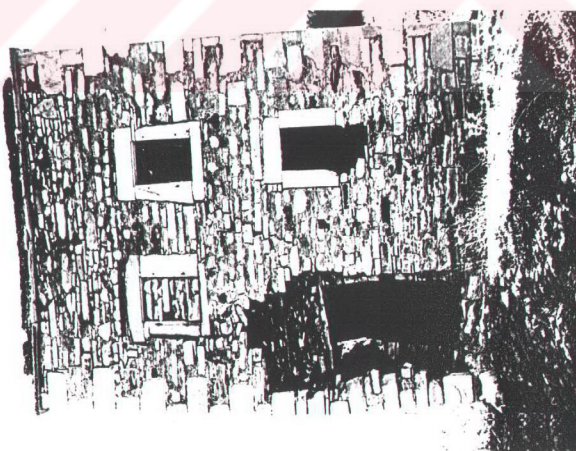
FIGURE.3.6. The View of the Tower House 46 on the 8th September, 1996

Following the road along the sea from Eski Foça to Yeni Foça, one can reach Kartera, which is situated in a valley and has a great number of tower houses (FIGURES.3.4 & 3.5). Although many of them collapsed, 43 towers have been observed forming a local texture on the accessed area. Most of these tower houses, scattered around, are overlooking the sea. The valley, covered with natural vegetation, ends with a forest. The inlet surrounded by this valley is one of the bays with rare beauty along the Foça coasts. Kartera is a deserted district, except a few houses used in certain months by people who come for farming and bee-keeping. In the region, which lies between Kartera and Sazlıca and includes also the Çanak Bay, there are tower houses among the trees, scattered along the coast. They are all abandoned and half-collapsed. They are rapidly vanishing. A tower house, the photo of which was taken in the first visit when it seemed on the verge of a collapse, has been found in the next visit, three months later, with its entrance part demolished (FIGURES.3.6 & 3.7).

! In the holiday complex consisting of units like apart-houses or bungalows, the restoration of the tower houses should be based on a plan determined by certain principles. The existing walls should not be destroyed, and the material and masonry for the parts to be repaired should be selected in a harmony with the original structure. The architectural elements on the façades and inner wall-faces, which are peculiar to tower houses, should not be destroyed. Especially in the repair works of the floors, the selected materials should be, at least, similar to the original ones. That is, wooden materials should be used. The existing dimensions of the doors and windows should not be changed. In the restoration of the tower houses with collapsed upper stories, the windows should be built in such quality, number, and size that the houses would not lose the characteristics of a tower. The landscape arrangements of the holiday complex should be planned according to the terrain and the positions of the tower houses. Since the tower houses have quite suitable plans, no additional structure should be built in the holiday complex. The facilities like cafe, bar, restaurant, etc., which are to be open for public use, should be chosen among the tower houses. The only missing parts of the original towers are toilet and bathroom. This problem can be solved by rearranging the adjoining outhouses so as to include such parts. These outhouses should be connected to the tower houses in a way causing minimum modification. Infrastructural problems, such as electricity and water, should be solved. While repairing the partially surviving tower houses, the traces of the completely collapsed towers should be preserved. This way, the repaired towers will show their respects for the collapsed towers.
