# CONSERVATION OF THE KANDOVAN NATURAL HERITAGE SITE, IN IRAN

Submitted to Graduate School of Natural and Applied Sciences  
in Partial Fulfillment of the Requirements  
for the Degree of Master of Science in  
Architecture

Yeditepe University  
2023

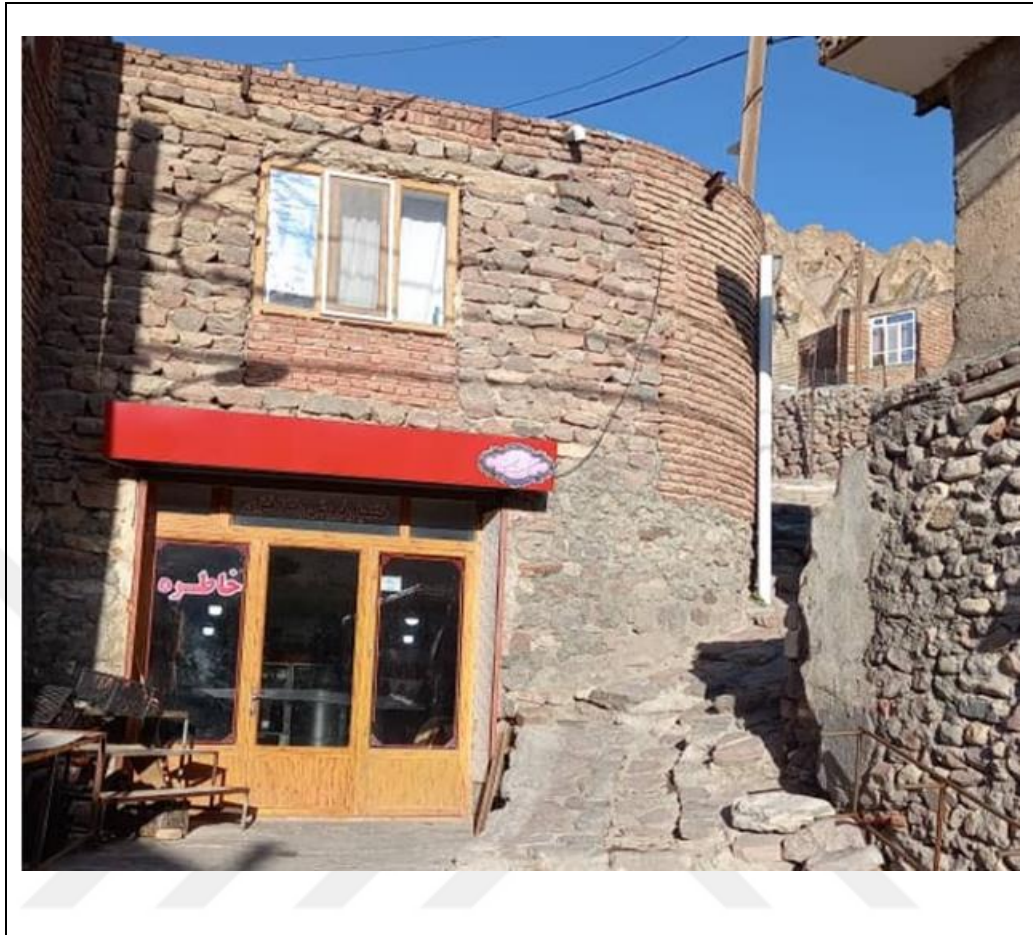
Figure 3.10. New Material [13].

And mainly due to the lack of familiarity with the relevant implementation techniques, they have bad conditions in terms of construction quality. The materials used in the old structure are stone rubble from the village and wooden beams and construction materials used in recent constructions are bricks, iron, plaster, sand and cement, which are mainly supplied from Esko.

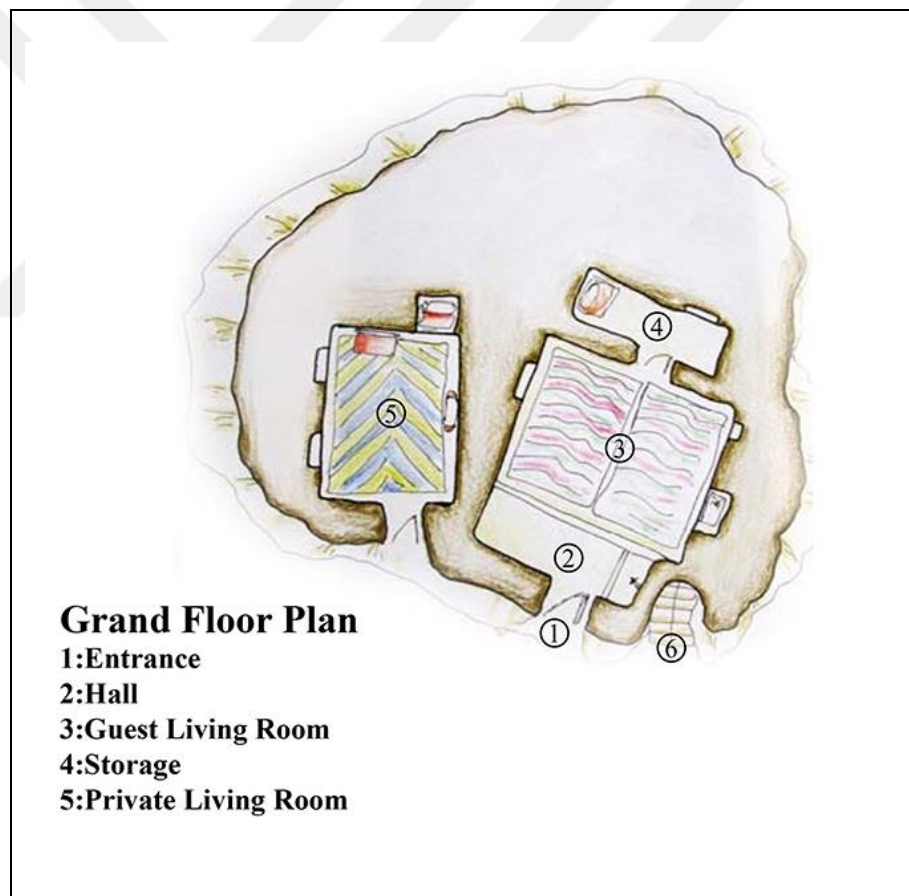
Figure 4.1. Grand floor plan of a Karan [6].

Karans: Karans which have been created by volcanic eruption of Sahand Mountain form the foundation of Kandovan. They are 10-15 meters high and 5-8 meters in diameter. These Karans made of igneous rocks and have prepared appropriate accommodation to reside in the cold climate of Kandovan [6].

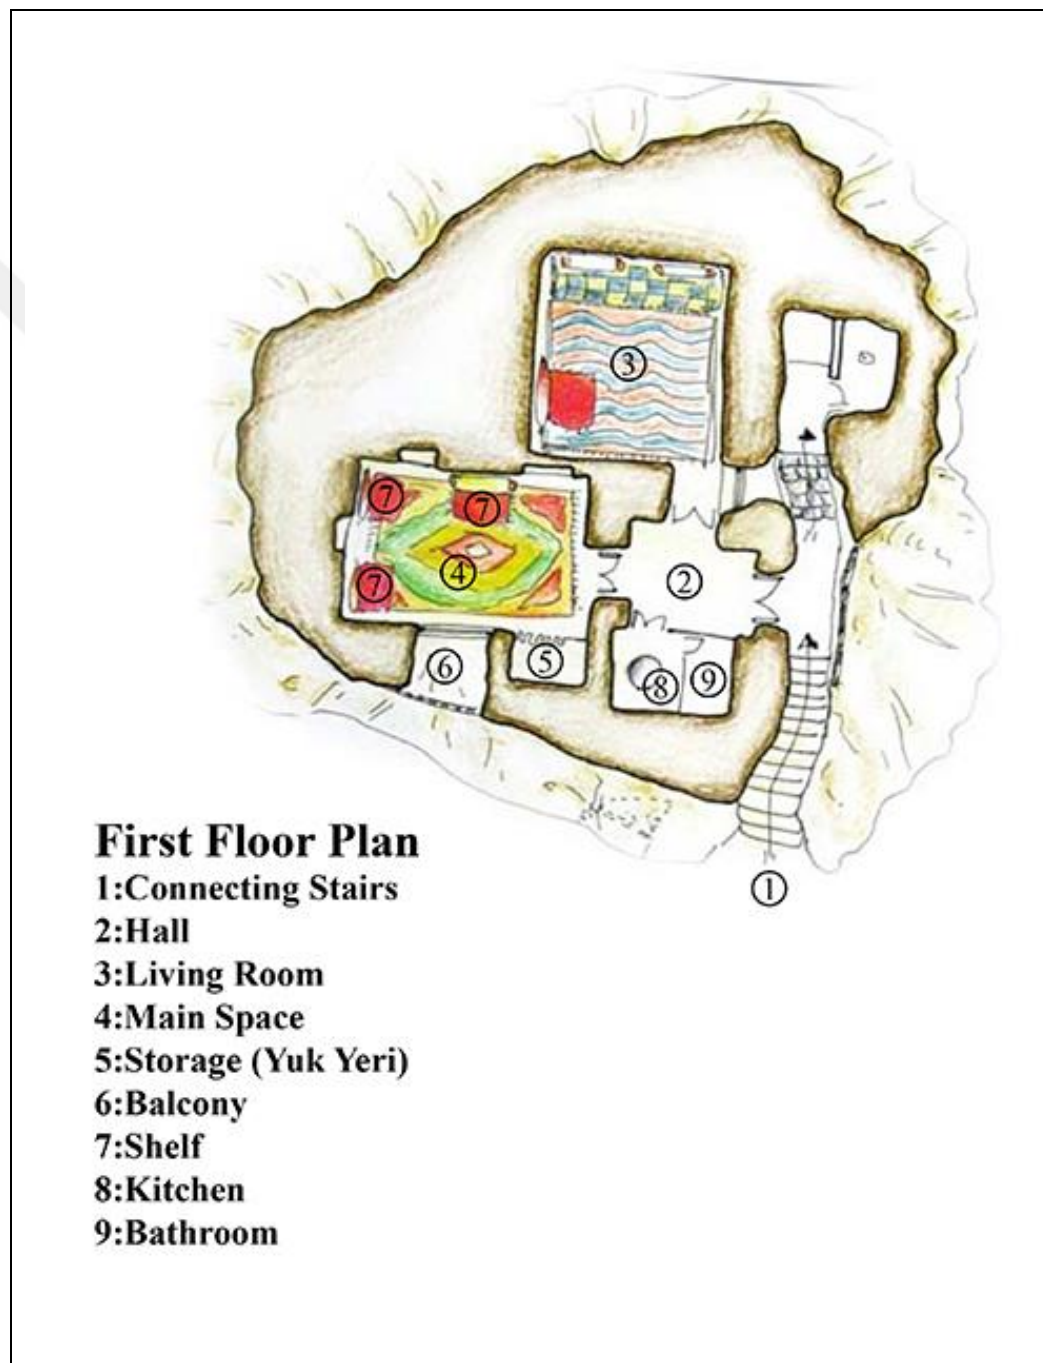
Figure 4.2. First floor plan of a Karan [6].

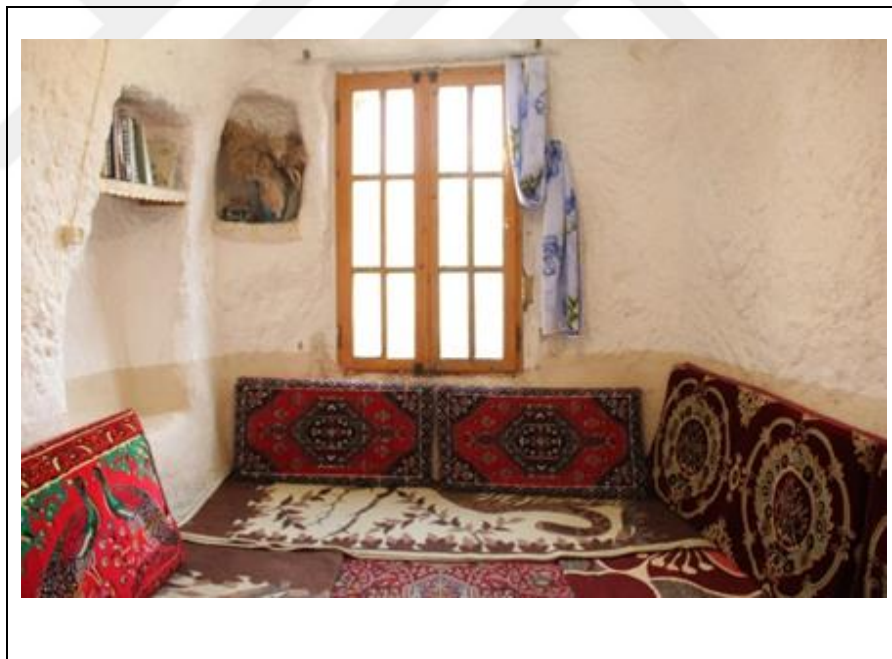
Figure 4.5. A living room for the gest people in a karan.

**Main Area** It is used both as a living room and as a bedroom. In some houses, it was also used as a guest room. In some houses, the sleeping area was raised with a stone platform and covered with rugs. A corner of the room is also reserved for family members to sleep. On the right side of the houses, I observed during the research, there are water containers, milk, and dairy products. A road and a channel for their waste are provided outside the house [14].

On the interior side walls, niches and shelves have been carved to hold items such as books, mirrors, and candles. some rock houses have a clamp on the ceiling for hanging lights (bulbs or chandeliers). The floor of the house is covered with rugs and hand-woven carpets.

Almost all the main rooms have a bread oven. In the past, these ovens played a major role in heating rock houses as well as baking bread, but nowadays, with the arrival of the natural gas network, these ovens are out of use. In the past, white earth from the surrounding area was used to whiten the walls, but nowadays plaster is used.

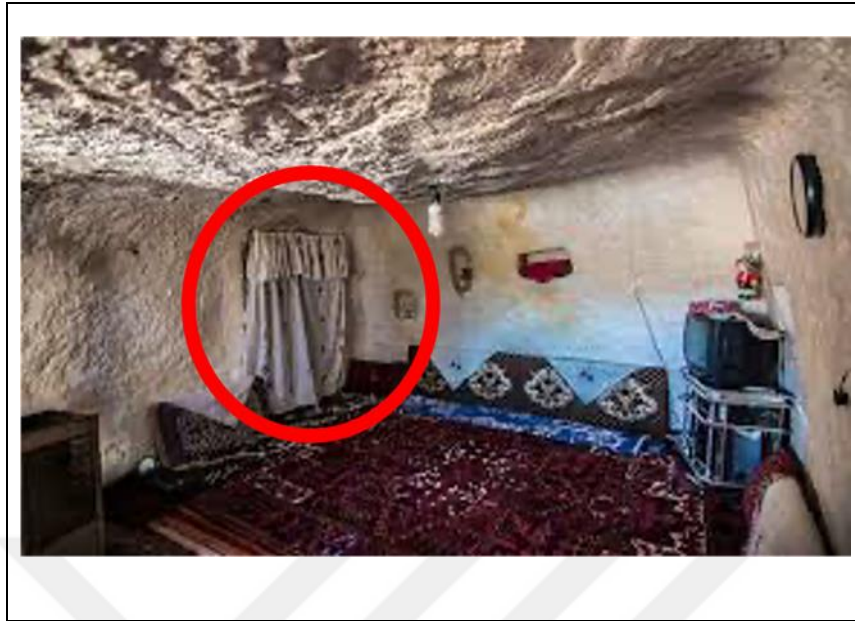
Figure 4.6. the Nish in a Karan (Yuk Yeri)

**Yuk Yeri:** It is a relatively large and flat place on the wall of the main room, which is used for placing quilts, mattresses, blankets and clothes. And it is separated from the main space by a curtain [15].

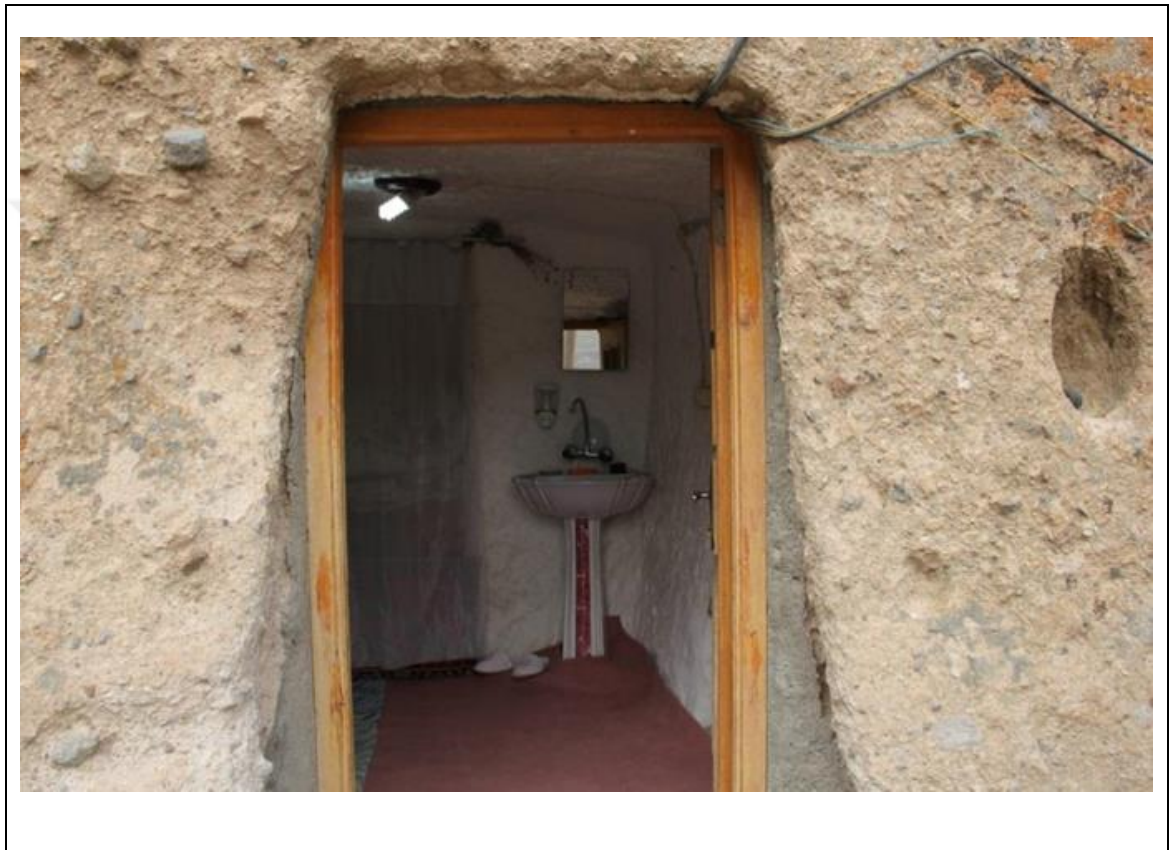
Figure 4.11. Kandovan houses astana [16].

**Astana:** The entrance part of each border is called (astana) in the local term and it can be seen in two ways. In large areas where there is no space limit, sometimes it is done as a separate inlet filter and washing dishes and clothes and even the residents themselves are

also done in this area. But in smaller borders, to prevent water from entering the living area, the threshold is separated from the main living area by a short stone wall, and washing is done in a part of the living area itself. The washing place is in the form of a small cement basin that is connected to the village tap water and has a hole outside to dispose of wastewater.

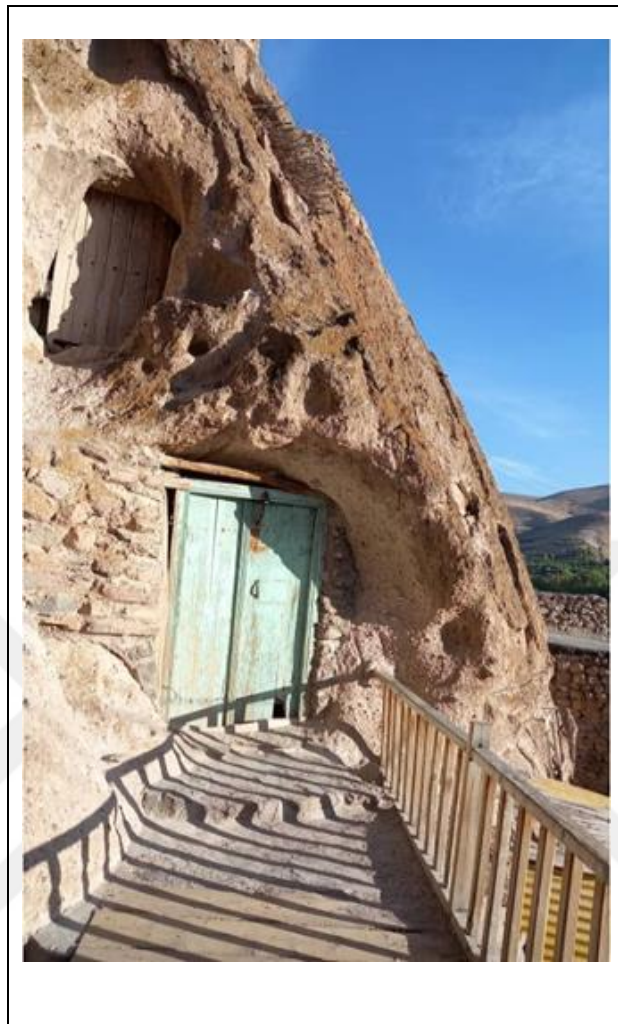
Figure 4.12. Example of entrance doors [15].

Entrance doors: Mainly due to the difficulty and limitations of digging, they are with a height of (1.50~1.60) cm and a width of (1~1.30) meters and to protect the borders from snow and rain as much as possible. They are embedded inside the walls. Most of them are made of wood. In recent years, very few of them have become iron.

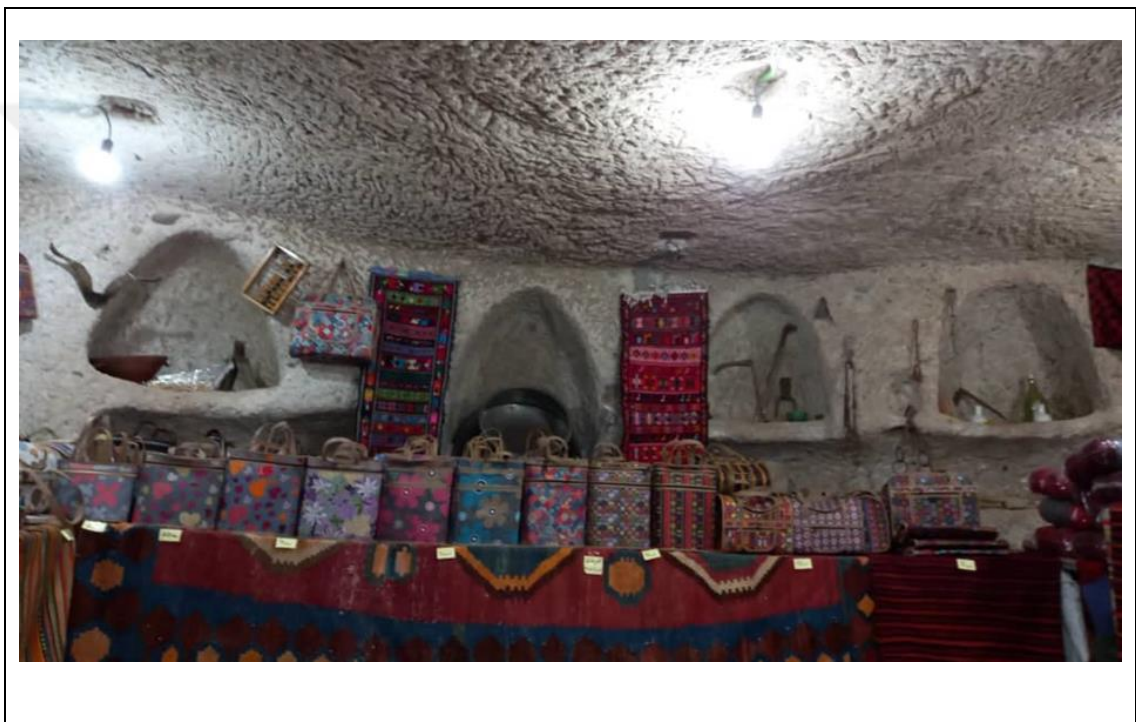
Figure 4.18. The nish inside the Karans that they use for shopping [13].

Business space: Commercial uses are spread on the side of the main road of the village, and in the bazaar area, there are units in the form of commercial use. The total area of commercial uses in the current situation is 2997.75 square meters and the per capita use is 5.06 square meters.

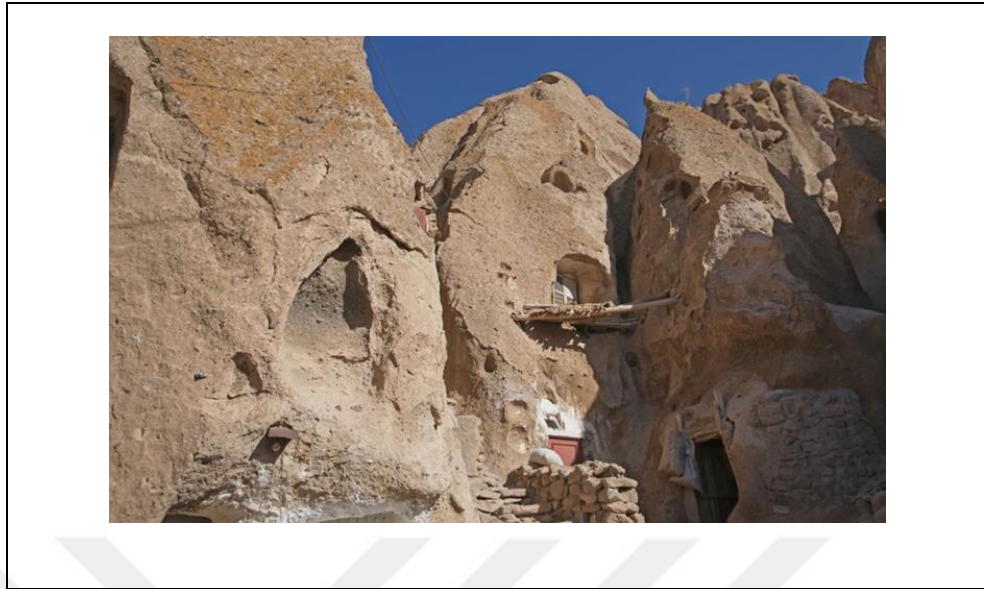
Figure 4.22. Rock architecture (NATURAL) [16].

The dominant architecture is rock architecture that has crystallized in the form of rocks that have been carved with primitive tools and tools throughout history and turned into spaces such as residential spaces, warehouses, stables, religious and sanitary spaces. In different periods, the way of digging the rocks often has a fixed shape and it is dug by master craftsmen with a pick, and only in different periods, according to the needs of people, new spaces have been formed. In terms of the distribution of spaces, the residential uses of barns and stables of each family are attached to each other as much as possible, and often each rock (border) contains residential uses, stables, and barns [15].

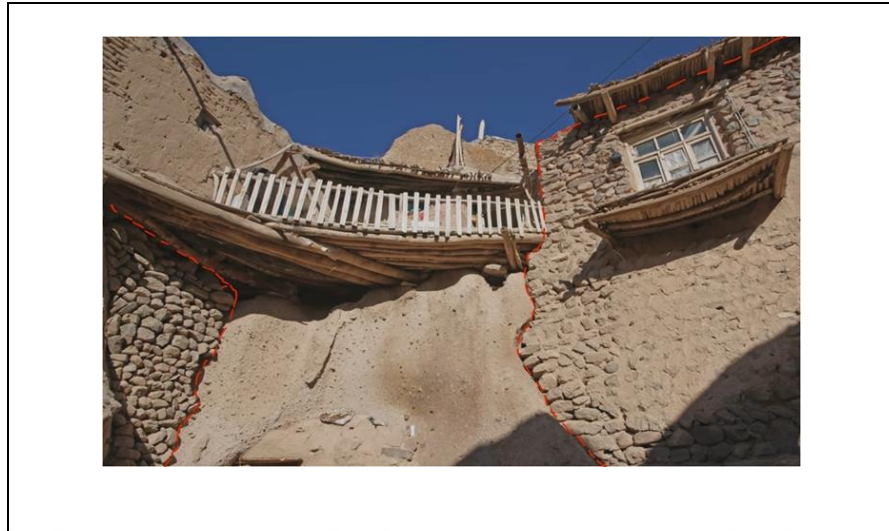
Figure 4.20. New and Old Karans [16].

this type of architecture complements rock architecture to provide suitable living spaces in the following periods, which is a combination of local river stone and mud straw (in the past) and cement sand mortar (currently) in the walls and beams. They are wooden with the final coating of mud on the roof. Most spaces such as tandir (bread baking place), kitchen, toilet, and storage, and sometimes residential spaces are built with these materials. In parts of the damaged borders, it was also used in the past to restore the damaged part or to fill unusable spaces inside the residential borders. The studied border sample is in Agha Jabasi neighbourhood (Agha neighbourhood) where the formation and development of the residential unit in the period of rock and stone architecture can be seen in it. According to the functional needs of the residential unit, a warehouse with stone materials has been built [15].

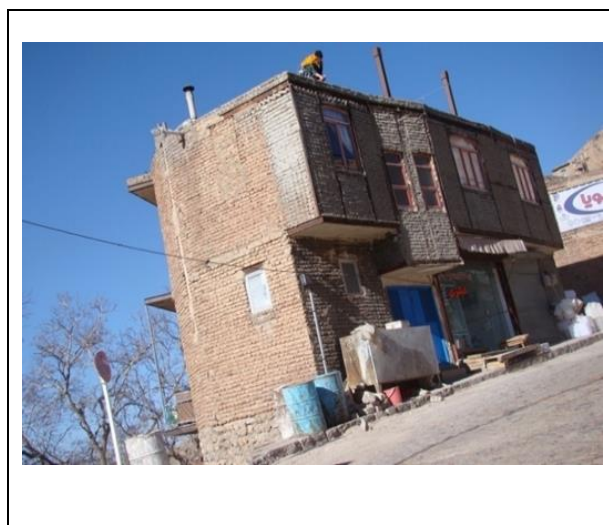
Figure 4.23. A new construction [16].

This type of architecture, which has nothing to do with the native architecture of Kandovan, is often built on the side of the main road for the purpose of commercial activities and sometimes residentially using materials such as brick and metal in a disproportionate and non-homogeneous manner with the native architecture. Mainly due to the lack of familiarity with relevant implementation techniques and non-compliance with standards, they have very poor conditions in terms of construction quality.

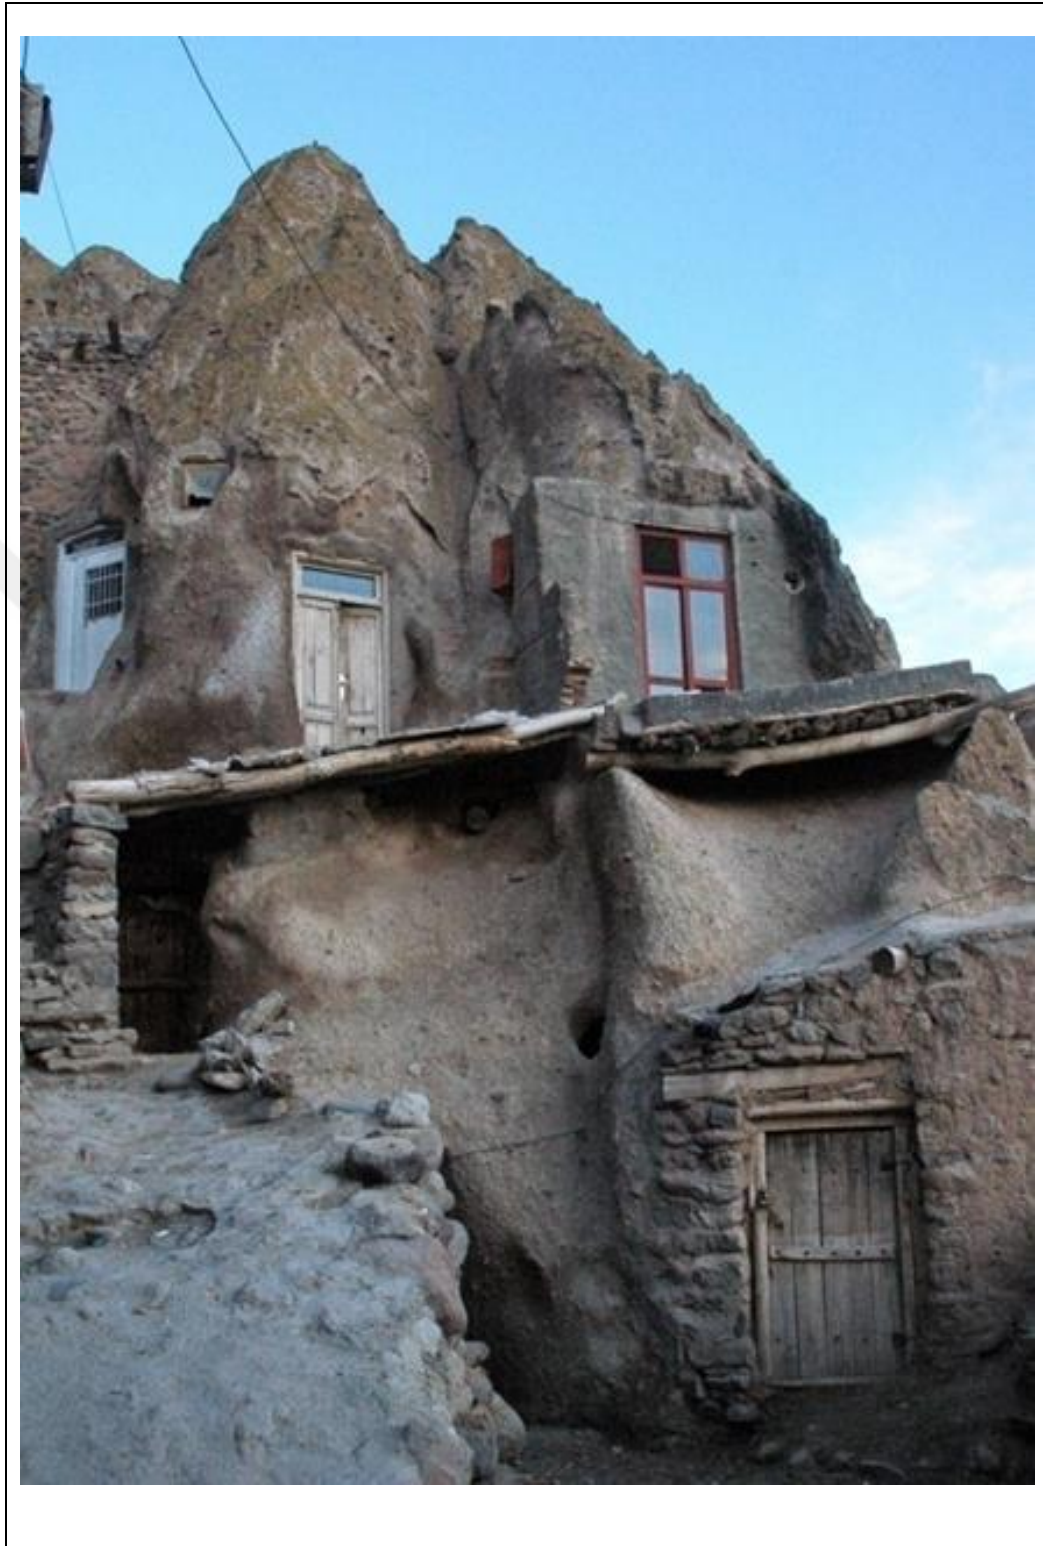
Figure 4.24. An example of a residential unit in which the effects of the architecture of all three periods can be seen [16].

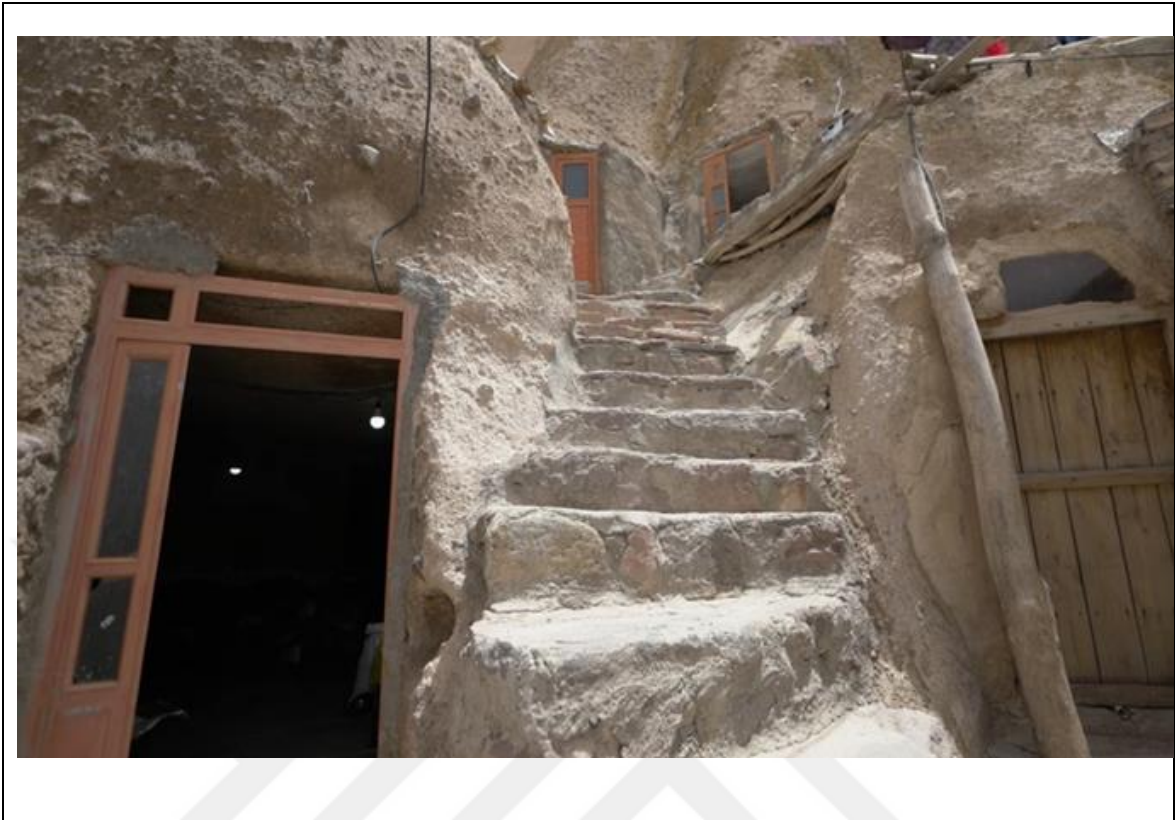
Figure 5.8. Man-made stairs and new building material

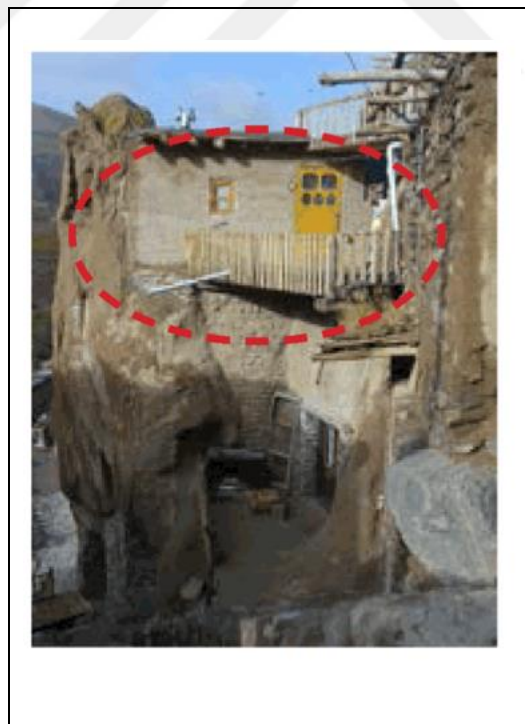
Figure 5.15. Adding an additional part and increasing the horizontal forces on the building.  
[22].

Figure 5.16. Back of the Karan and the additional part on the Karan [22].

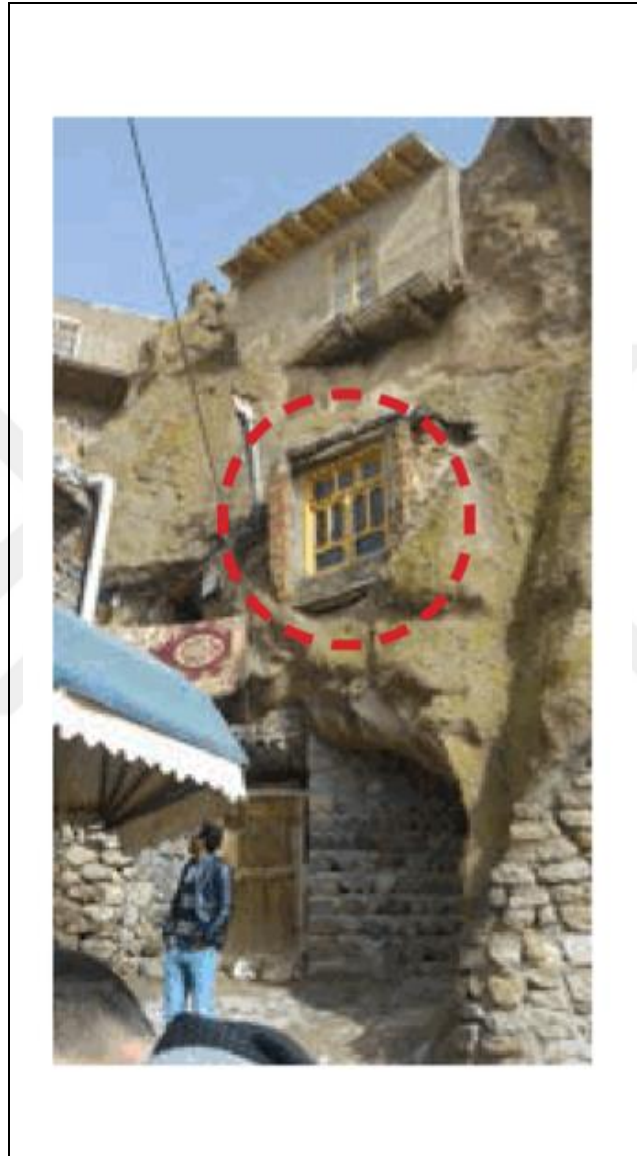
Figure 5.17.Karan's window [22].

**A.3. Expanding the dimensions of light entry holes and turning them into large windows, which weakens the wall and disrupts the direct path of compressive forces.**
