ERROR QUANTIFICATION IN CRACK MEASUREMENT OF BUILDING  
MATERIALS USING TERRESTRIAL LASER SCANNING (TLS)

A THESIS SUBMITTED TO  
THE GRADUATE SCHOOL OF NATURAL AND APPLIED SCIENCES  
OF  
MIDDLE EAST TECHNICAL UNIVERSITY

IN PARTIAL FULFILLMENT OF THE REQUIREMENTS  
FOR  
THE DEGREE OF MASTER OF SCIENCE  
IN  
CIVIL ENGINEERING

DECEMBER 2020

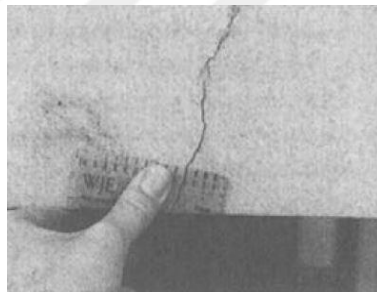
Figure 2.1. Manual Crack Measurement Using a Width Gauge (Farmer, 2004)

In practice, these specialists physically visit structures, inspect damage indicators in building components with naked eye, and gathers observational and quantitative data (The Applied Technology Council, 1998)(Figure 2.1) and (Figure 2.2 (a), and (b)).

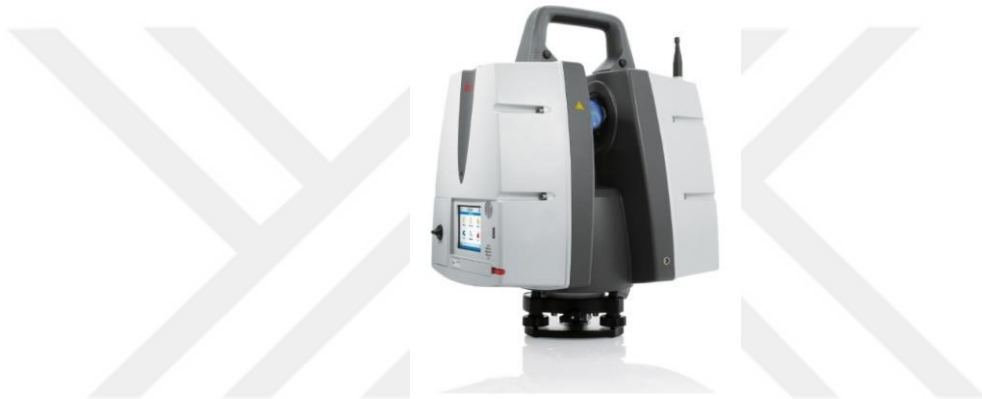
Figure 3.2. Leica ScanStation P40 (Leica Geosystems AG, 2018)

Throughout this thesis, one of the most robust remote sensing instruments, Leica Scan Station P40 3D TLS, is used for data acquisition (Figure 3.2). The device operates on the principle of TOF, as shown in Figure 3.3.

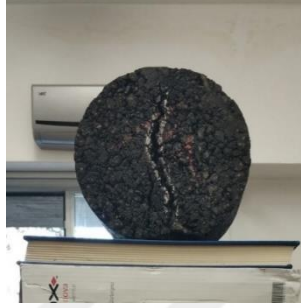
Figure 4.1. Cracked Asphalt Specimen

This case study is conducted in two stages. In both stages, the cracked pavement specimen given below in Figure 4.1 is scanned.

Before the sample is marked with white chalk, an initial scanning is carried out without markings; however, it is observed that it is not easy to make any measurements along the cracked line due to the absence of a contrast on the surface of the object. For this reason, first, the surface is marked with white chalk to create a contrast, then the rest of the experiments are carried out.

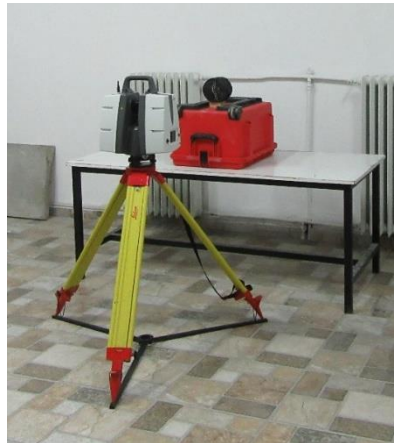
Figure 4.4. Experimental Setup in Case Study-1, Stage-1

The corresponding test atmosphere and the experimental setup are demonstrated in Figure 4.3 (a), (b), and (c) and Figure 4.4, respectively.

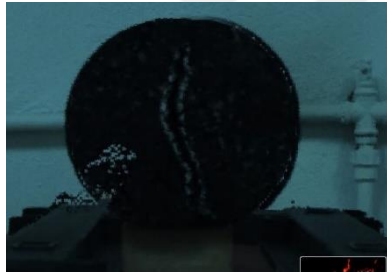
(a) Color from Scanner

(b) Hue/Intensity Map Color

1. Importing of each scan data in Leica Cyclone Register 360
2. Optimization of the cloud color by changing the color setting to the Hue/Intensity map. This modification regulates the visual representation of the points according to their normal directions, with different colors. Thus, it eases the selection of the edge points and increases the accuracy of the measurement. The representative change in the view is shown in Figure 4.5 (a) and (b)
3. Selection of crack edges by providing the maximum amount of zoom-in view
4. Measurement of the distances between the chosen points using the software's distance measuring tool

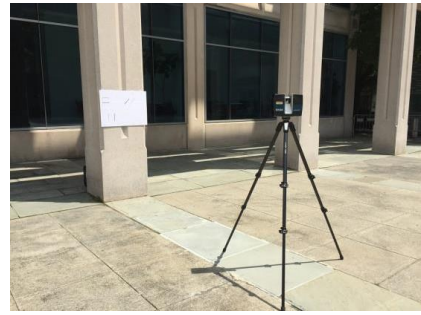
(a) Foam Board for Cracks Simulation

(b) Scanning Set-up

Figure 4.9. The Experiment Setup (Shi & Ergan, 2019)

As illustrated in Figure 4.9 (a) below, the researchers simulated the cracks with different dimensions by cutting the white foam board manually and prepared the related testbed as given in Figure 4.9 (b). They used the Faro Focus S150 terrestrial laser scanner for data acquisition. Furthermore, they used a digital caliper for measuring the ground truth values of the crack dimensions and used a laser meter for arranging the scanning distances Figure 4.10 (a).

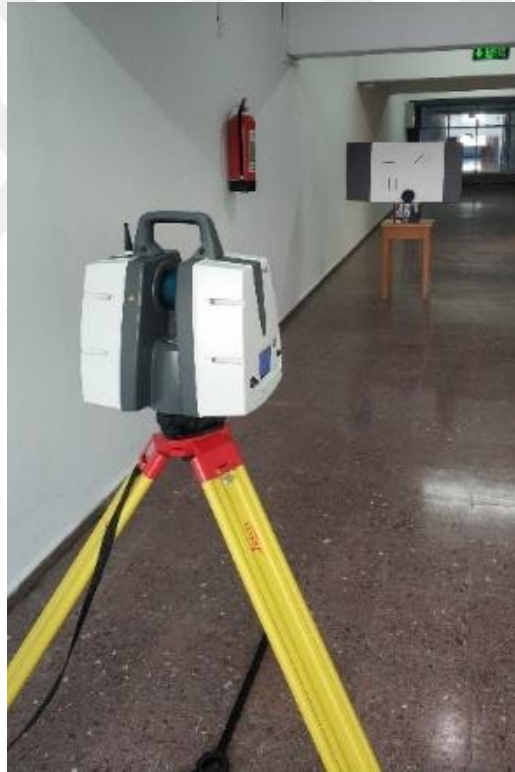
Figure 4.13. The Experiment Setup in Case Study-2

Later, the experiment setup is installed, as demonstrated in Figure 4.13. During the installation, the laser scanner is calibrated, and then the target setup is located accordingly. To verify the values designed for scanning distances, both the laser scanner's built-in distance measurement tool and laser distance meter are used.

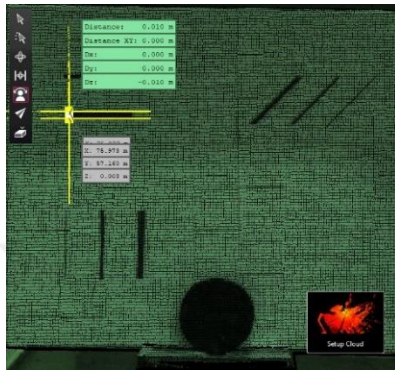
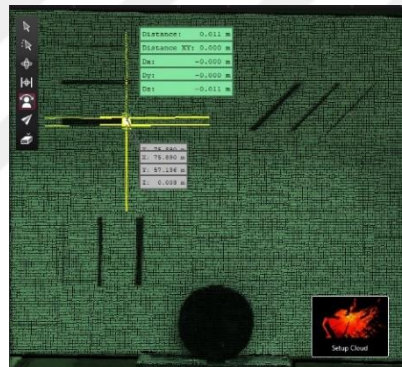
(a). Left End (10 mm)

(b). The Middle (11 mm)

(c). Right End (11 mm)

point throughout the dimensions is chosen as a point of interest, and five repetitive measurements are taken via digital compass at that place. Then, these repetitive measurements are averaged to obtain a final measurement value for each dimension as given in Table 4.13. The purpose of this process is to minimize the error caused by manual measurement on the foam board.

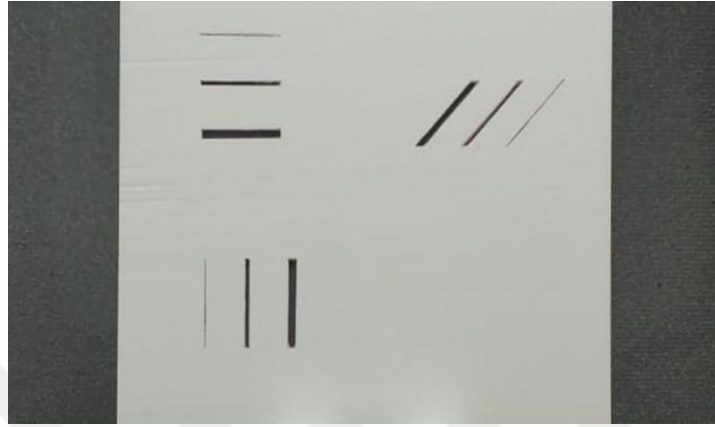
Figure 5.3. Foam Board Specimen\*

\*The ground truth values of the specimen's crack widths are given in Table 4.13 in Chapter 4.

Subsequently, two test setups are established. In the first setup, a foam board specimen, which is previously scanned in Chapter 4, is used, as shown in Figure 5.3. In the second one, the RC specimen showed in Figure 5.4 is scanned.

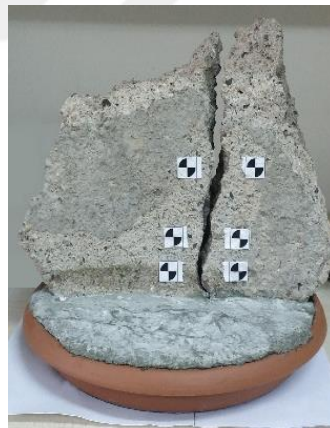
Figure 5.4. Labeled RC Specimen\*

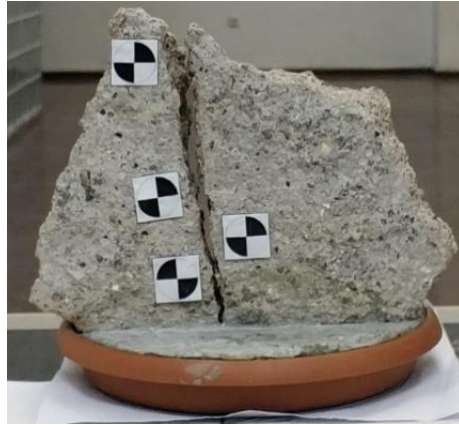
Figure 5.9. RC Specimen Used in Case Study-1\*

In this case study, the RC specimen given in Figure 5.9 below, is scanned multiple times with predefined scan settings that will also be used while scanning other building materials.

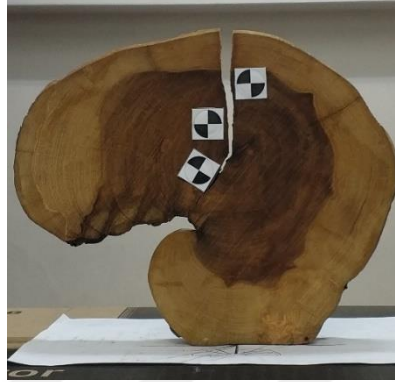
Figure 5.12. Wooden Specimen Used in Case Study-2

In this case study, the wooden specimen given in Figure 5.12 is scanned multiple times following the same scan settings used in the previous section.
