**ARCHITECTURAL APPRAISAL AND  
CURRENT CONDITION ASSESSMENT OF  
OTTOMAN MINARETS IN ISTANBUL**

Master's Thesis

Therefore, this study is concerned with evaluating the Ottoman minarets in the city of Istanbul, being the city of minarets. A reconnaissance study was conducted for ten famous minarets in the city of Istanbul, and their damage was assessed from a structural and biological standpoint. Remedial solutions were also proposed according to the results of the exploratory study to evaluate the current conditions of the minarets.

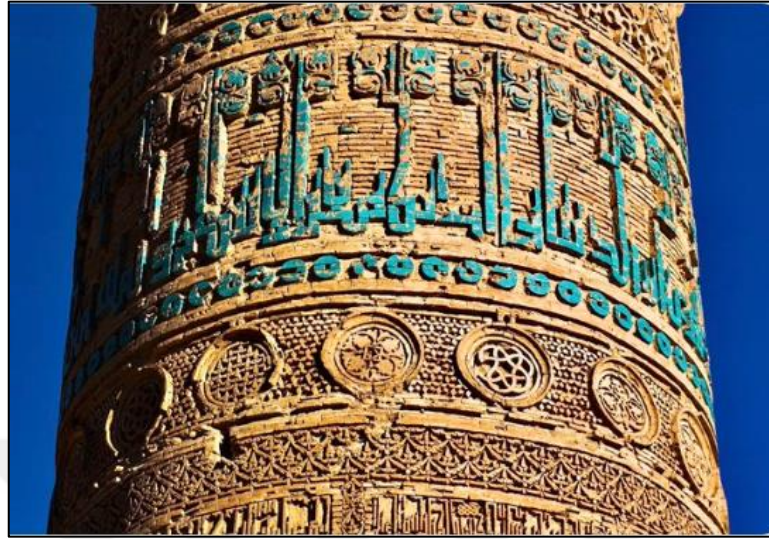
**Figure 2.1:** Decoration of Geometric Patterns in Jam's Minaret in Iran [31].

symmetry. Figure 2.1 shows the aesthetic value of the minaret through the geometric engravings.

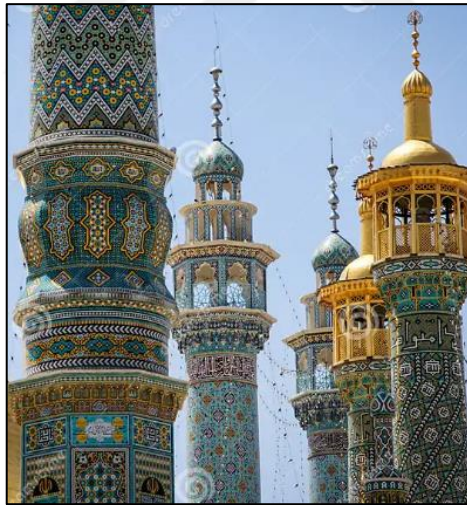
**Figure 2.2:** Shows the Decorations of the Magnificent Persian Minaret [29].

- c. Calligraphic decoration: Arabic calligraphy has significantly impacted the minaret through the sublime and purposeful meanings and words decorated as stripes. Figure 2.2 depicts the aesthetic values of the minaret, which are imparted by decorations and inscriptions in Arabic calligraphy, which give it a distinct heritage and cultural character.

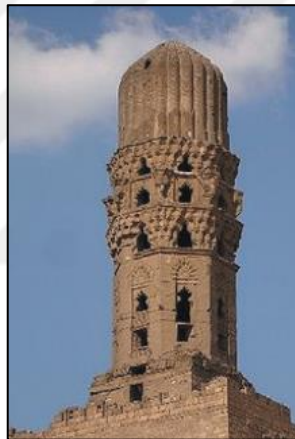
**Figure 3.3:** Al-Hakem Minaret in Cairo [18].

After that, the shape of the minaret increased. The polygonal minaret appeared in the Fatimid era, as illustrated in Figure 3.3, representing the Al-hakem minaret in Cairo.

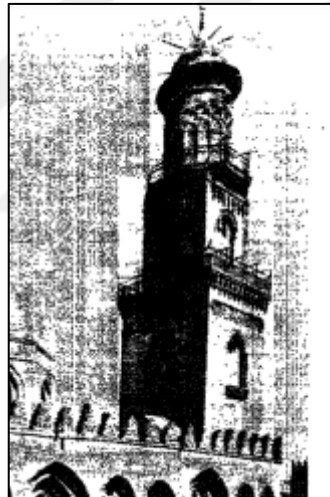
**Figure 3.5:** Minaret of Sultan Qlawuun [20].

Mamluk Egypt preferred the complex variety in the minaret as the minaret of Al-Sultan Qlawuun, as illustrated in Figure 3.5, and cylindrical minarets spread in Iraq, Iran, and Central Asia [6].

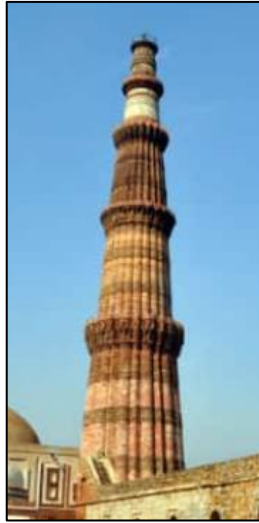
**Figure 3.6:** Qutub Al-Din minaret in India [21].

The Indian minarets were cylindrical, narrowing as they rose to the top, and decorated with balconies and ribs on the body.

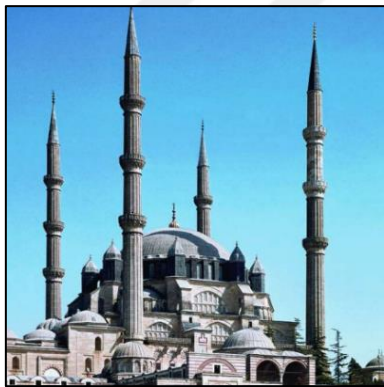
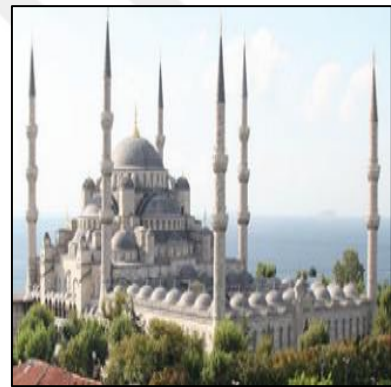
**Figure 3.7:** Ottman Minaret.

As for the minaret, In the Ottoman era, it spread in Asia Minor, Egypt, and other countries subject to the Ottoman Empire. It was cylindrical in shape or many-sided, high, thin, and slender, surmounted by a pointed conical peak [13]. The number of minarets in one mosque increased until it reached six, as in the Sultan Ahmed Mosque in Istanbul, Turkey.

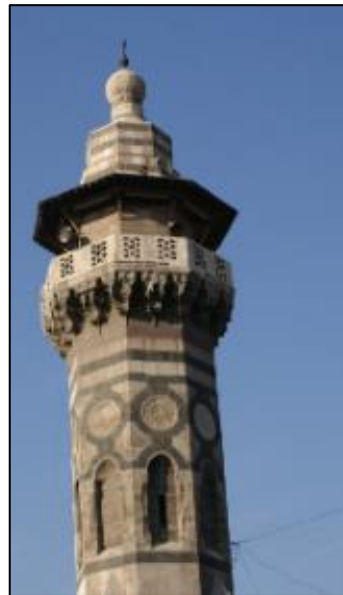
**Figure 4.6:** The Siba'i School, Damascus [43].

As for the Ottoman minarets in the Levant, the many-sided minarets (16 sides) with a balcony and without a canopy, and their conical ends armored with lead, appeared, but in a limited number of mosques, and the octagonal minaret with a balcony and canopy remained more common. In Damascus, the minarets of the Ottoman era were distinguished by alternating white and black stone. The columns of the minaret as the Siba'i school are illustrated in Figure 4.6 [43].

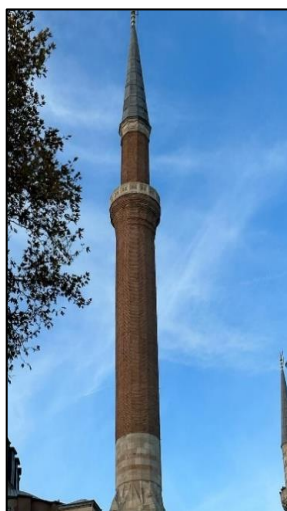
**Figure 5.2:** Southeast Minaret [77].

- a. Southeast minaret: This minaret was the first to be established by Sultan Mehmed II in 1481. Then, it was rebuilt from bricks and heightened by Sultan Beyazid II to match the new rising minarets. [54]

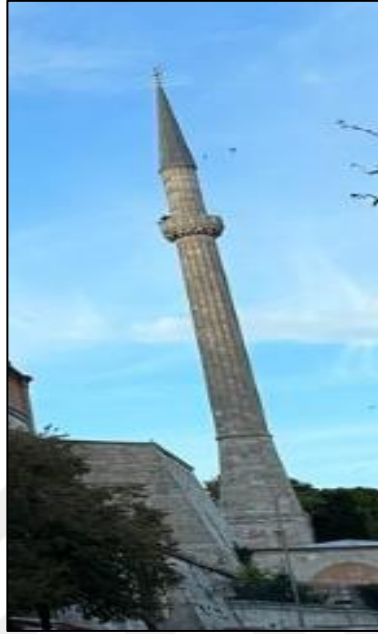
**Figure 5.3:** Northeast Minaret [77].

- b. Northeast minaret: It was built by Mohammed II from wood when he occupied the city. It was rebuilt by Selim II when he conducted the first Ottoman rehabilitation of Hagia Sophia Sofia between (1573-1577). [55].

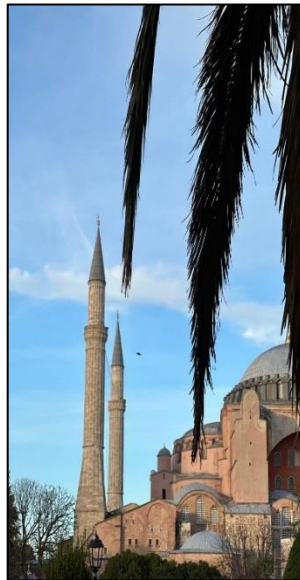
**Figure 5.4:** South-Western and North-Western Minarets [77].

- c. South-western and north-western minarets: These minarets were built by Sultan Murad III in compliance with his father, Sultan Selim II's wishes, as the number of the minarets in a mosque signifies its importance. [56].

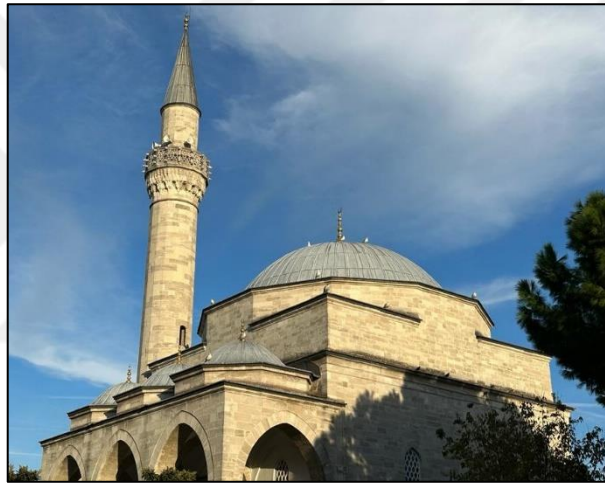
**Figure 5.7:** Firuzaga [77].

Firuz Aga was constructed by Firuz Aga, who was the chief treasurer of Sultan Bayezid II. The mosque was constructed in 1491. The single balcony minaret of Firuz Aga Mosque is on the left, and the boot at the body is exceptionally short-chequered. The main body diameter and the boot diameter are almost the same. The balcony is in a classical style adorned with muqarnas decoration. It's worth mentioning that the tomb of Firuz Aga is located in front of the left wall where the minaret is present. [58].

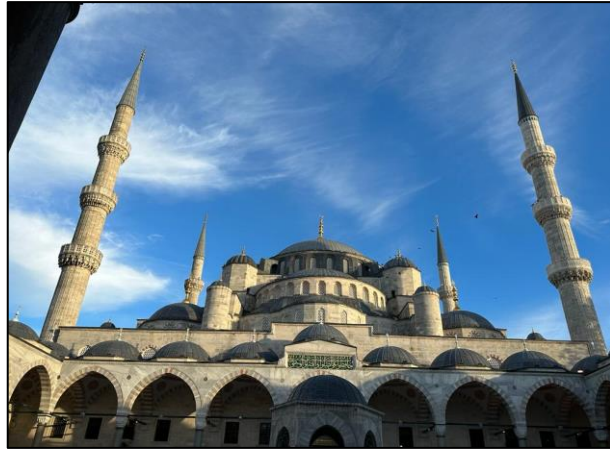
**Figure 5.9:** The Blue Mosque [77].

The blue mosque, which is also named Sultanahmet mosque, is considered one of the most significant Islamic structures in Istanbul. As mentioned before, the number of minarets in a mosque signifies its importance. There are six minarets dominating the city's skyline, four with three balconies around the central space in Sultan Ahmet and two with two balconies on the courtyard wall. The minarets were built according to the traditional Turkish style, and a spiral staircase ascends to the balconies. [62].

Four minarets are standing at the corners of the mosque. Each of these minarets is shaped like a pencil. The six minarets are 64m in height. The tops of the domes and the spires of the minarets are covered with lead, and the end ornament is made of gold-plated copper. The diameter of the minaret begins to decrease starting from the upper neck of the first balcony and it continues to decrease until the end ornament. [63].

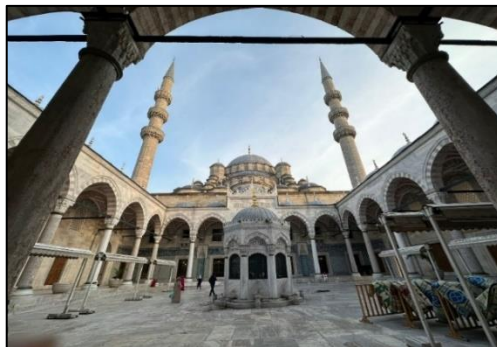
**Figure 5.10:** Yeni Cami [77].

Yeni Cami (the new mosque), construction started in 1597 and was finished in 1663. The reason why it took almost 66 years for the mosque to be constructed is that Safiye Sultan, the wife of Sultan Murat II and the mother of Sultan Mehmet, wanted a mosque built in her name. Davut Aga drew the plans and started laying out the foundation. When they began digging the foundation, water was pouring out, which delayed the construction. During that time, Sultan Mehmet III died, and according to tradition, the mother of the Sultan was sent to an old palace, so the mosque was abandoned for almost 57 years. During Sultan Mehmet VI's reign, his mother saw the mosque in a terrible state and decided to complete the building. Mustafa Aga started the construction using Davut Aga's drawing, and the mosque was opened for worship in February 1663. The mosque is a beautiful example of 17th-century Turkish architecture. It has two 50m tall minarets with a square base. Grooved cylindrical body with three balconies adorned with muqarnas decoration and a cone-shaped spire. [64].

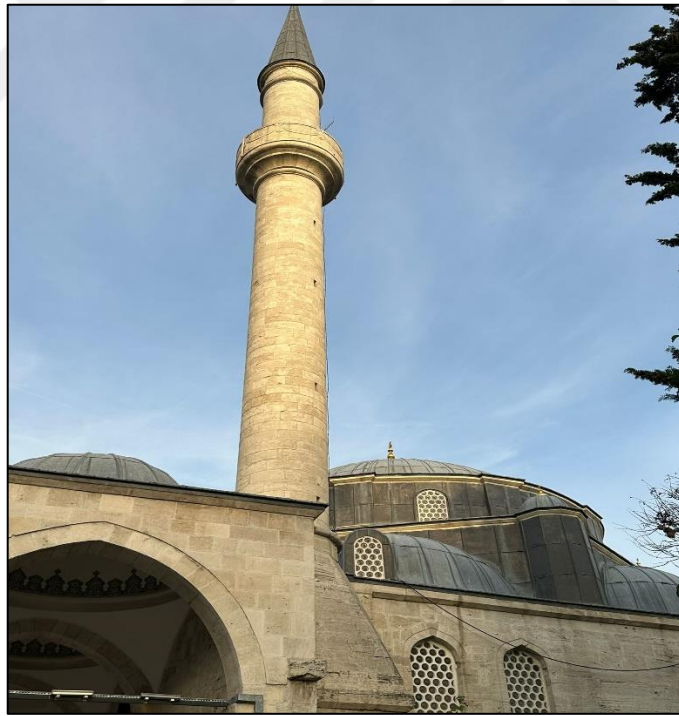
**Figure 5.11:** Fındıklı Molla Çelebi Camii [77].

was extended outside. The square-based, cylindrical-bodied minaret located in the northwest corner of the mosque was renovated in late periods. The balcony form of the minaret has decorations under the cone and on the balcony. The minaret is accessed from the outside via a low arched door in the narthex and from the inside via another door in the same direction.[65].

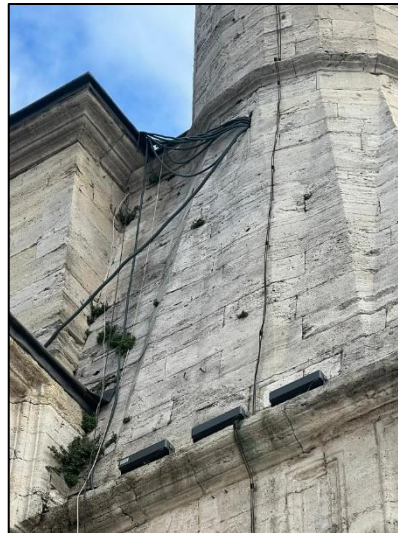
The structural integrity and lifespan of a minaret can be reduced due to the separation of masonry blocks. Therefore, an investigation was conducted to assess the separation between masonry blocks for each minaret. The results showed that there was no separation noticed between blocks for all selected minarets, except for the Yeni Camii minarets. The investigation revealed a very slight separation between masonry blocks in the Yeni Camii minarets, which did not exceed more than 10% of the surface of the minaret.

**Figure 5.16:** Separation Formed in Yeni Camii.
