**NUMERICAL INVESTIGATION ON THE  
EFFECTIVENESS OF SEISMIC RETROFITTING OF A  
HISTORICAL MASONRY MOSQUE**

**Master of Science Thesis**

**Program in Mechanics, Department of Civil Engineering**

**June 2018**

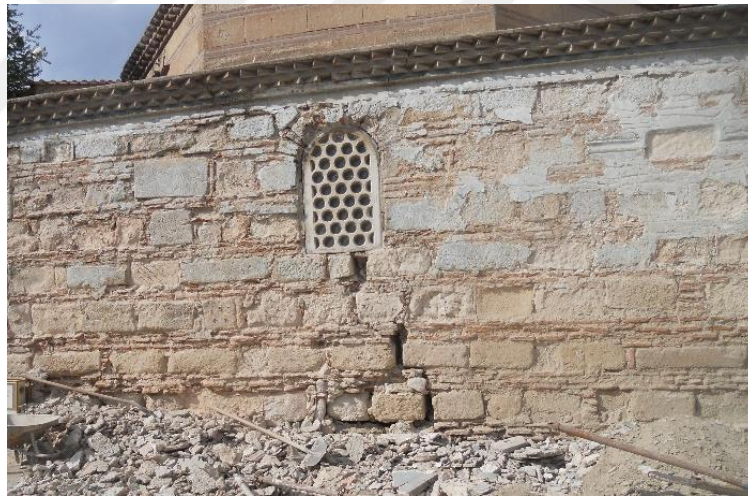
- iii. Severe damage was observed on the South Wall. The crack initiated vertically from the top level of the wall façade and the width of the crack below the window opening was reached up to centimeters as shown in Figure 2.8(a). Additionally, loss of wooden beams located along the South Wall was reported. Wooden beams were in charge of compensating low tensile strength of the masonry elements in the load bearing wall cross sections (Figure 2.8(b)).

*(a) Vertical cracks*

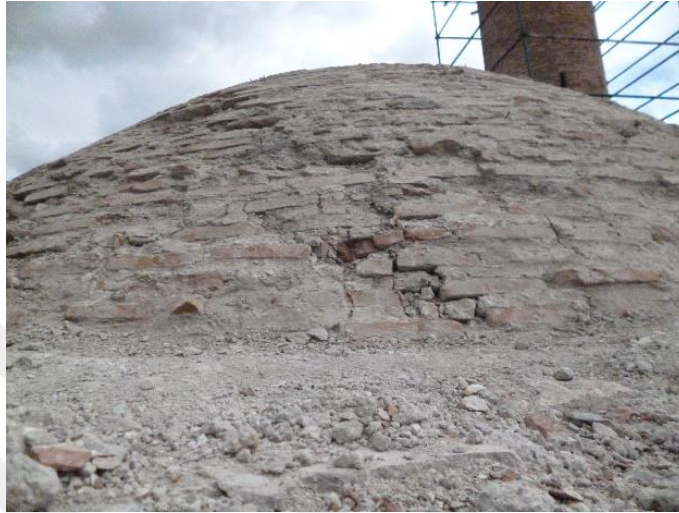
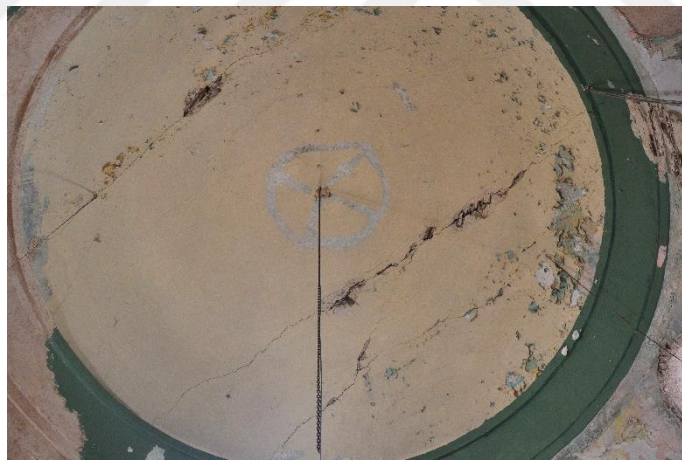
- vi. Extensive damage is reported not only at the intrados but also at the extrados when lead surface cover of the dome was removed. It is possible to say that the stability of the dome is debatable for the future events due to the existing crack propagation (Figure 2.11).

*(a) Crack observed on the extrados*

*(b) Crack observed on the intrados*

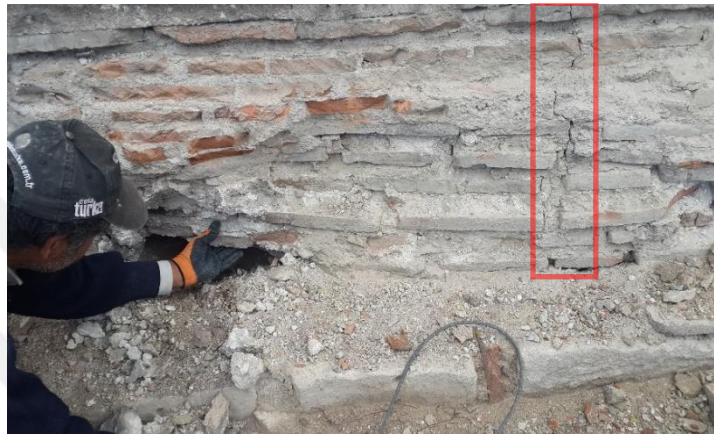
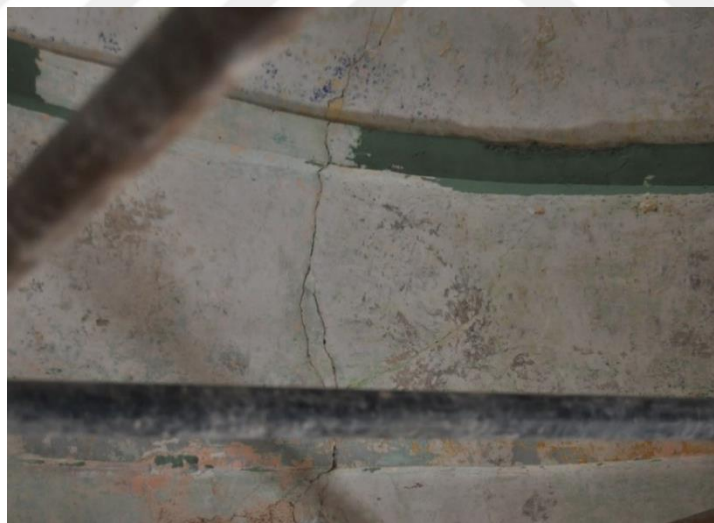
- vii. Additionally, vertical cracks were noticed on the octagonal drum, both interior and exterior surfaces (Figure 2.12). It is believed that the structural walls exhibited out-of-plane movement so that opening of the octagonal drum, support of the dome, can be concluded. In fact, lack of integral behavior of the mosque contributed to the cracks observed on the octagonal drum which followed the crack propagation on the dome.

*(a) Exterior crack on the octagonal drum*

*(b) Interior crack on the octagonal drum*

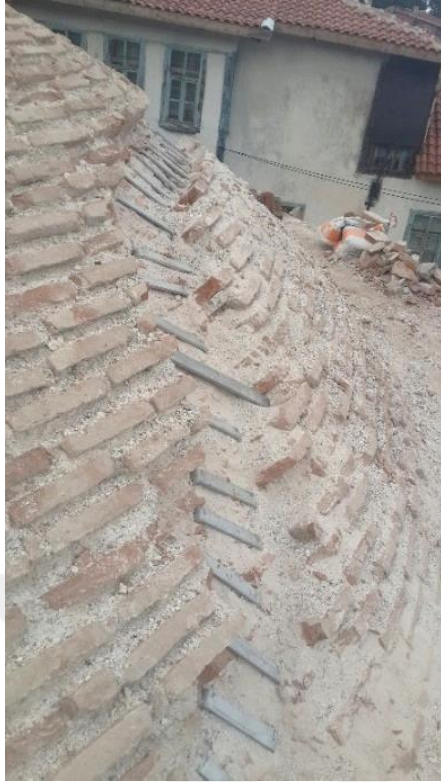
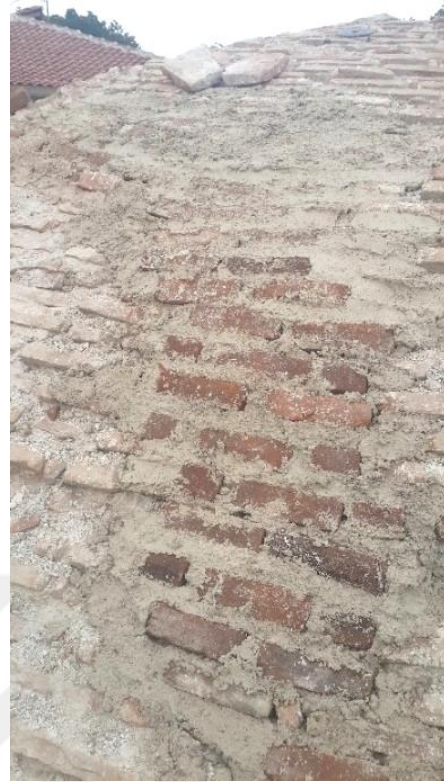
Firstly, the old material beside the crack line at the extrados was removed. Stainless steel elements were fixed in the perpendicular direction of the crack line, after high strength grout injection was applied to the crack openings. Finally, steel elements were covered by masonry material which were compatible with the old material (Figure 2.14). In case of high tensile stresses, the stress distribution is expected on the masonry units with low tensile capacity where the steel elements are fixed. Additional cracks are expected due to change in high tensile stress distribution. Therefore, additional improvements are necessary in order to overcome the crack opening and ensure structural safety.

*(a) Removing the old material*

**Figure 2.14.** *Application of stitching technique on the extrados*

(c) Stainless steel elements fixed along the crack

(e) Covering the steel elements

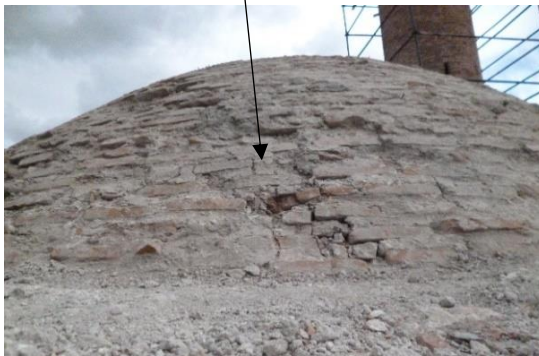
(Figure 5.5). At last, the dome experiences damage which seems to be originated because of the in-plane mechanism of the transversal walls and out-of-plane movement of longitudinal walls in +X direction (Figure 5.6).

(a) Top view

(b) Bottom view (intrados)

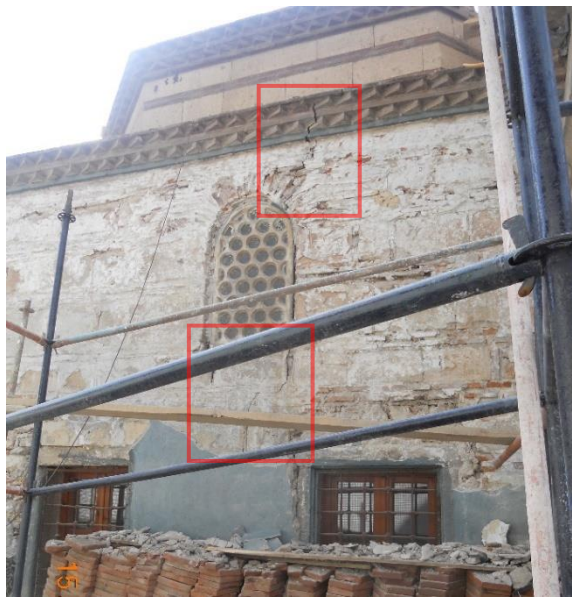
(a) Vertical crack on the East façade

(b) Total tensile principal strains on the East façade, under the Bingöl EQ ( $t=3.99s$ )
