THE USE OF ASBESTOS AS A CONSTRUCTION MATERIAL IN PUBLIC  
BUILDINGS: A CASE STUDY

A THESIS SUBMITTED TO  
THE GRADUATE SCHOOL OF NATURAL AND APPLIED SCIENCES  
OF  
MIDDLE EAST TECHNICAL UNIVERSITY

JANUARY 2020

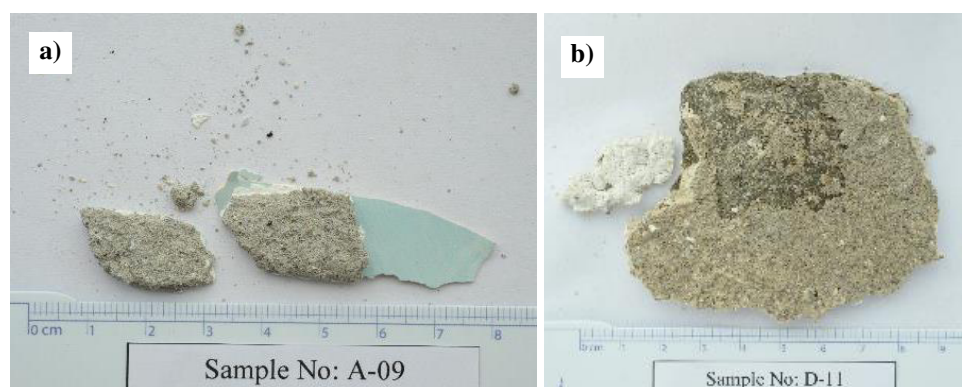
Figure 3.7. Representative macro-photographs of wall materials; a) finishing coat + wall paint, b) scratch coat

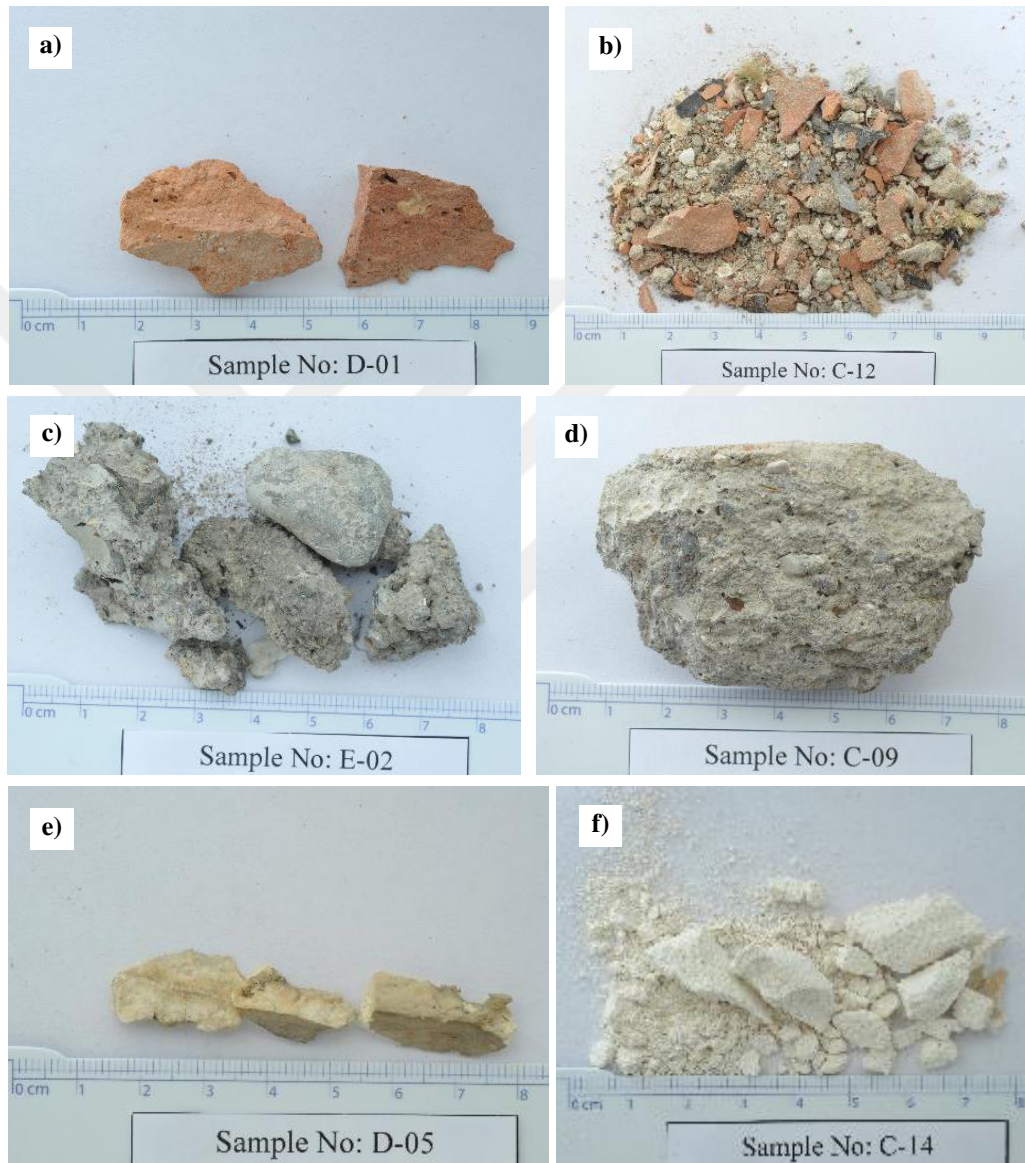
*Figure 3.8.* Representative macro-photographs of wall materials; a) brick, b) materials fragmented from the main bodies, c) exposed concrete, d) concrete, e) marble, f) plasterboard

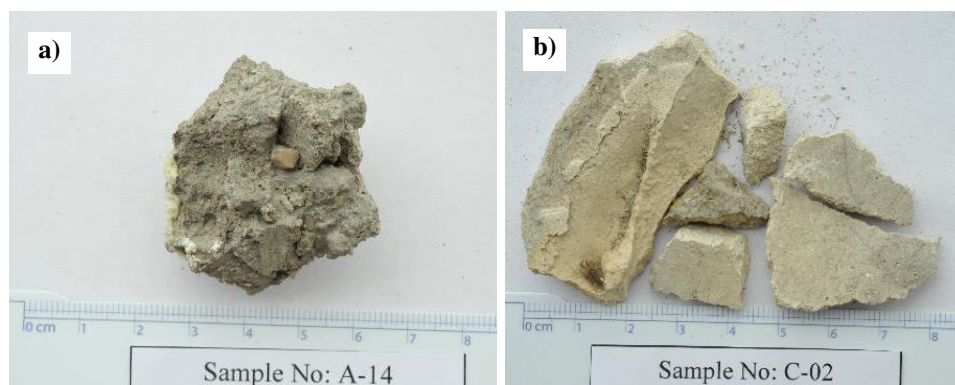
Figure 3.9. Representative macro-photographs of the floor materials; a) concrete, b) concrete tile

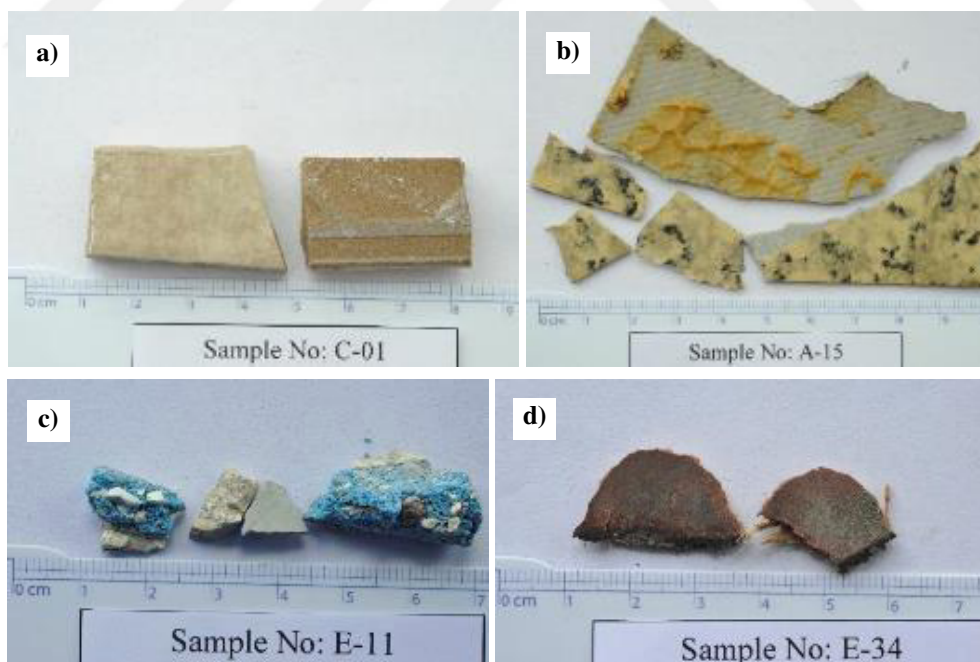
Figure 3.10. Representative macro-photographs of floor materials; a) ceramic tile, b) vinyl floor covering, c) epoxy, d) floor covering based textile

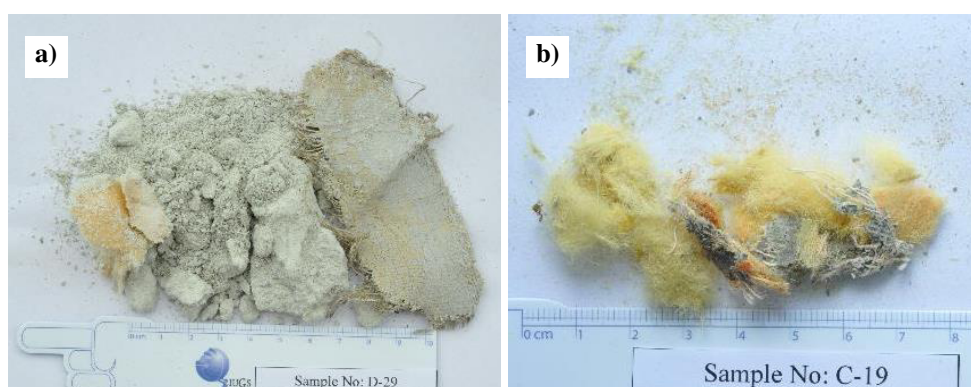
Figure 3.11. Representative macro-photographs of insulation materials; a) heat changer pipe insulation, b) pipe insulation

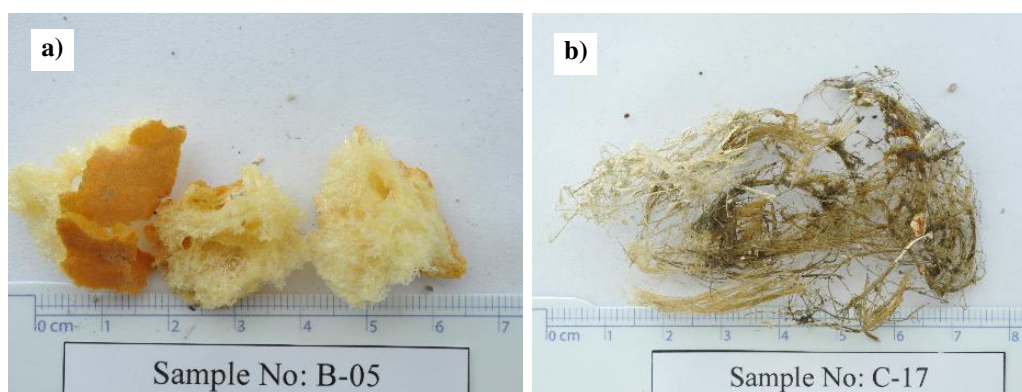
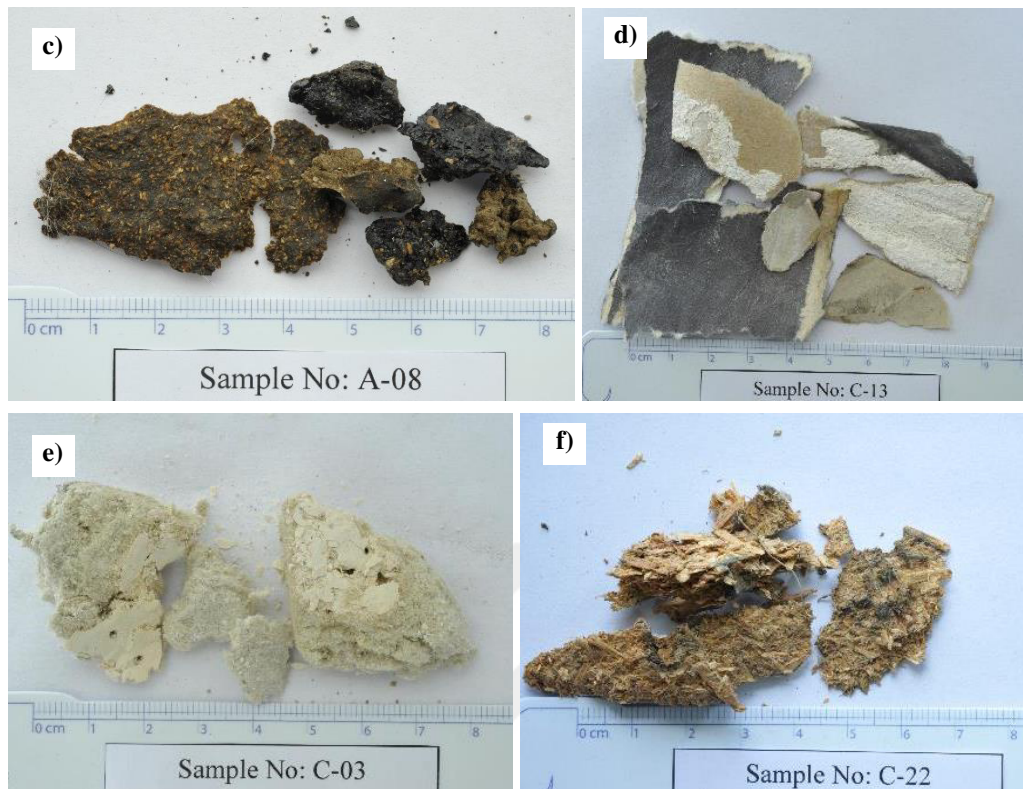
*Figure 3.12.* Representative macro-photographs of insulation materials; a) foamed sealant, b) heat resistant rope, c) vibration absorber, d) insulating paper, e) dropped ceiling, f) melamine coated chipboard

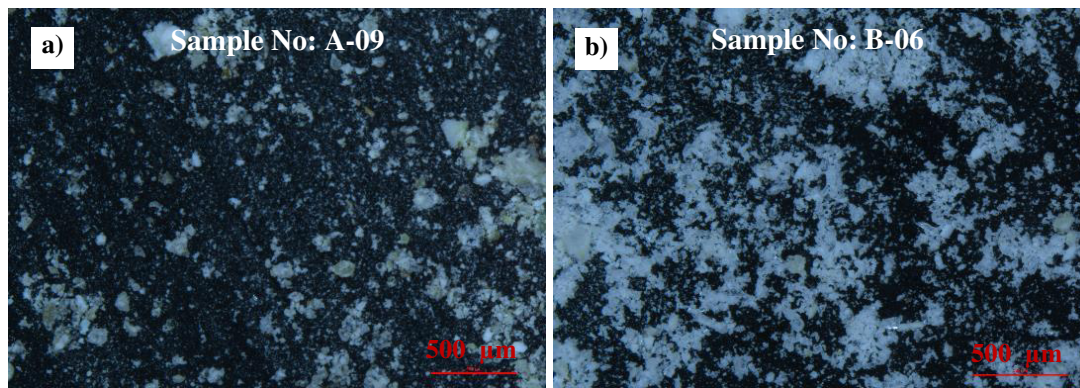
Figure 3.14. Representative micro-photographs by stereo microscope showing the samples without the fibrous form (marked by a cross mark in Table 3.8); a) Wall (finishing coat + wall paint), b) Floor (concrete tile)

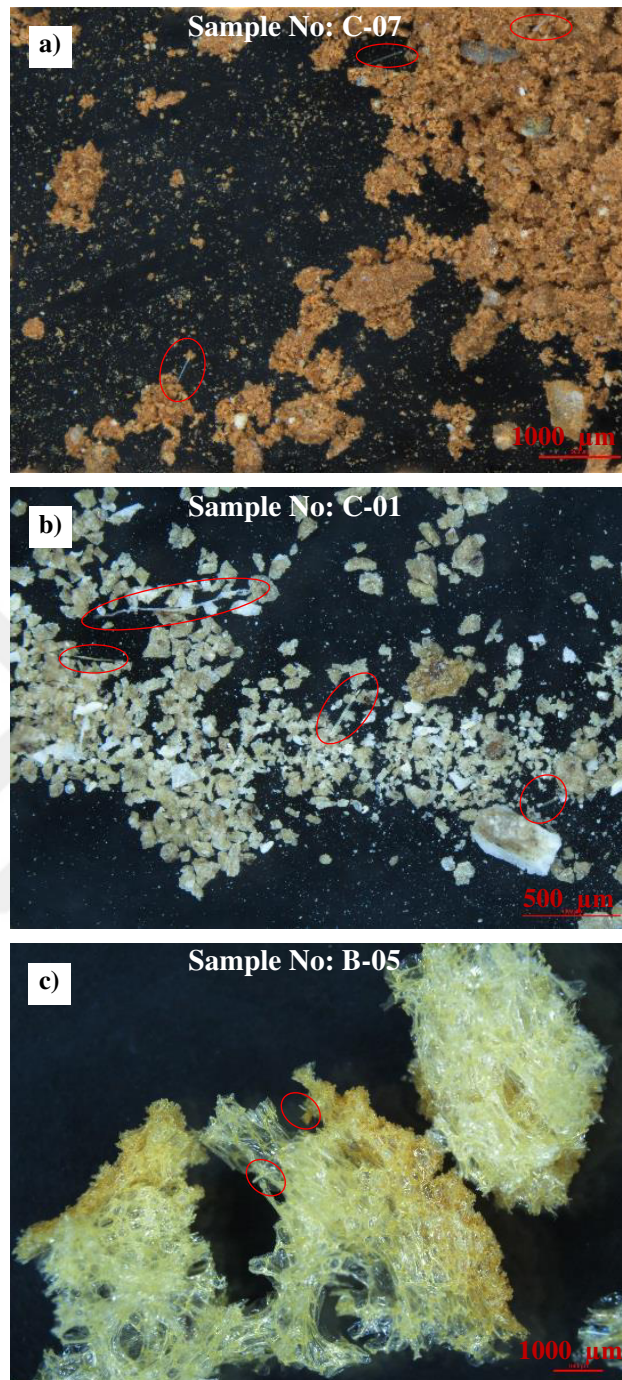
Figure 3.15. Representative micro-photographs by stereo microscope showing the samples with the fibrous form (marked by a check mark in Table 3.8); a) Wall (brick), b) Floor (ceramic tile), c) Insulation (foamed sealant) [red circled area displays fibrous materials]

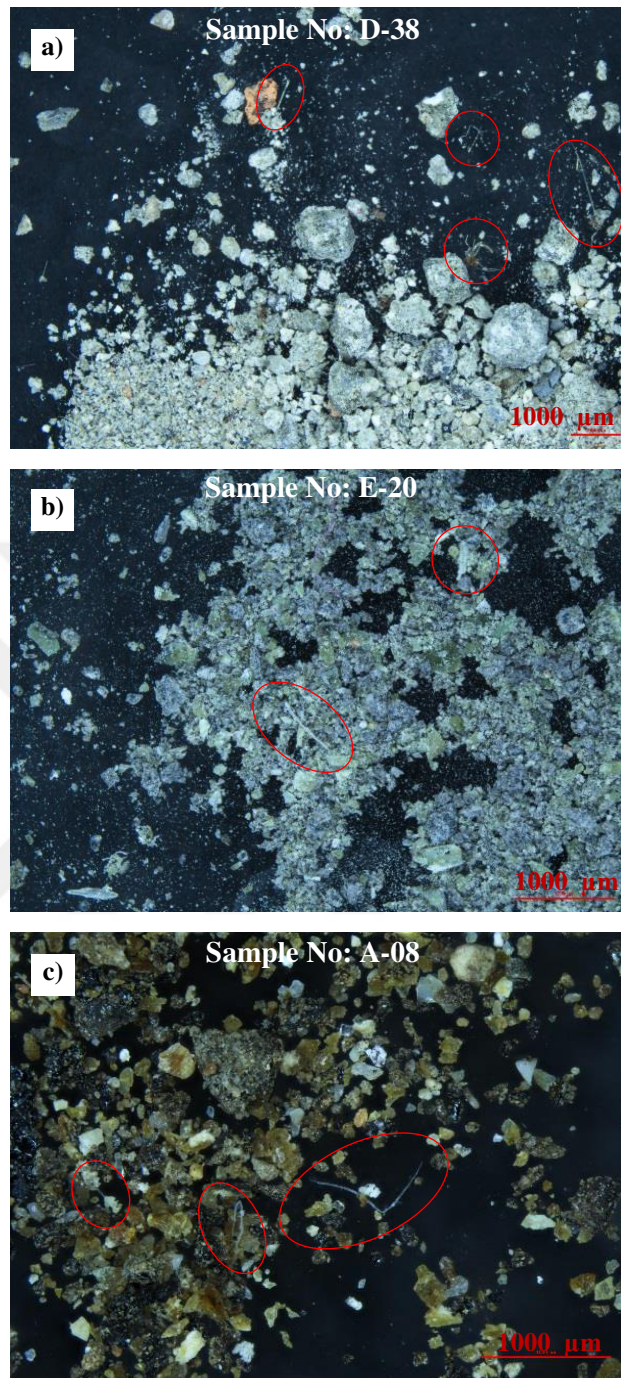
Figure 3.16. Representative micro-photographs by stereo microscope showing the samples with the fibrous form (marked by two check marks in Table 3.8); a) Wall (scratch coat), b) Floor (concrete tile), c) Insulation (vibration absorber) [red circled area displays fibrous materials]

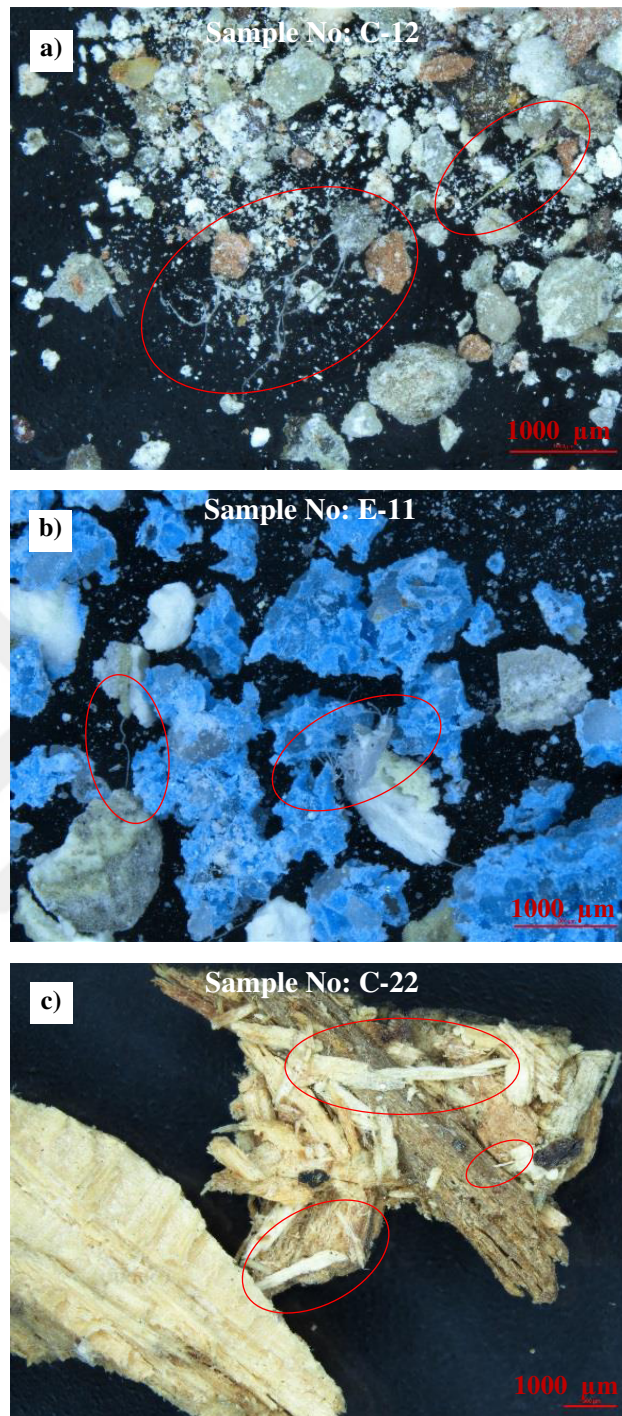
*Figure 3.17. Representative micro-photographs by stereo microscope showing the samples with the fibrous form (marked by three check marks in Table 3.8); a) Wall (materials fragmented from main bodies), b) Floor (epoxy), c) Insulation (melamine coated chipboard ceiling cladding) [red circled area displays fibrous materials]*

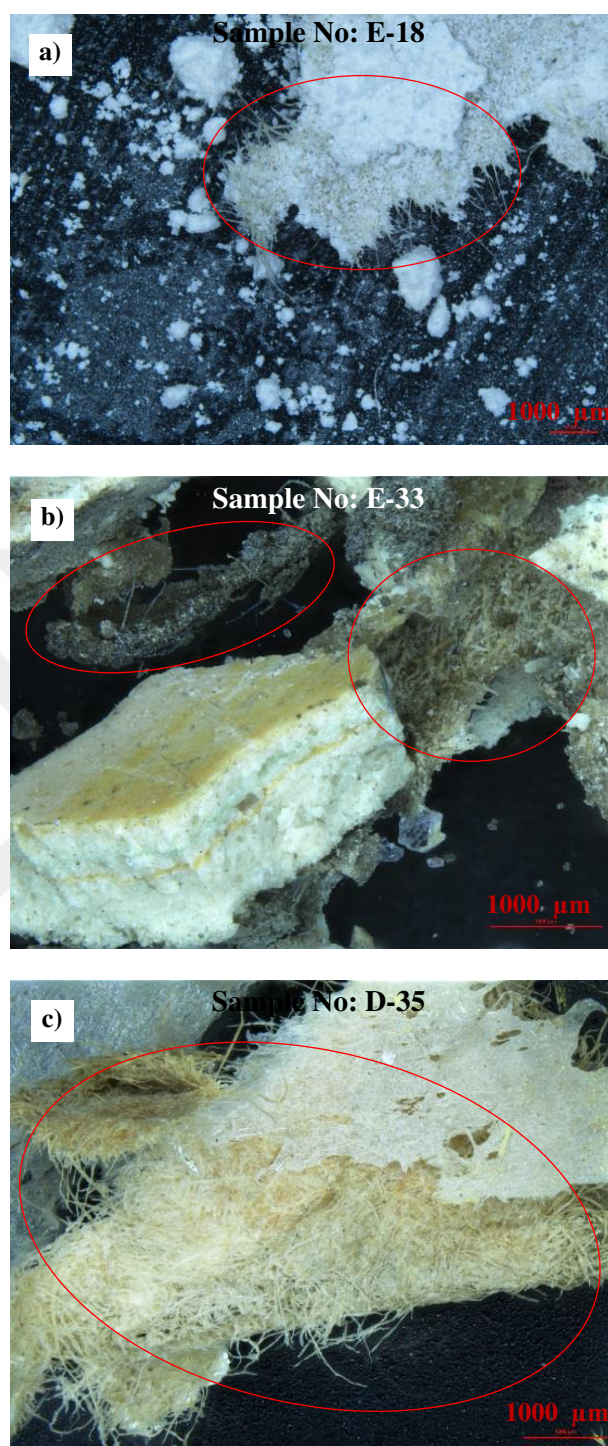
*Figure 3.18. Representative micro-photographs by stereo microscope showing the samples with fibrous form (marked by four check in Table 3.8); a) Wall (plasterboard), b) Floor (vinyl floor covering), c) Insulation (heat exchanger pipe insulation) [red circled area displays fibrous materials]*

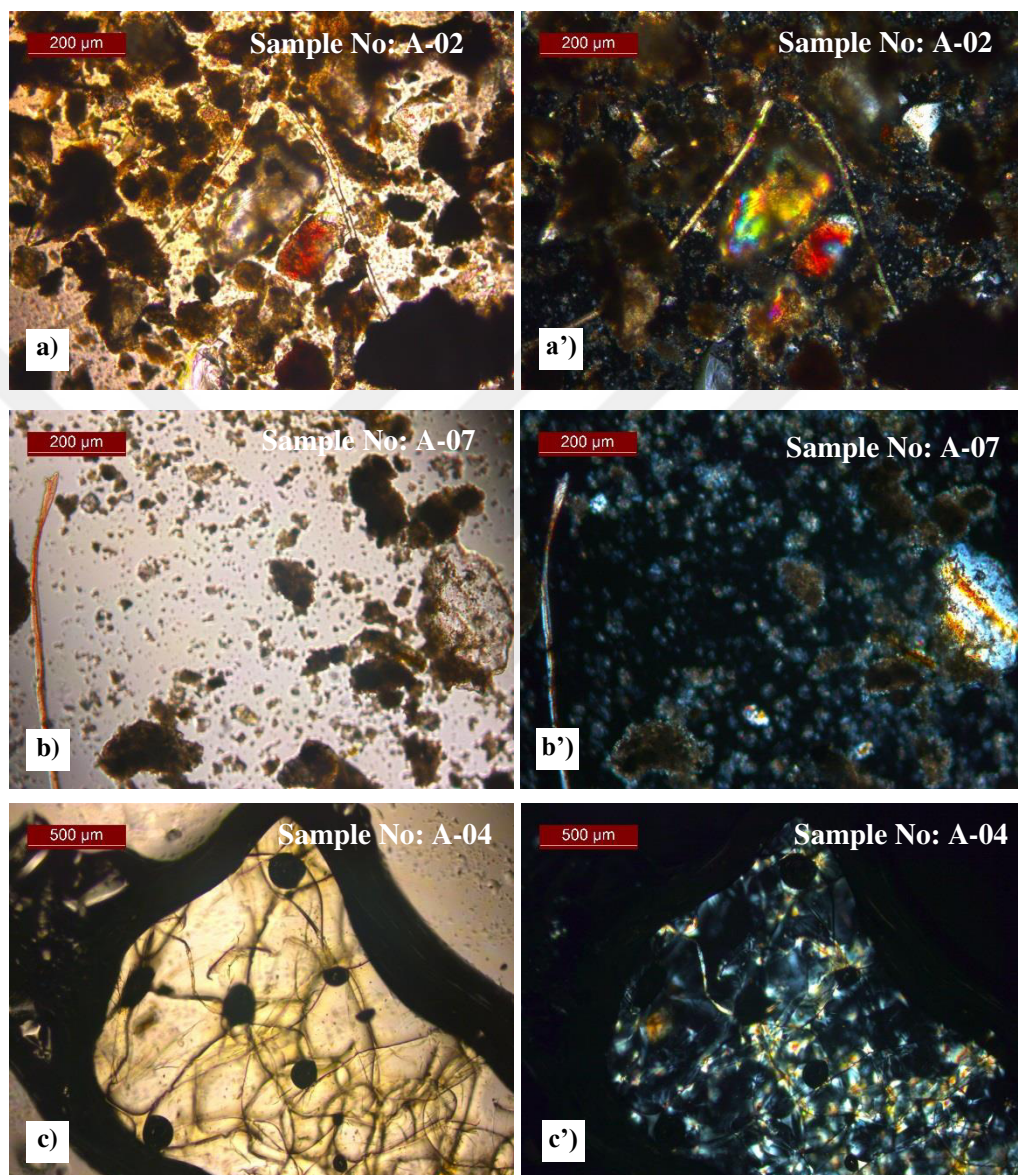
Figure 3.19. Representative micro-photographs of the samples with two check marks under PLM; a) Wall (scratch coat), b) Floor (vinyl floor covering), c) Insulation (foamed sealant) [*a, b, c are plane polarized light, a', b', c' are cross polarized lights*]

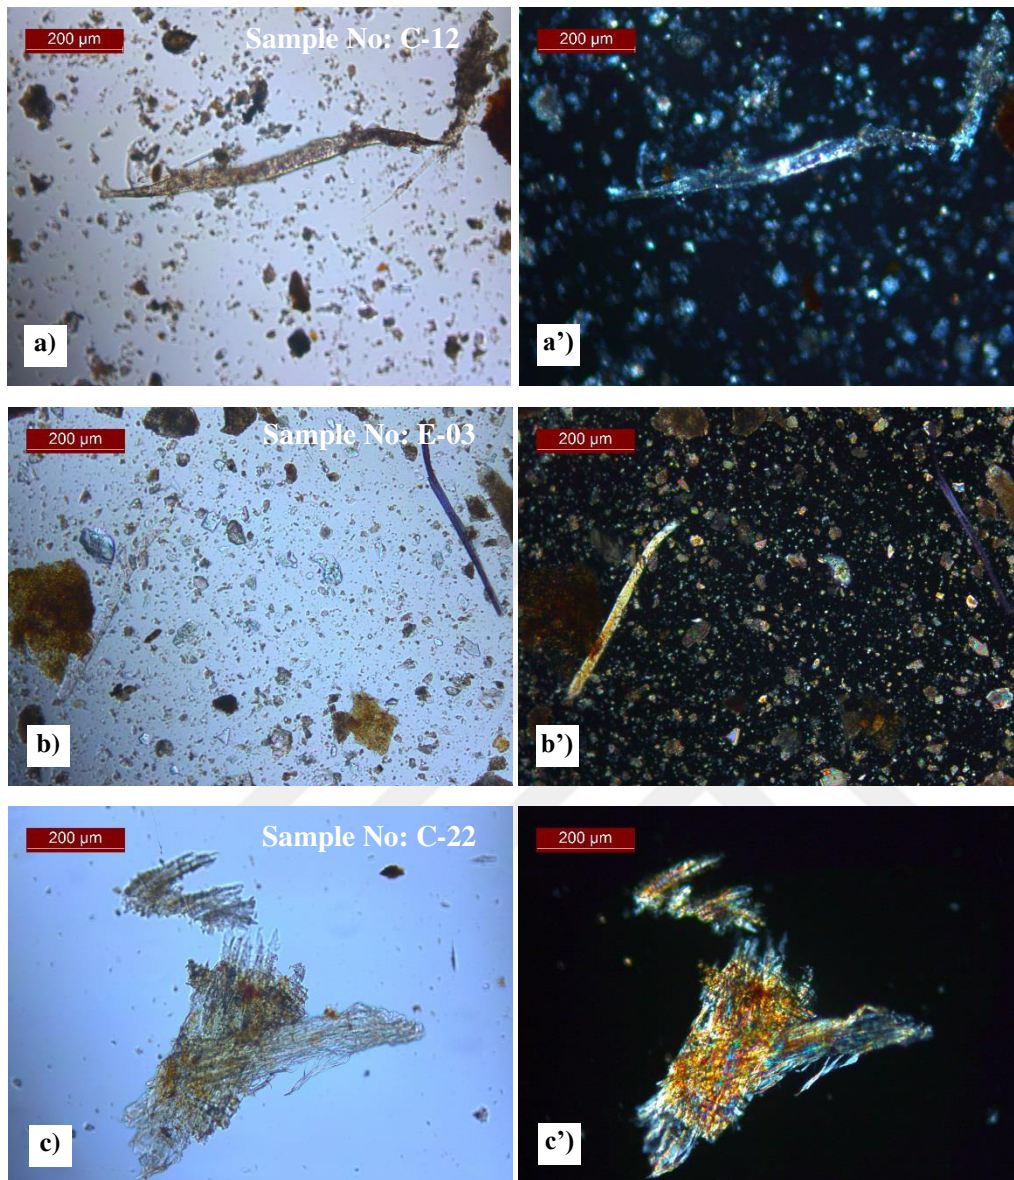
Figure 3.20. Representative micro-photographs of the samples with three check marks under PLM; a) Wall (materials fragmented from main bodies), b) Floor (concrete tile), c) Insulation (melamine coated chipboard ceiling cladding) [*a, b, c are plane polarized light, a', b', c' are cross polarized lights*]

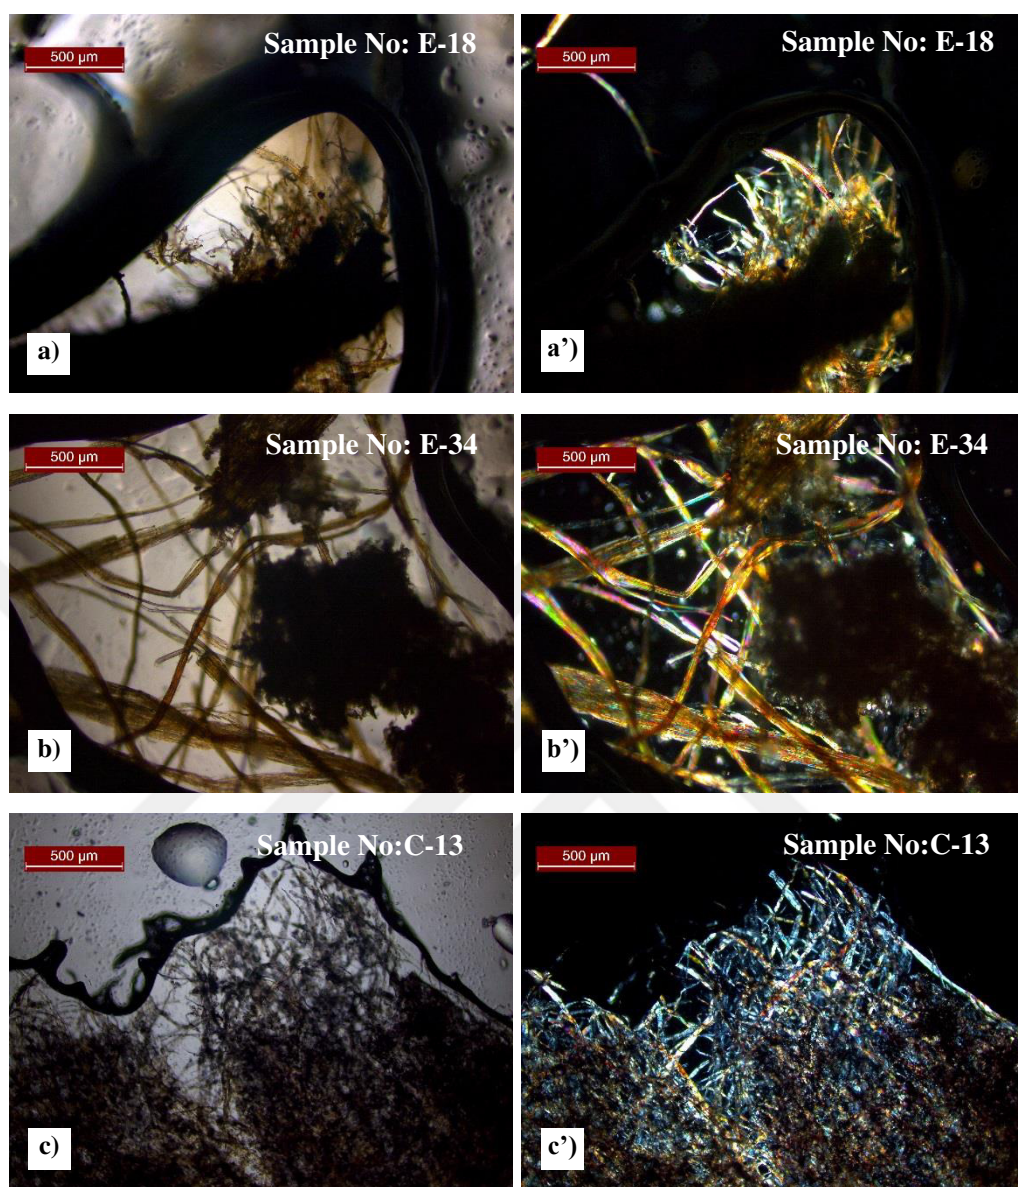
*Figure 3.21. Representative micro-photographs of the samples with four check marks under PLM; a) Wall (plasterboard), b) Floor (textile-based floor covering), c) Insulation (insulating paper) [a, b, c are plane polarized light, a', b', c' are cross polarized lights]*

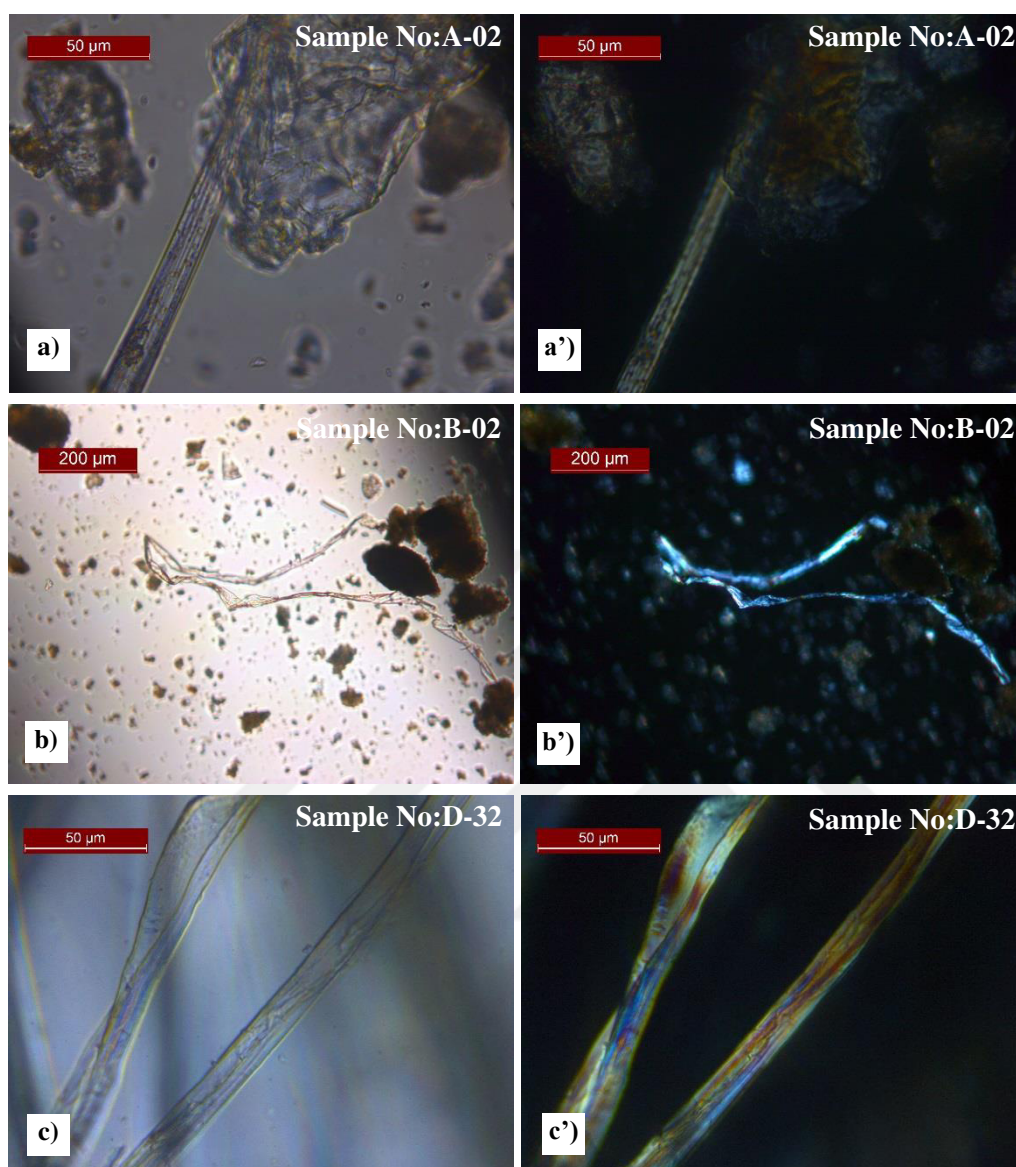
Figure 3.23. Representative micro-photographs for Chrysotile from; a) Wall (scratch coat), b) Floor (vinly floor covering + concrete) c) Insulation (pipe insulation) [*a, b, c are plane polarized lights, a', b', c' are cross polarized lights*]

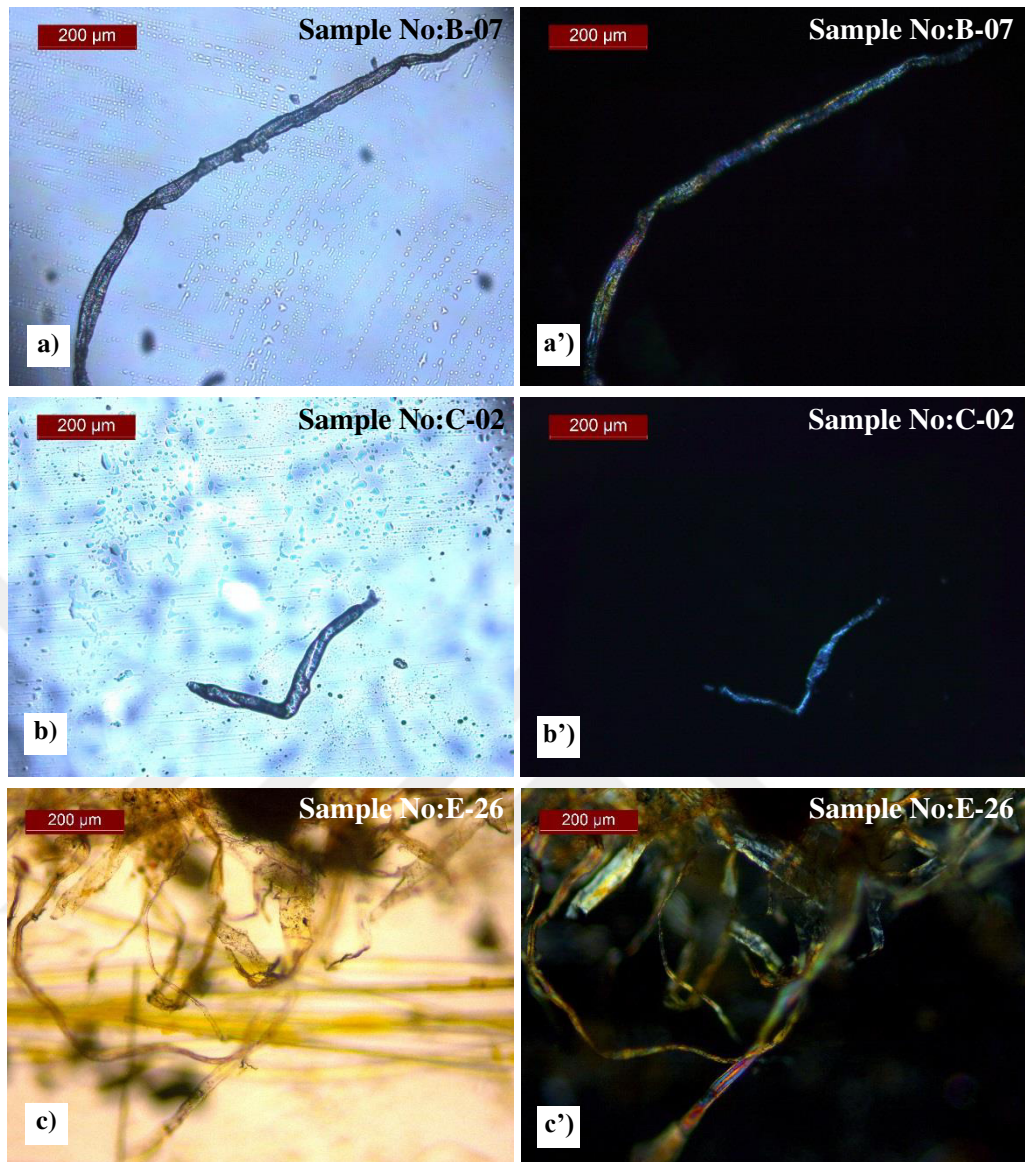
Figure 3.24. Representative micro-photographs for Tremolite in; a) Wall (exposed concrete), b) Floor (concrete tile), c) Insulation (pipe insulation) [*a, b, c are plane polarized light, a', b', c' are cross polarized lights*]

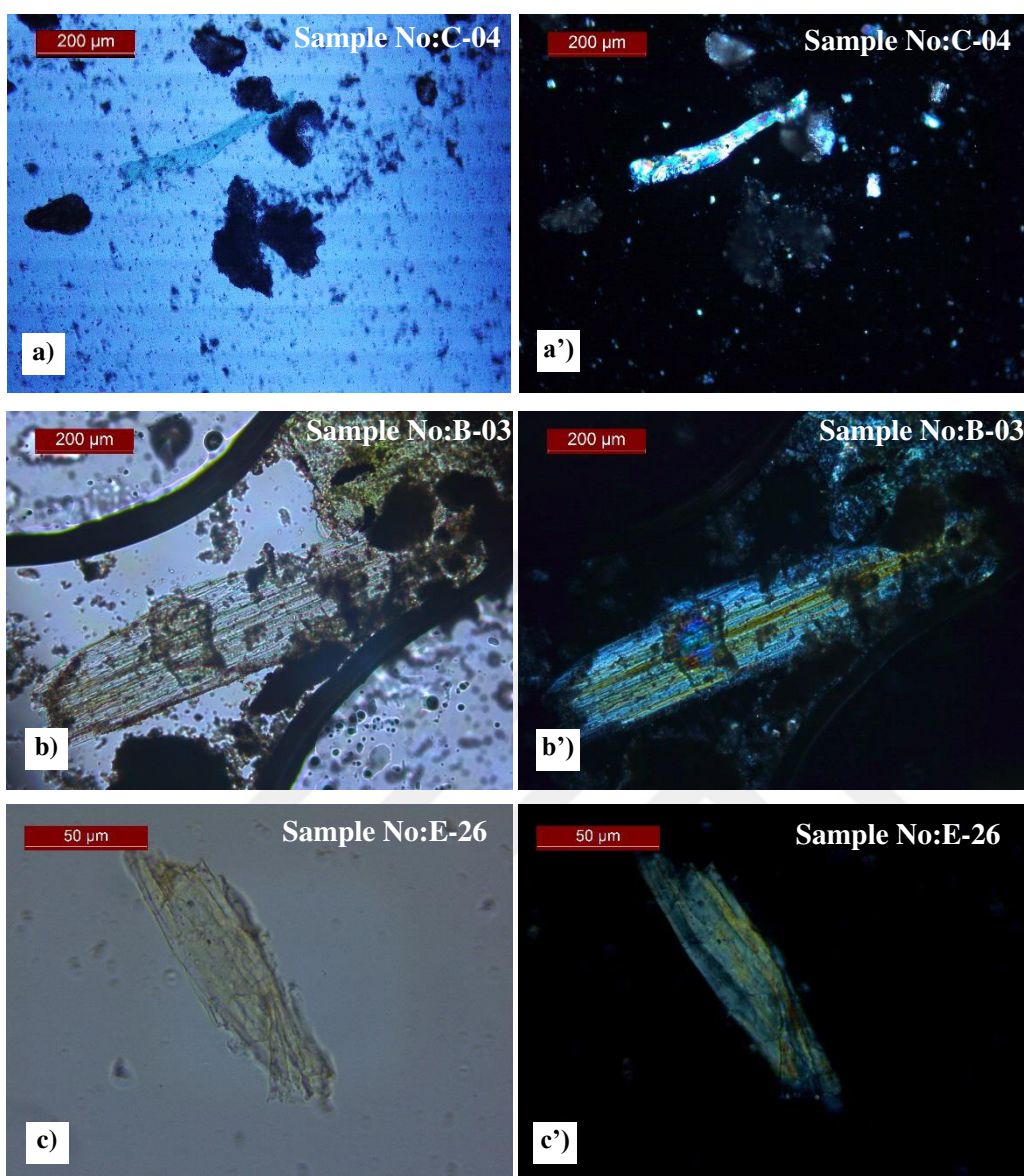
Figure 3.25. Representative micro-photographs for in Actinolite; a) Wall (finishing coat + wall paint), b) Floor (concrete tile) c) Insulation (pipe insulation) [*a, b, c are plane polarized light, a', b', c' are cross polarized lights*]

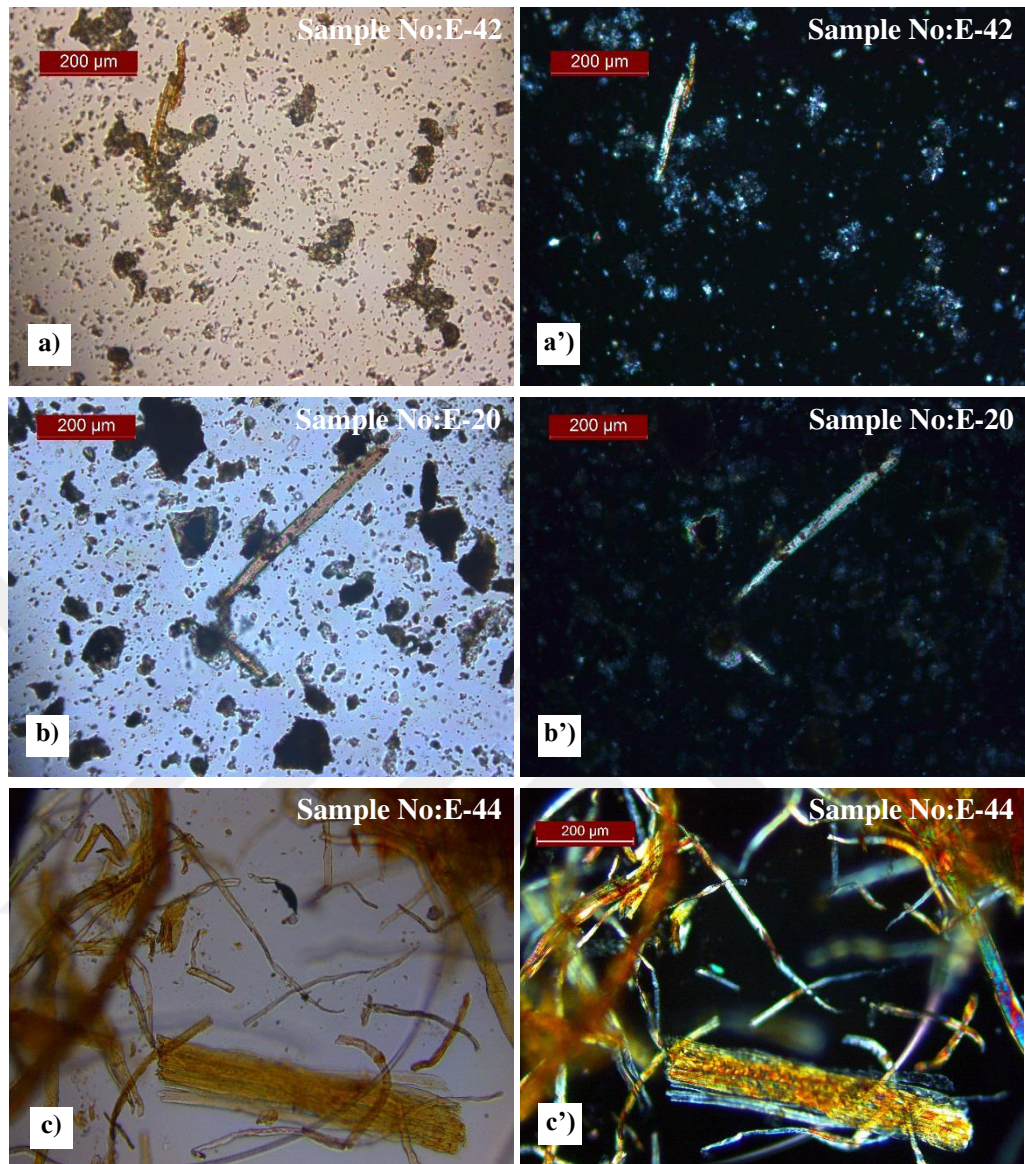
Figure 3.26. Representative micro-photographs for Anthophyllite in; a) Wall (finishing coat), b) Floor (concrete tile) c) Insulation (melamine coated chipboard) [*a, b, c are plane polarized light, a', b', c' are cross polarized lights*]

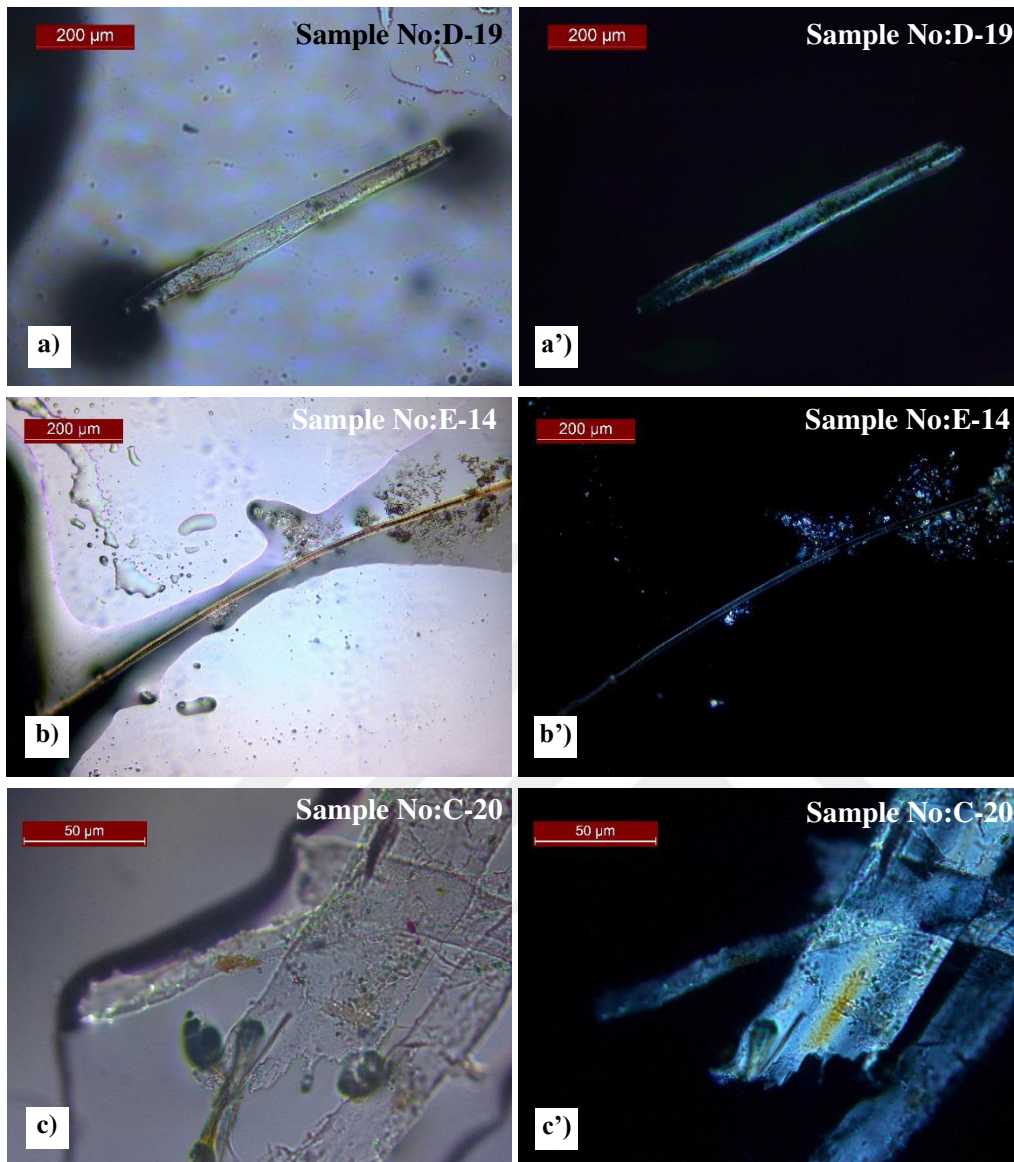
Figure 3.27. Representative micro-photographs for Amosite in; a) Wall (materials fragmented from main bodies), b) Floor (concrete tile) c) Insulation (pipe insulation) [*a, b, c are plane polarized light, a', b', c' are cross polarized lights*]

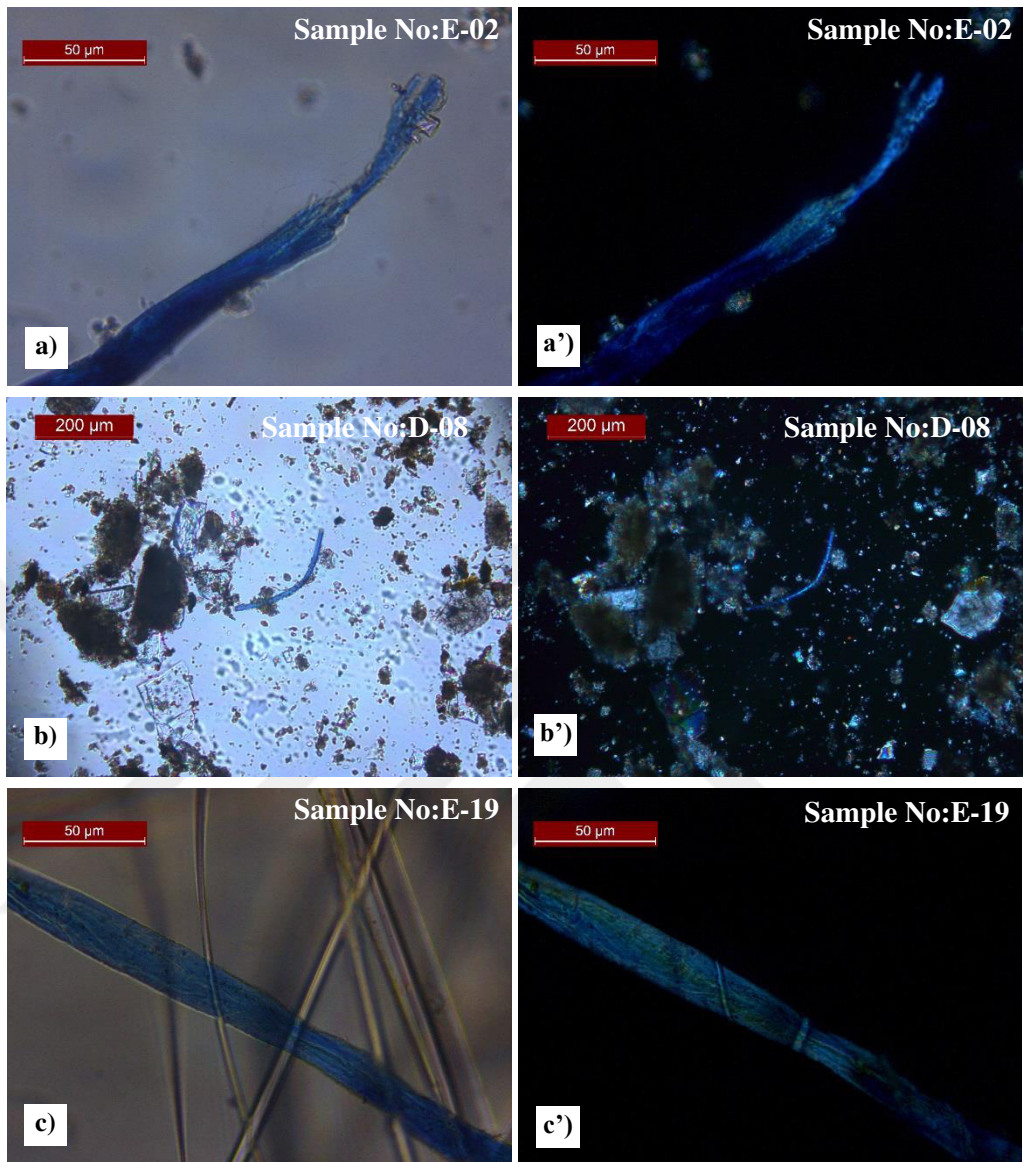
Figure 3.28. Representative micro-photographs for Crocidolite in; a) Wall (exposed concrete), b) Floor (concrete tile) c) Insulation (pipe insulation) [*a, b, c are plane polarized light, a', b', c' are cross polarized lights*]
