ASSESSMENT OF THE EFFECTS OF ADAPTIVE REUSE INTERVENTIONS  
ON  
THREE APARTMENT BUILDINGS IN BEYOĞLU, İSTİKLAL STREET

A THESIS SUBMITTED TO  
THE GRADUATE SCHOOL OF NATURAL AND APPLIED SCIENCES  
OF  
MIDDLE EAST TECHNICAL UNIVERSITY

BY  
FÜSUN TAMER TÜRER

IN PARTIAL FULFILLMENT OF THE REQUIREMENTS  
FOR  
THE DEGREE OF MASTER OF SCIENCE  
IN  
CONSERVATION OF CULTURAL HERITAGE IN ARCHITECTURE

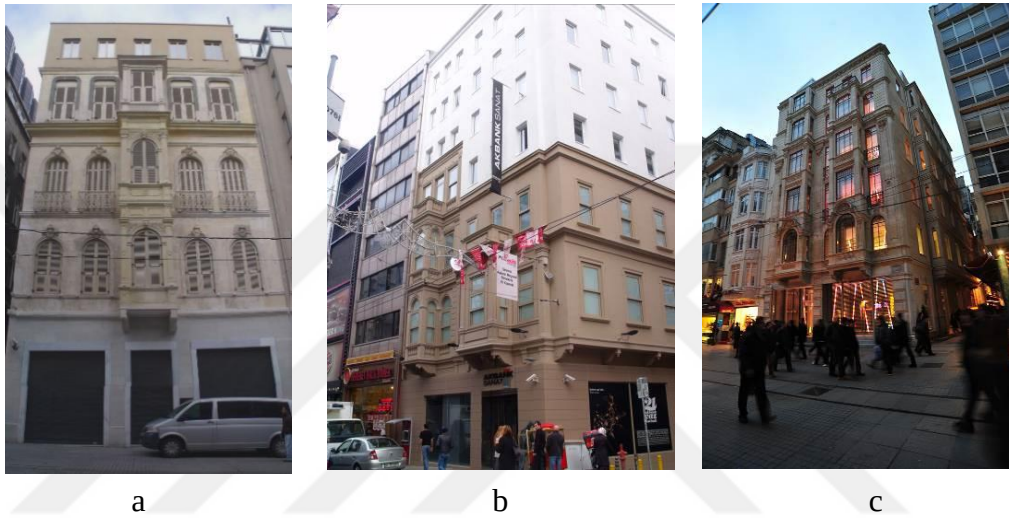
Figure 1.3. (a)SALT Cultural Center (Personal Archive), (b) Aksanat Cultural Center (Personal Archive), (c) Borusan Cultural Center. Source: [www.gadarchitecture.com](http://www.gadarchitecture.com), last accessed in February 11, 2020

- SALT Cultural Center, whose façades have been conserved and some changes have been made in its interior,
- AKSANAT Cultural Center, which has a mass attachment next to and above the apartment building and whose interior has been completely changed,
- BORUSAN Cultural Center, whose façades have been conserved but its interior is completely emptied and redesigned.

İstiklal Street is chosen as the study area for this thesis, where the relationship between carrying capacity and the new function is examined in adaptive reuse interventions for the reasons explained above. The three apartment buildings on this street, which have been adapted as cultural centers with different approaches, have been selected as cases for the detailed analyses of adaptive reuse processes. (Figure 1.3) These buildings are;

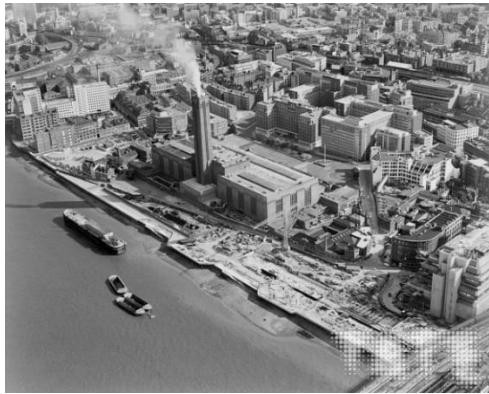
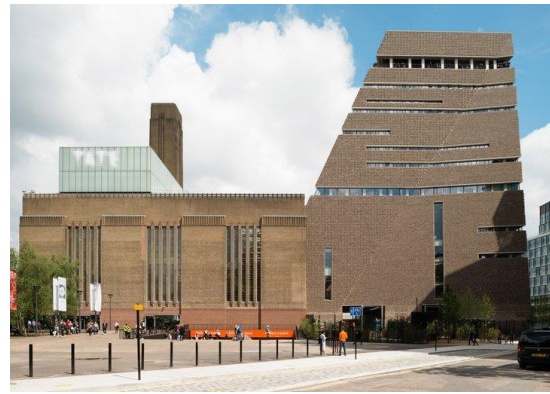
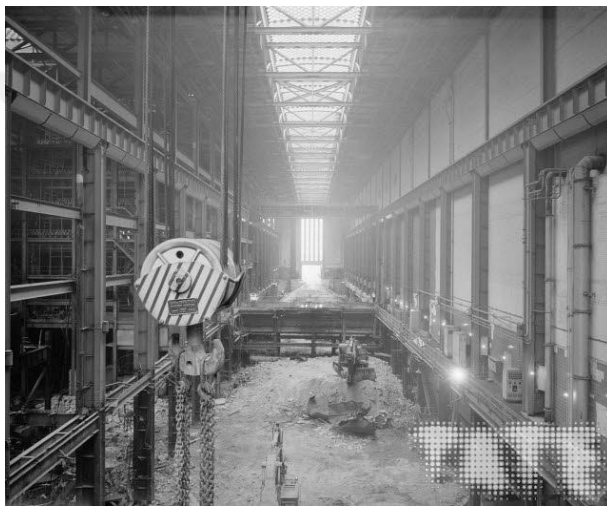
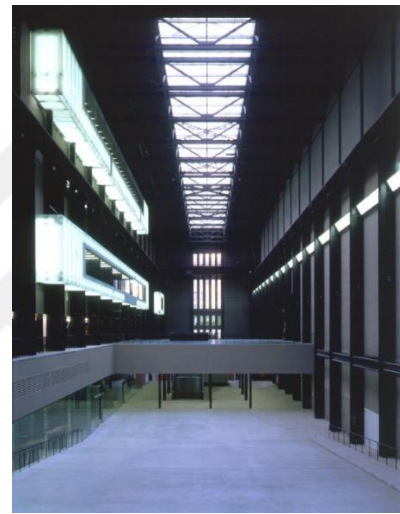
The abovementioned relationship between adaptive reuse, economic values and use value can be clearly seen in the example of Tate Modern building in London. The building, which was designed as a power station by Sir Giles Gilbert in 1947, closed down and abandoned in 1981 as a result of developments in the field of industry and energy. Thereafter, while it was being discussed that the building became dilapidated, posed a risk for the society and needed to be demolished, in 1995, Swiss architects Herzog & de Meuron expressed that they can prepare an adaptive reuse project to transform the building into a museum without demolishing. With this project, it is seen that the building is now one of the most famous buildings in London and attracts visitors from all over the world. (Figure 2.2)<sup>10</sup>

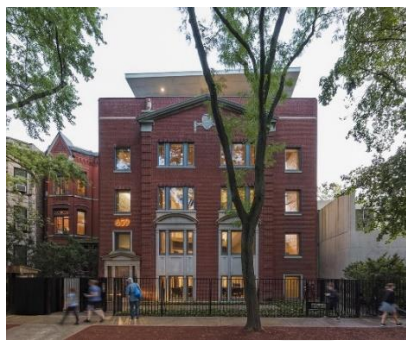
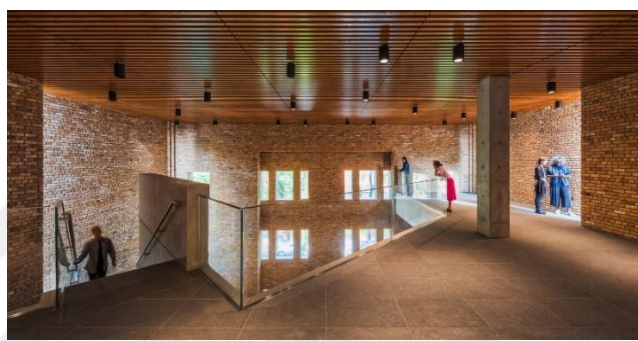
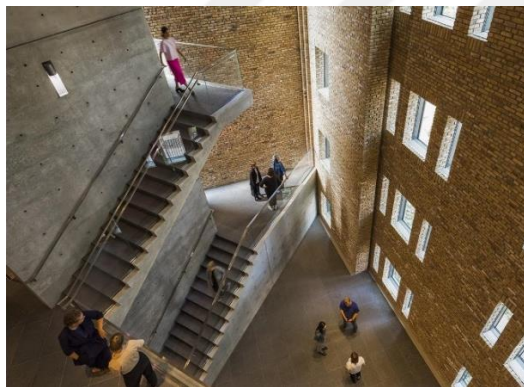
Figure 2.4. Photographs of Wrightwood 659 building (from Jeff Goldberg's archive); (a)Outer View, (b) Inner View, (c) Inner View from Circulation Gallery, (d) Inner View. Source: <http://www.archello.com/project/wrightwood-659/>, last accessed in May 23, 2020

Chicago, designed by Tadao Ando, is an example of the mentioned adaptive reuse implementations. The apartment building, which was constructed in 1920s reflecting the character of the region, is being used as an exhibition hall as a result of its adaptation. It is seen that the outer walls of the building is conserved during the adaptive reuse implementation. However, the interior of the building was completely emptied and a new reinforced concrete structure was rebuilt in accordance with the requirements of exhibition hall in terms of light and space dimensions. (Figure 2.4)

Due to the lack of the original building to meet the requirements of the new function in spreading adaptive reuse implementations, it is frequently observed that only the authenticity of the building façades are conserved and the interior layout is partially or completely changed. This circumstance causes the authenticity and document value of architectural asset to be lost. Wrightwood 659 building in

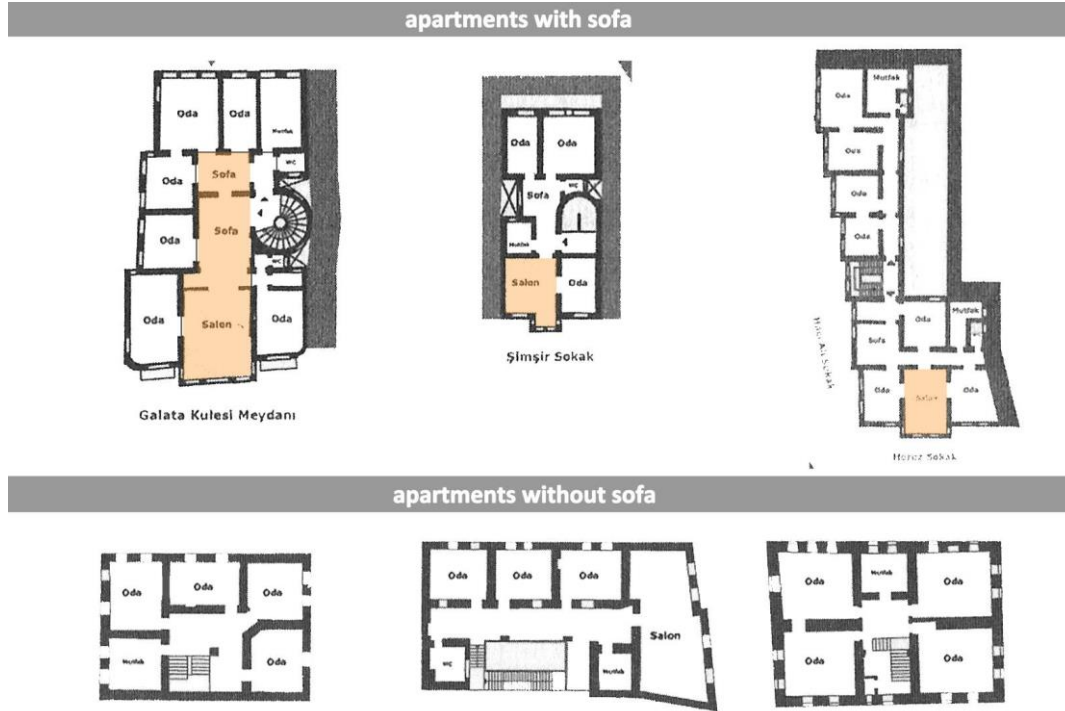
Table 3.6 Apartment building types whether there is sofa or not (prepared by the author based on the drawings obtained from the book named “Apartman”) (Öncel, 2010, p. 263-264).

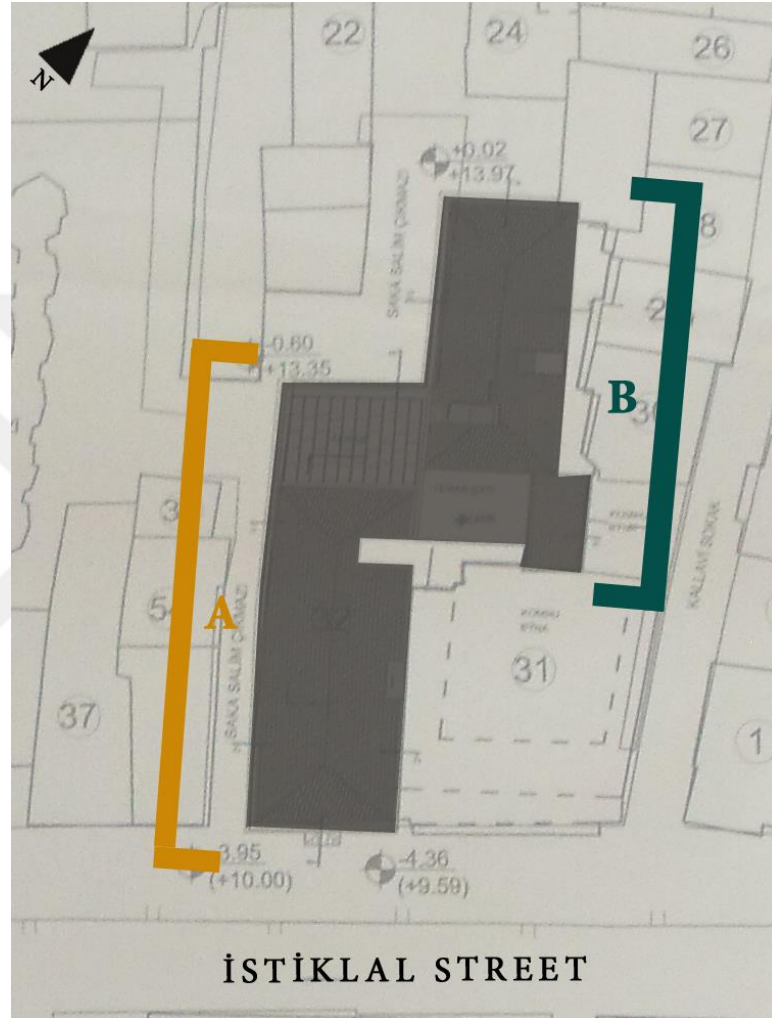
Figure 3.25. Drawing showing blocks of the building (prepared by the author, based on the drawing obtained from İstanbul No. II Regional Conservation Committee of Cultural Assets Archive)

Looking at the mass properties of the building, it looks like the combination of two masses. The effects of this feature in the mass can also be observed from the interior. Therefore, in this study, these masses will be referred to as A and B blocks (Figure 3.25).

When the façade features of the building are analyzed in general, it is seen that the lower floors and the top floor of the building are distinctly different from each other. When the façade of the building that overlooks İstiklal Street is analyzed, it is seen that the façade is cladded with stone on the ground floor and the first three floors of Block A. The top floor is painted on the same façade. It is remarkable that the paint and stones on the façade have the same color hue. Although the surface material is stone on the ground floor and the three floors above it, it is easily realized that the ground floor is cladded with a different kind of stone than the others. This difference is thought to be made in order to strengthen the difference of the floors on façade layout. On the other façades of the building, which look at Saka Salim Dead

End, it is seen that the material is the same color painting with the façades except for the ground floor façade in Block A and the basement floor façade in Block B. In these façades, surface of the ground floor of Block A and the basement floor of Block B are cladded with stone.

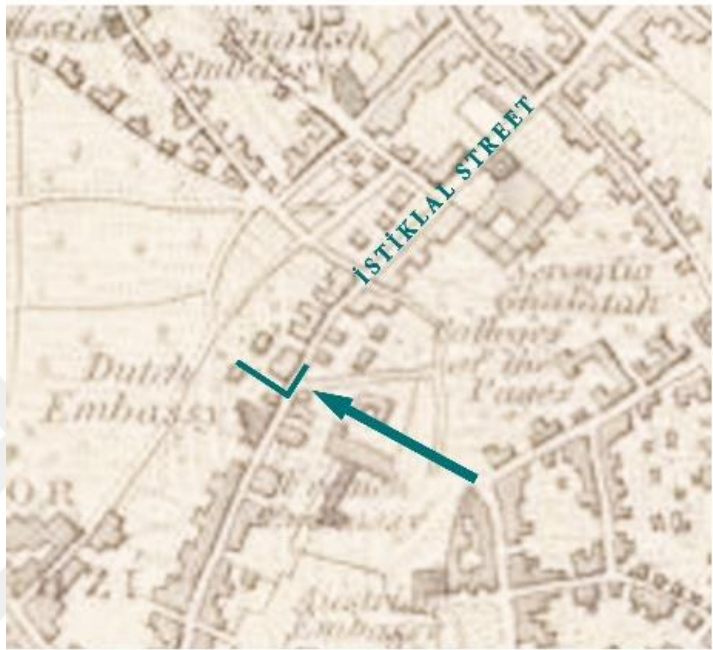
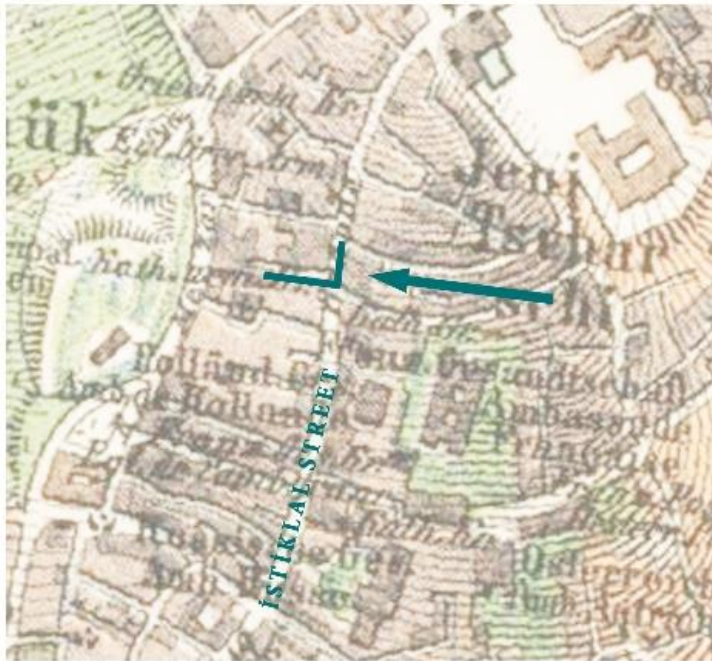
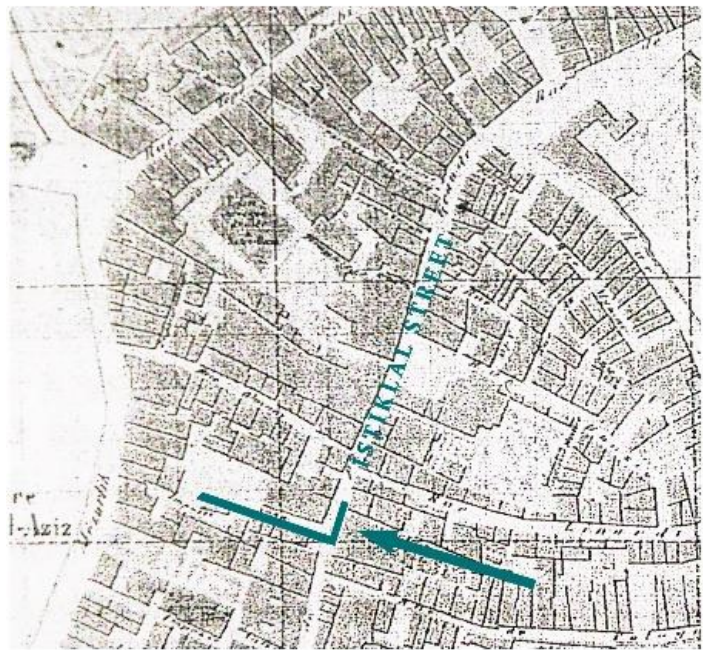
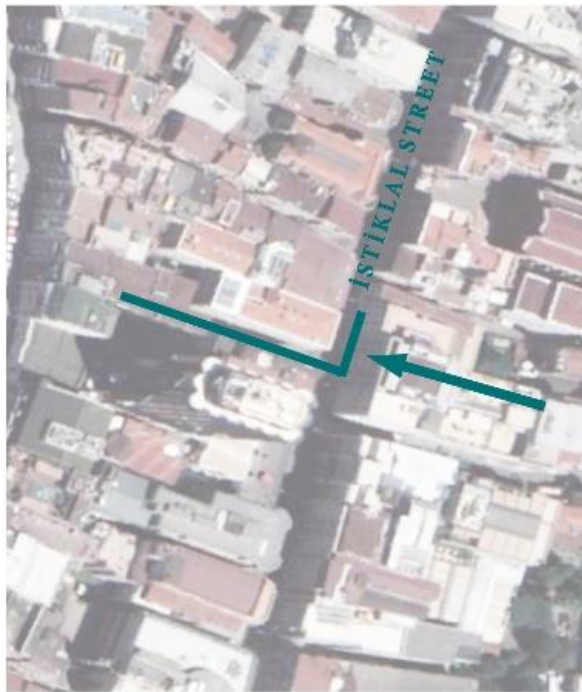
Table 3.18 Location of the plot in old maps; 1853 City Map. Source: [www.istanbulurbandatabase.com](http://www.istanbulurbandatabase.com), last accessed in January 21, 2020, 1861-1876 Cadastral Map (Restitution Project Report), 1882 City Map. Source: [www.istanbulurbandatabase.com](http://www.istanbulurbandatabase.com), last accessed in January 21, 2020, 1905 Goad Insurance Map (Dağdelen, İ. (2007). 1948 Suat Nirven Map (Tarih Vakfı, 2000), 2018 Aerial Photo (Google Earth) (prepared by the author based on the maps obtained from the sources written before)

In the 1861-1876 cadastral works conducted during the Sultan Abdulaziz Period, the plot and its surroundings can be seen in more detail than the maps of the same period (Table 3.18). In contrast to the “1853 and 1882 City Maps”, the mass on the plot in the cadastral map is similar to the current state. There is a plot with a short edge on İstiklal Street and extending towards the back. However, in this map, two blocks of the current building are shown as separate buildings. As the cadastral works are more detailed research products than the city maps, the state of the plot in the cadastral map made in 1861-1876 period can be considered as the most detailed state of the original plot.

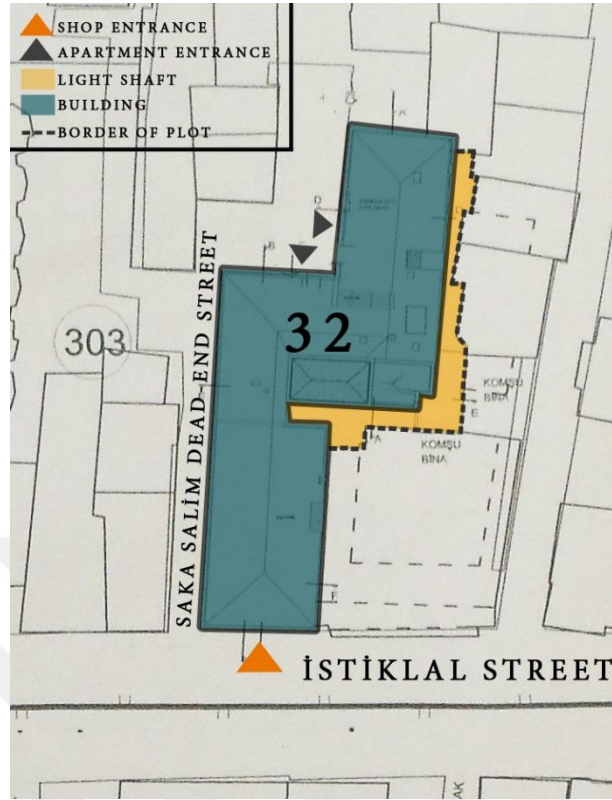
Figure 3.27. Original location of the building on the plot (prepared by the author, based on the drawing obtained from İstanbul No. II Regional Conservation Committee of Cultural Assets Archive)

At the original state of the building, Block A has two entrances, one on the east and the other on the west. In Block B, there are three entrances on the south façade, one main entrance and two service entrances. (Figure 3.27)

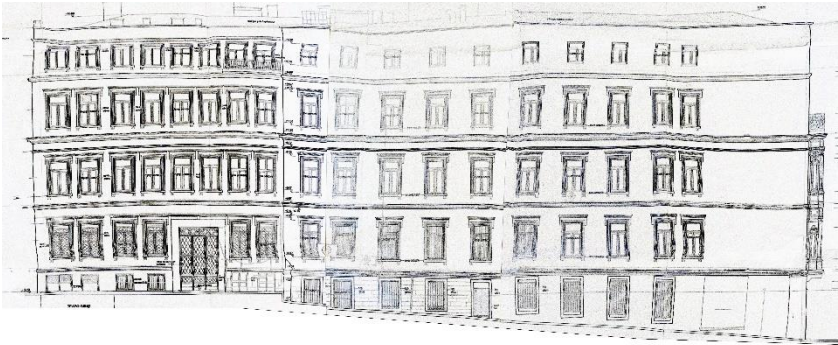
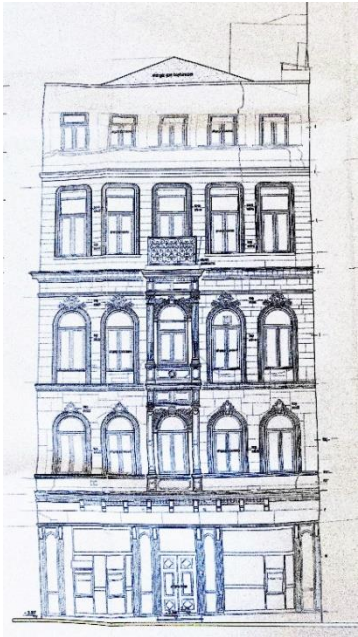
Table 3.23 Measured drawings prepared in 2008 (the drawings were obtained from İstanbul No. II Regional Conservation Committee of Cultural Assets Archive)

| GROUND FLOOR PLAN | SOUTH FAÇADE | EAST FAÇADE |
| FIRST FLOOR PLAN | SECTION | |

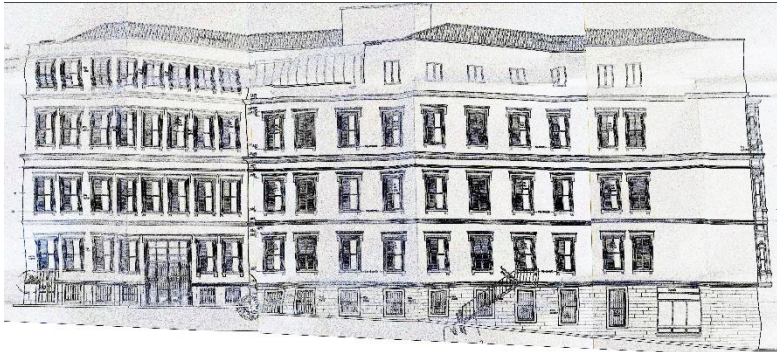
Table 3.24 Restoration project prepared in 2009 (the drawings were obtained from İstanbul No. II Regional Conservation Committee of Cultural Assets Archive)

| GROUND FLOOR PLAN | SOUTH FAÇADE | EAST FAÇADE |
| FIRST FLOOR PLAN | SECTION | |

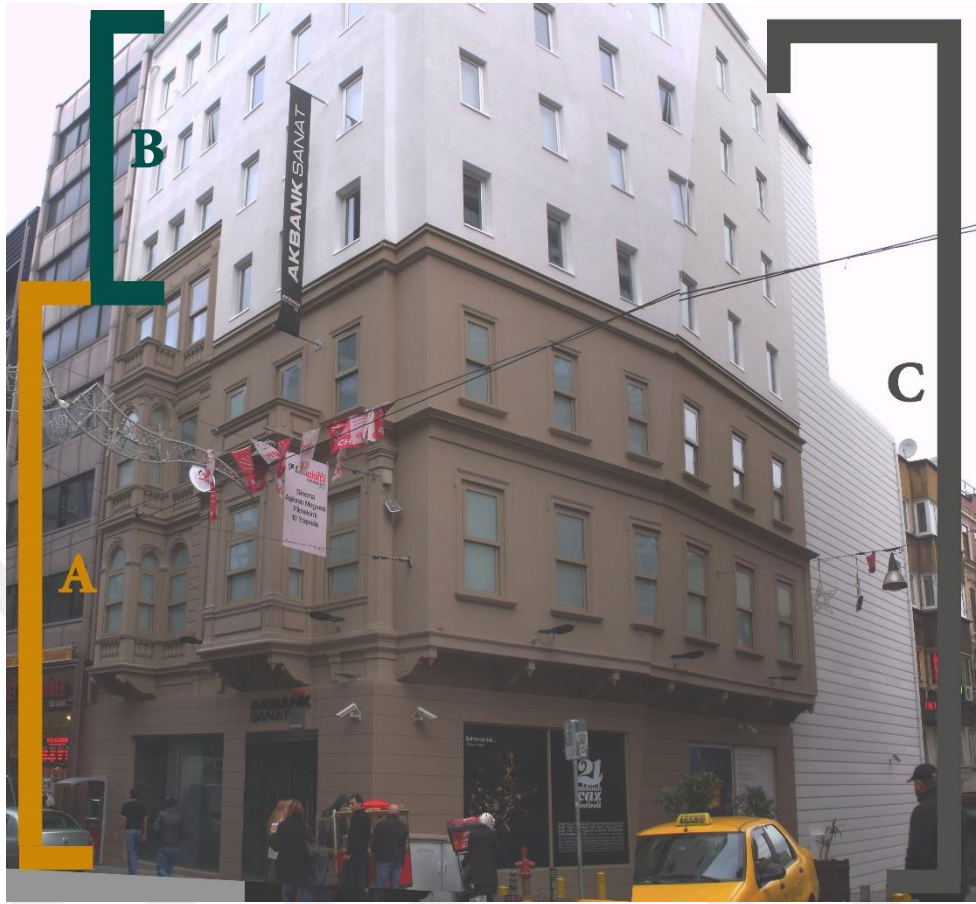
Figure 3.30. Drawing showing blocks of the building (prepared by the author, based on the photograph obtained from Personal Archive)

When the Aksanat Cultural Center building is viewed from the outside, it can be seen that three different blocks named as A, B, C, are built adjacent to each other on the vertical and horizontal axis (Figure 3.30). The three different block perception

formed on the façades has no perception in the interior and plan layout. A part of the brown painted Block A has three floors and the other part of it has four floors. Cantilevers, openings and ornaments that reflect the 19th century architectural features of Beyoğlu district can be observed on the façades of this block. There are wide openings and a wide entrance door at the ground floor level. At this level, a façade is coated with a distinct horizontal lined cladding material in a compatible color with the upper floors. The upper floors have balconies, closed cantilevers and arched or rectangular window openings repeated along the façade. At the same time, there are ornaments around of the windows and on the corners of the cantilevers on the façade of the block facing İstiklal Street.

White painted Block B was built on top of Block A. Since Block A, which is the part where the original façades are conserved, has two floors over the ground floor on the east side and three floors over the ground floor on the west side, Block B rises from the third floor on the east side and from the fourth floor to the sixth floor. There is only one type of window opening on both façades of Block B. These openings were arranged to be simplified repetitions of original window openings in Block A in terms of their proportions and positions.

The other block, namely Block C, was attached to the north side of the building. This block has only one façade facing Zambak Street. The block rises from the street level and a part of the block has six floors and the other part has three floors above the ground. Block C is completely blank and it is coated with a distinct horizontal lined cladding material.

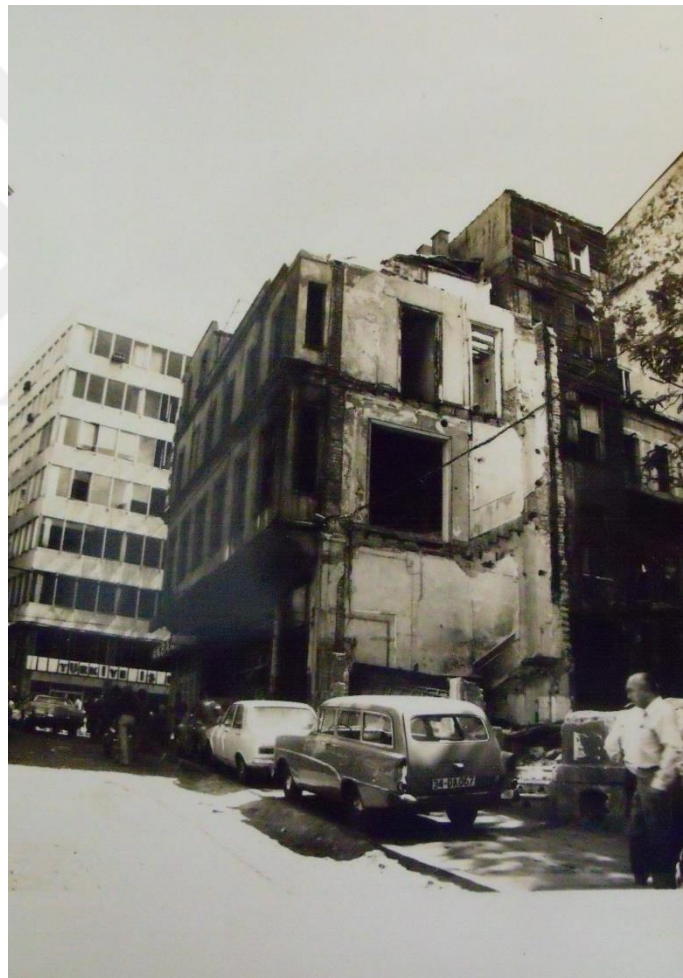
Figure 3.33. Photograph taken in 1975 (Photo Album of Restitution Project)

By analyzing the photographs between 1960 and 1975, the structural system of the original buildings on block #404 plot #1, #2 and #36, is understood to be formed of masonry brick wall system with jack arches (Figure 3.33).

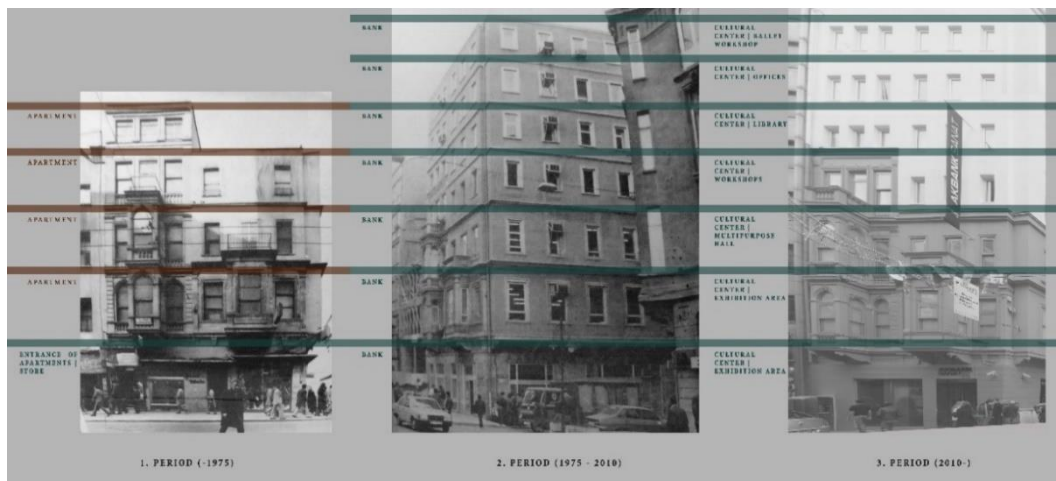
Table 3.30 Change of function according to floors in the building in three periods; Photo of the 1st and 2nd Periods (Photo Album of Restitution Project), Photo of the 3rd Period (Personal Archive) (prepared by the author, based on the photographs obtained from İstanbul No. II Regional Conservation Committee of Cultural Assets Archive and Personal Archive)

In this process, it is observed that the upper floors, which were originally residential units, have gradually adaptively reused as commercial functions (Table 3.30). During this period, the spaces on the upper floors of the buildings were separated from the vertical circulation by partitions in interior, and different commercial functions such as a dentist clinic and a photography studio were placed on each floor. According to the restoration project in 1975, it is understood that separate commercial units on the ground floors of the buildings were combined and adapted to be used as an Akbank branch. In the same year, the new building that was formed by combining the buildings also on the upper floors and constructing additional masses was started to be adaptively reused as a bank building (Table 3.30). The building, which continued to be used as a bank until 1990, started to be used as a cultural center in 1990.

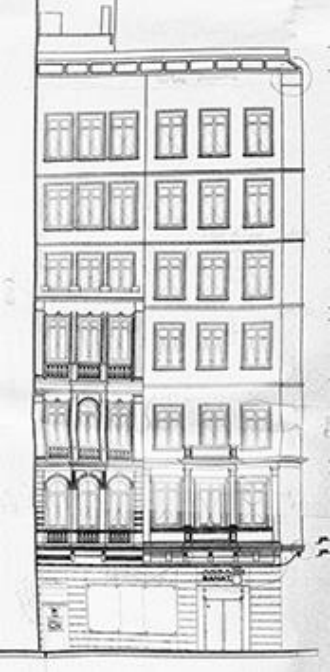
Table 3.35 Measured drawings prepared in 2010 (the drawings were obtained from İstanbul No. II Regional Conservation Committee of Cultural Assets Archive)

| GROUND FLOOR PLAN | NORTH FAÇADE | EAST FAÇADE |
| FIRST FLOOR PLAN | SECTION | |

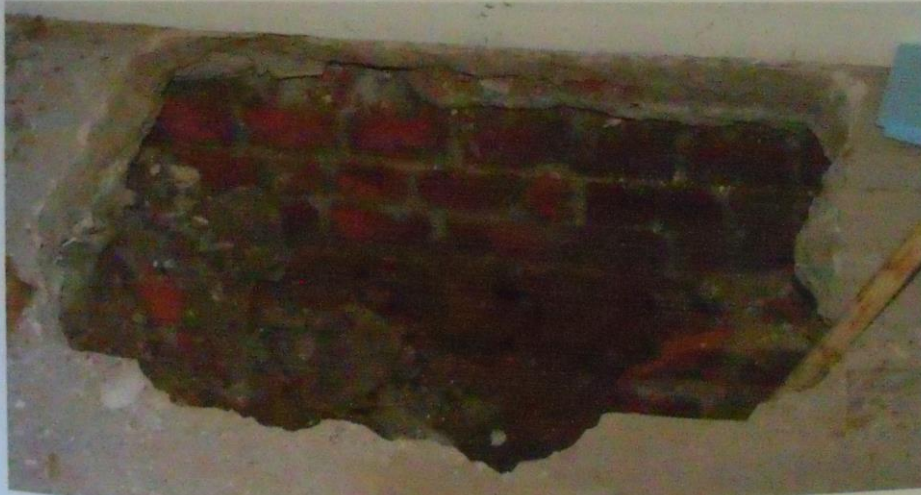
1.Bodrum kat (-3.98 m.) temel

Bu durum deprem yükleri açısından, binaya hiç yeni fonksiyon verilmesi de sakıncalı bir durum ortaya koymaktadır. Binanın kısa yönünde (kuzey-güney) ciddi bir deprem karşısındaki dayanımı çok zayıf olacaktır. Bu durum statik raporlar ve yerinde yapılan testlerle de bilimsel olarak ortaya konulmuştur. Binanın mevcut statik durumu açısından ikinci önemli tespit de yapının temel derinliği ile ilgilidir. Binanın -3.98 m. kotunda yapılan sondaj çalışması sonucu yapının özgün temel derinliği ve kullanılan malzemeler görülmüştür. Bina taşıyıcı duvar altı mevcut temel derinliği 30 cm. olarak ölçülmüştür.

Bu durum, mevcut kat adedi ve etkileyen yükler dikkate alındığında, mevcut taş duvar alt temel sisteminin yetersiz<sup>1</sup> olmasına neden olmaktadır.
