**ANALYTICAL EVALUATION OF SELECTED CONCRETE  
STRUCTURES AGAINST EARTHQUAKES IN TURKEY**

**M.Sc. THESIS IN  
CIVIL ENGINEERING**

**FERİDE CEYLAN**

**JANUARY 2024**

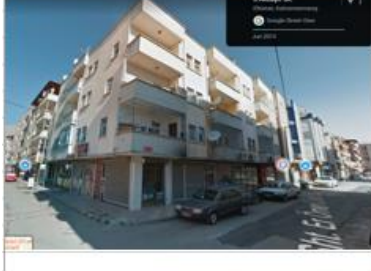
| | 45. YAPI | kat sayısı | 4 | | | YSP(BAÇP) | BDP |

| | | deprem sınıfı puanı | 2. bölge | | 90 | 75 | 75 |
| | | yumuşak kat | var | 1 | 30 | | |

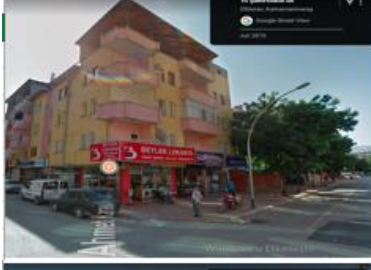
| | 46. YAPI | kat sayısı | 5 | | | YSP(BAÇP) | BDP |

| | | deprem sınıfı puanı | 2. bölge | | 80 | 65 | 20 |
| | | yumuşak kat | var | 1 | 30 | | |

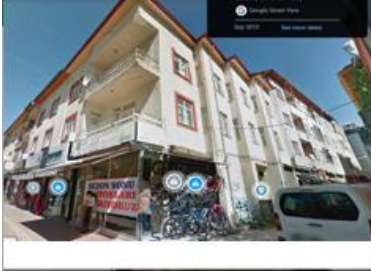
| | 47. YAPI | kat sayısı | 3 | | | YSP(BAÇP) | BDP |

| | | deprem sınıfı puanı | 2. bölge | | 100 | | 15 |
| | | yumuşak kat | var | 1 | 20 | | |

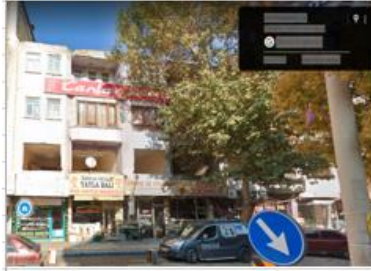
| | 49. YAPI | kat sayısı | 4 | | | YSP(BAÇP) | BDP |

| | | deprem sınıfı puanı | 2.bölge | | 90 | | 25 |
| | | yumuşak kat | var | 1 | 30 | | |

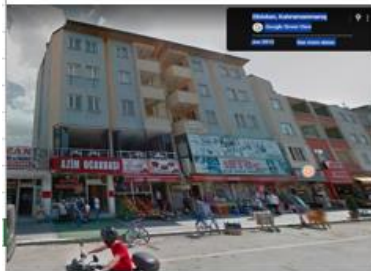
| | 50. YAPI | kat sayısı | 5 | | | YSP(BAÇP) | BDP |

| | | deprem sınıfı puanı | 2. bölge | | 80 | 65 | 105 |
| | | yumuşak kat | var | 1 | 30 | | |

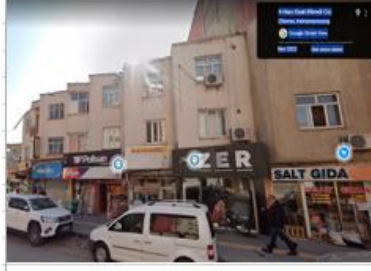
| | 51. YAPI | kat sayısı | 3 | | | YSP(BAÇP) | BDP |

| | | deprem sınıfı puanı | 2. bölge | | 100 | | 15 |
| | | yumuşak kat | var | 1 | 20 | | |

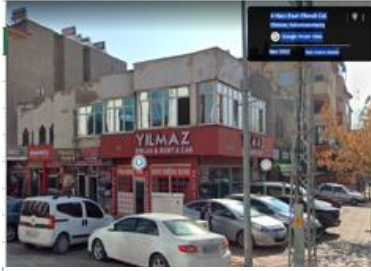
| | 52. YAPI | kat sayısı | 2 | | | YSP(BAÇP) | BDP |

| | | deprem sınıfı puanı | 2. bölge | | 120 | | 60 |
| | | yumuşak kat | var | 1 | 10 | | |

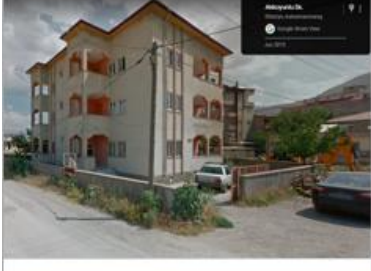
| | 53. YAPI | kat sayısı | 4 | | | YSP(BAÇP) | BDP |

| | | deprem sınıfı puanı | 2. bölge | | 90 | | 70 |
| | | yumuşak kat | yok | 0 | 30 | | |

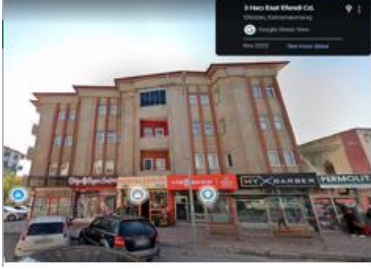
| | 54. YAPI | kat sayısı | 4 | | | YSP(BAÇP) | BDP |

| | | deprem sınıfı puanı | 2. bölge | | 90 | 75 | 75 |
| | | yumuşak kat | var | 1 | 30 | | |

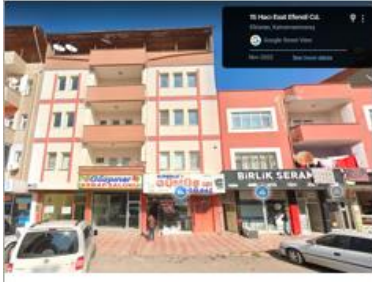
| 55. YAPI | kat sayısı | 5 | | | YSP(BAÇP) | BDP |

| | deprem sınıfı puanı | 2. bölge | | 80 | 65 | 55 |

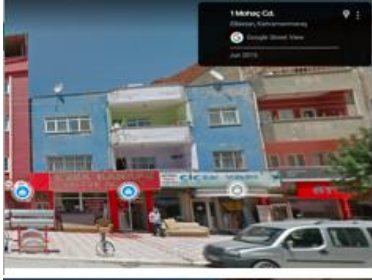
| 56. YAPI | kat sayısı | 3 | | | YSP(BAÇP) | BDP |

| | deprem sınıfı puanı | 2. bölge | | 100 | | 35 |

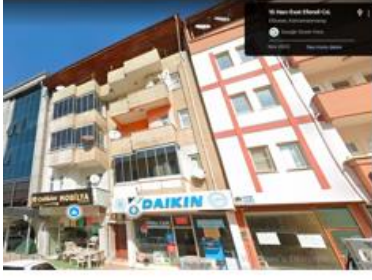
| 57. YAPI | kat sayısı | 5 | | | YSP(BAÇP) | BDP |

| | deprem sınıfı puanı | 2. bölge | | 80 | 65 | 30 |

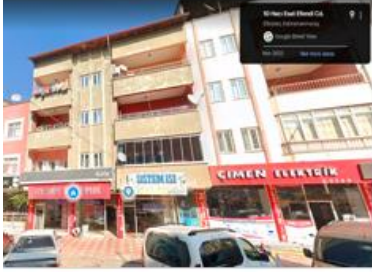
| 58. YAPI | kat sayısı | 4 | | | YSP(BAÇP) | BDP |

| | deprem sınıfı puanı | 2. bölge | | 90 | 75 | 75 |

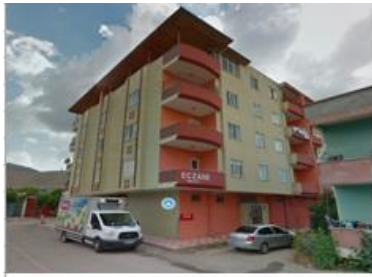
| 79. YAPI | kat sayısı | 5 | | | YSP(BAÇP) | BDP |

| | deprem sınıfı puanı | 2. bölge | | 80 | 65 | 85 |

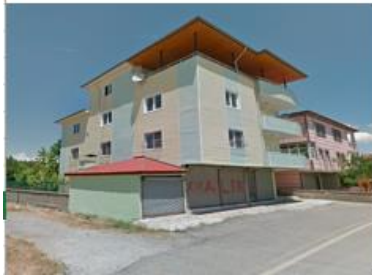
| 80. YAPI | kat sayısı | 4 | | | YSP(BAÇP) | BDP |

| | deprem sınıfı puanı | 2. bölge | | 90 | 0 | 0 |

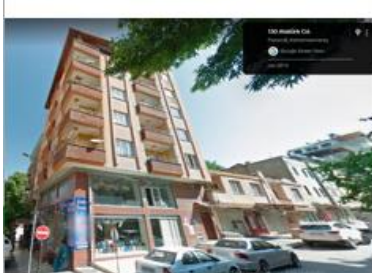
| 96. YAPI | kat sayısı | 7 | | | YSP(BAÇP) | BDP |

| | deprem sınıfı puanı | 1. bölge | | 50 | 55 | 0 |

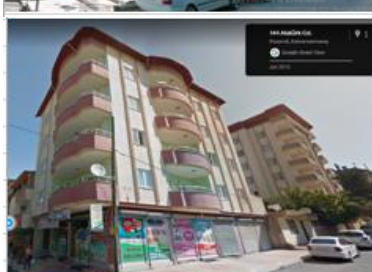
| 97. YAPI | kat sayısı | 5 | | | YSP(BAÇP) | BDP |

| | deprem sınıfı puanı | 1. bölge | | 60 | 65 | 45 |

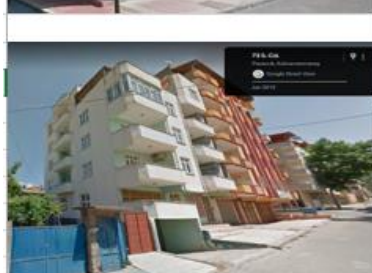
| 98. YAPI | kat sayısı | 5 | | | YSP(BAÇP) | BDP |

| | deprem sınıfı puanı | 1. bölge | | 60 | 65 | 35 |

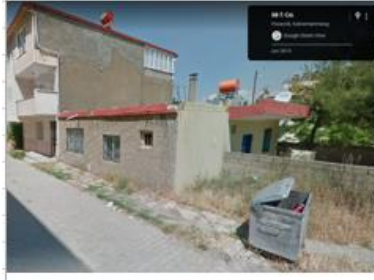
| 99. YAPI | kat sayısı | 1 | | | YSP(BAÇP) | BDP |

| | deprem sınıfı puanı | 1. bölge | | 90 | | 55 |

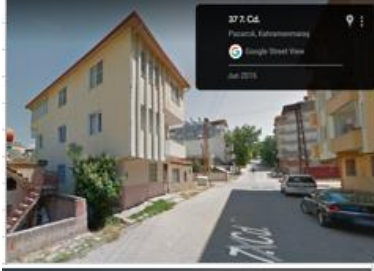
| 100. YAPI | kat sayısı | 3 | | | YSP(BAÇP) | BDP |

| | deprem sınıfı puanı | 1. bölge | | 80 | | 25 |

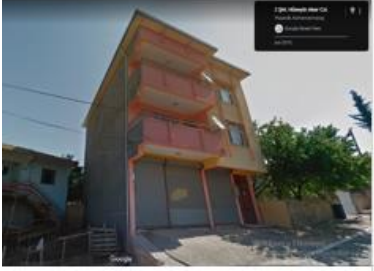
| 101. YAPI | kat sayısı | 3 | | | YSP(BAÇP) | BDP |

| | deprem sınıfı puanı | 1.bölge | | 80 | | 20 |

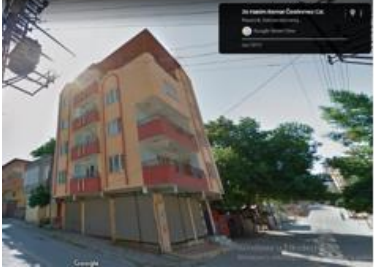
| 102. YAPI | kat sayısı | 5 | | | YSP(BAÇP) | BDP |

| | deprem sınıfı puanı | 1. bölge | | 60 | 65 | 17 |
